How to Construct an AC Mitigation system from an operator's perspective

From a 6 month to 1 year perspective

Jon-Michael Brand
T&S Corrosion Project Engineer
Consumers Energy

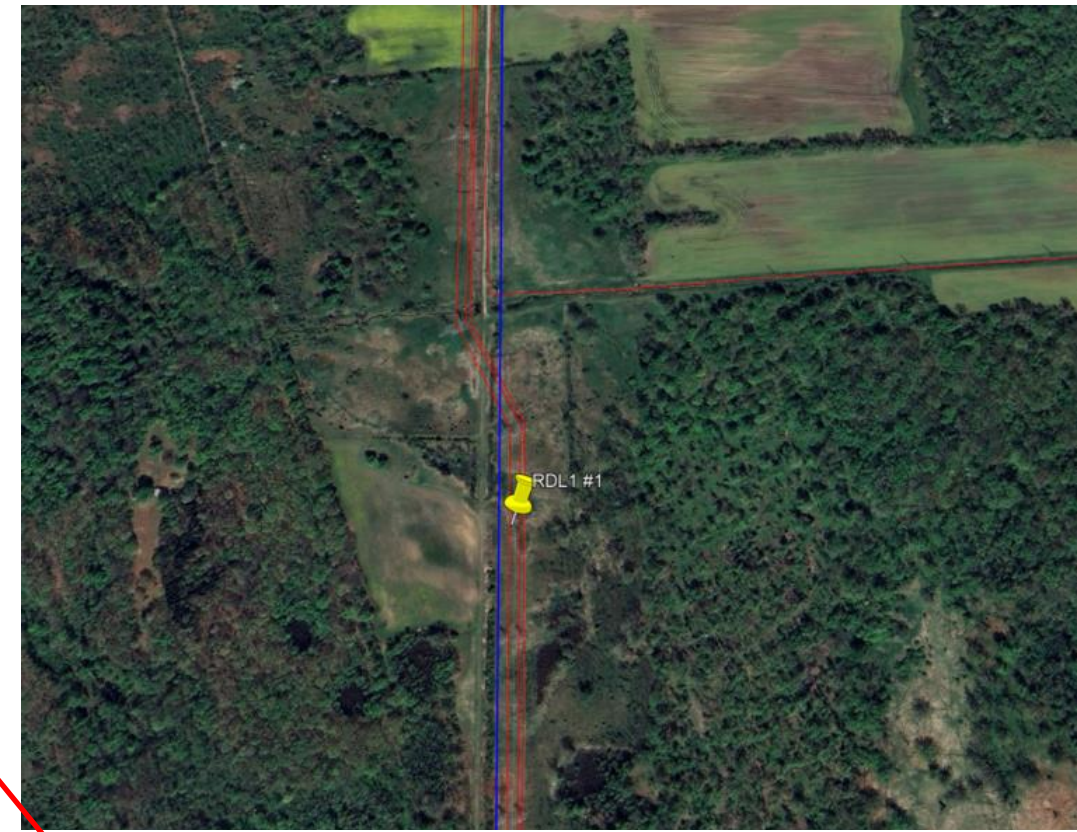
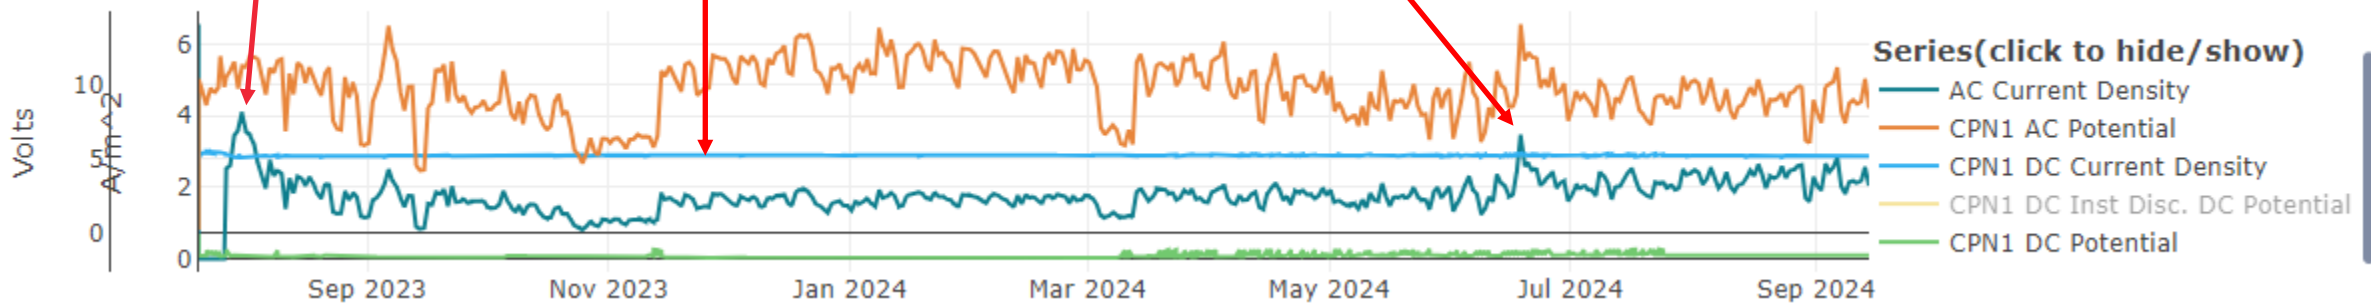
L-1300 RDL#1

- RDL#1- 1.2 miles of B Ave.
 - 6/2/2023 – 7:49 am – 10.1 VAC

No Real Concern

- AC Current Density less than 4 A/m²
- AC voltage less than 15 VAC
- **DC** Current Density averages around 2.5 A/m²

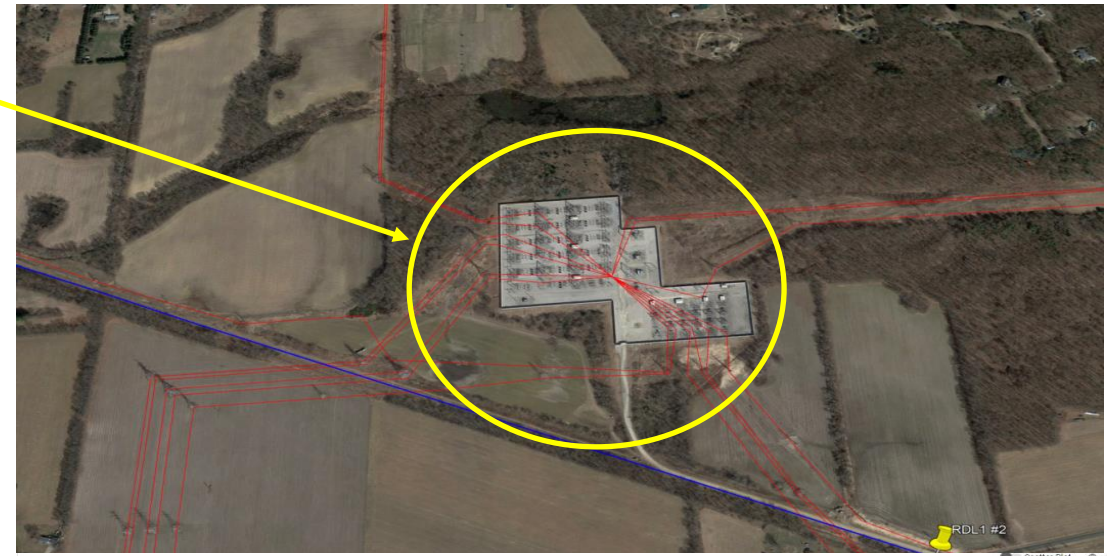
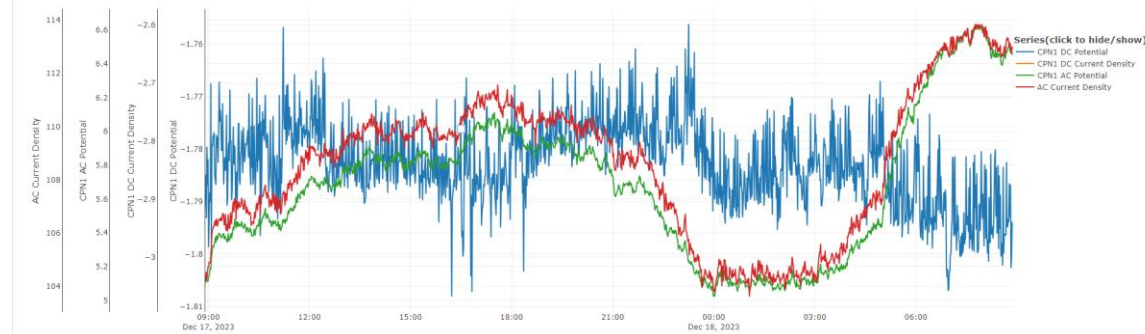
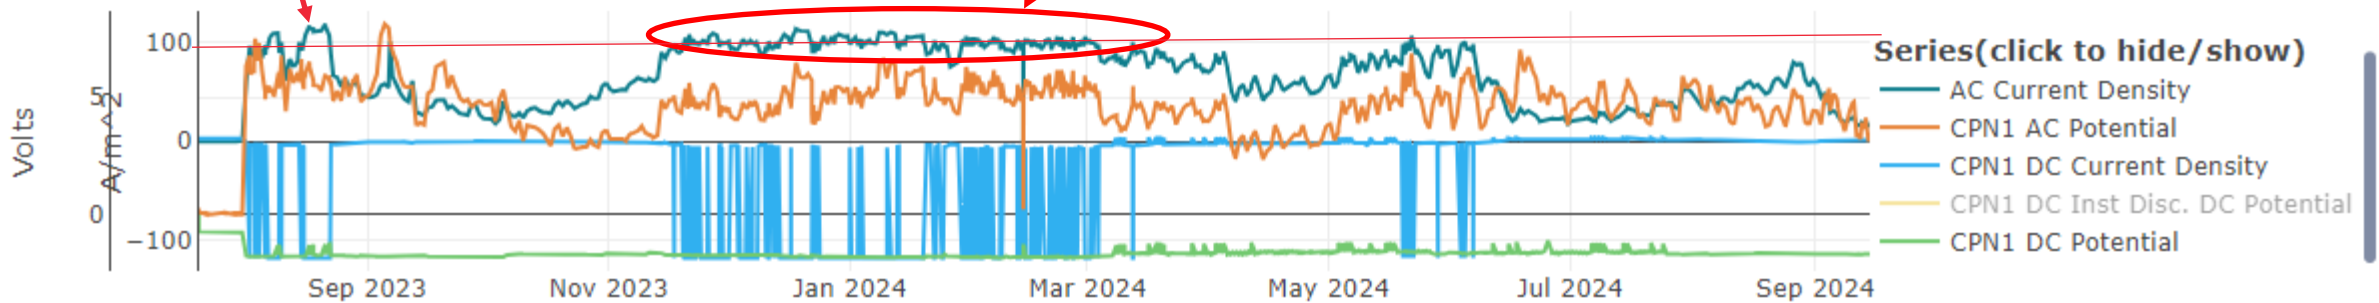
L-1300 RDL#2

- RDL#2 Riverside Drive
 - 6/2/2023 – 7:49 am – 10.1 VAC

No Real Concern

- AC Current Density over 100 A/m²
- AC voltage less than 15 VAC

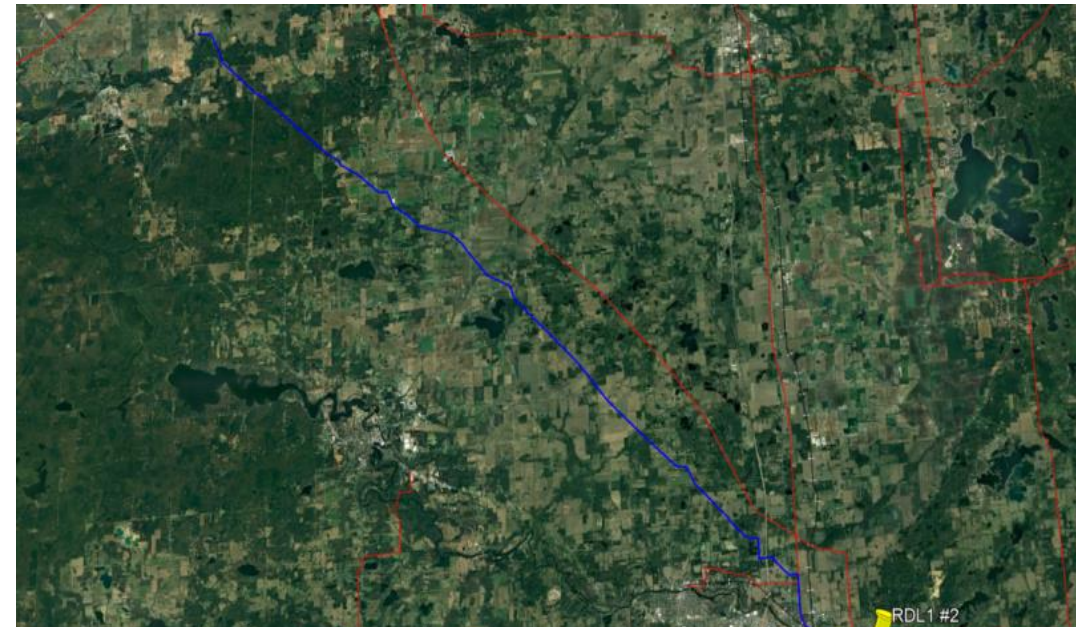
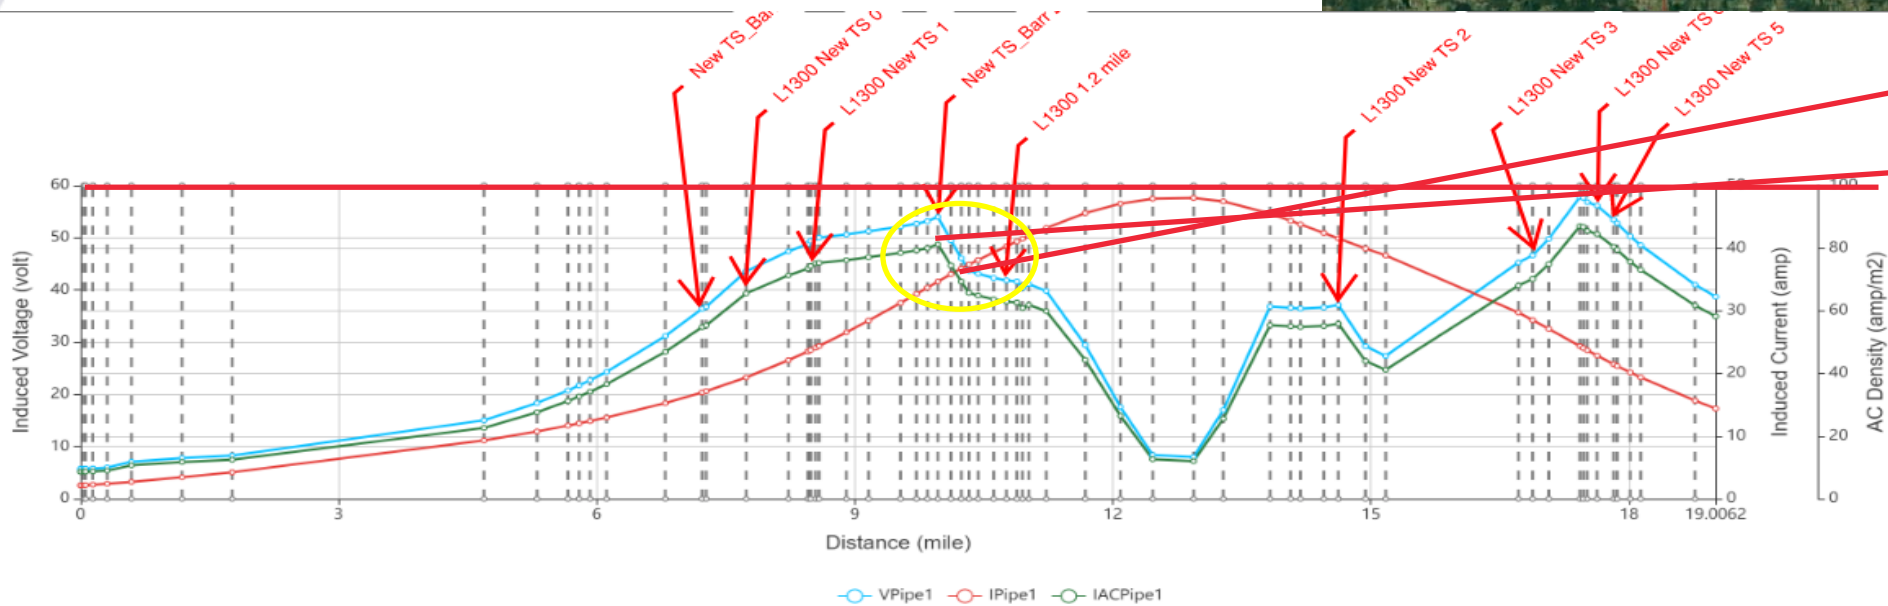
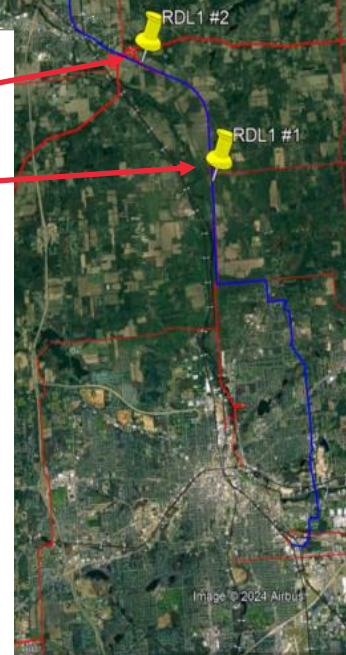
L-1300

- First Model (PRCI)
 - Zero is South
 - Some Soil res included (5', 10' & 15')
 - Model shows peaks
 - 90 VAC – Is this real?
 - Need more inputs
 - Coating Quality
 - Real Pipeline Data
 - AC Voltages
 - DC Potentials
 - Coupon Current Densities
 - AC - 1cm²
 - DC – 10 cm²

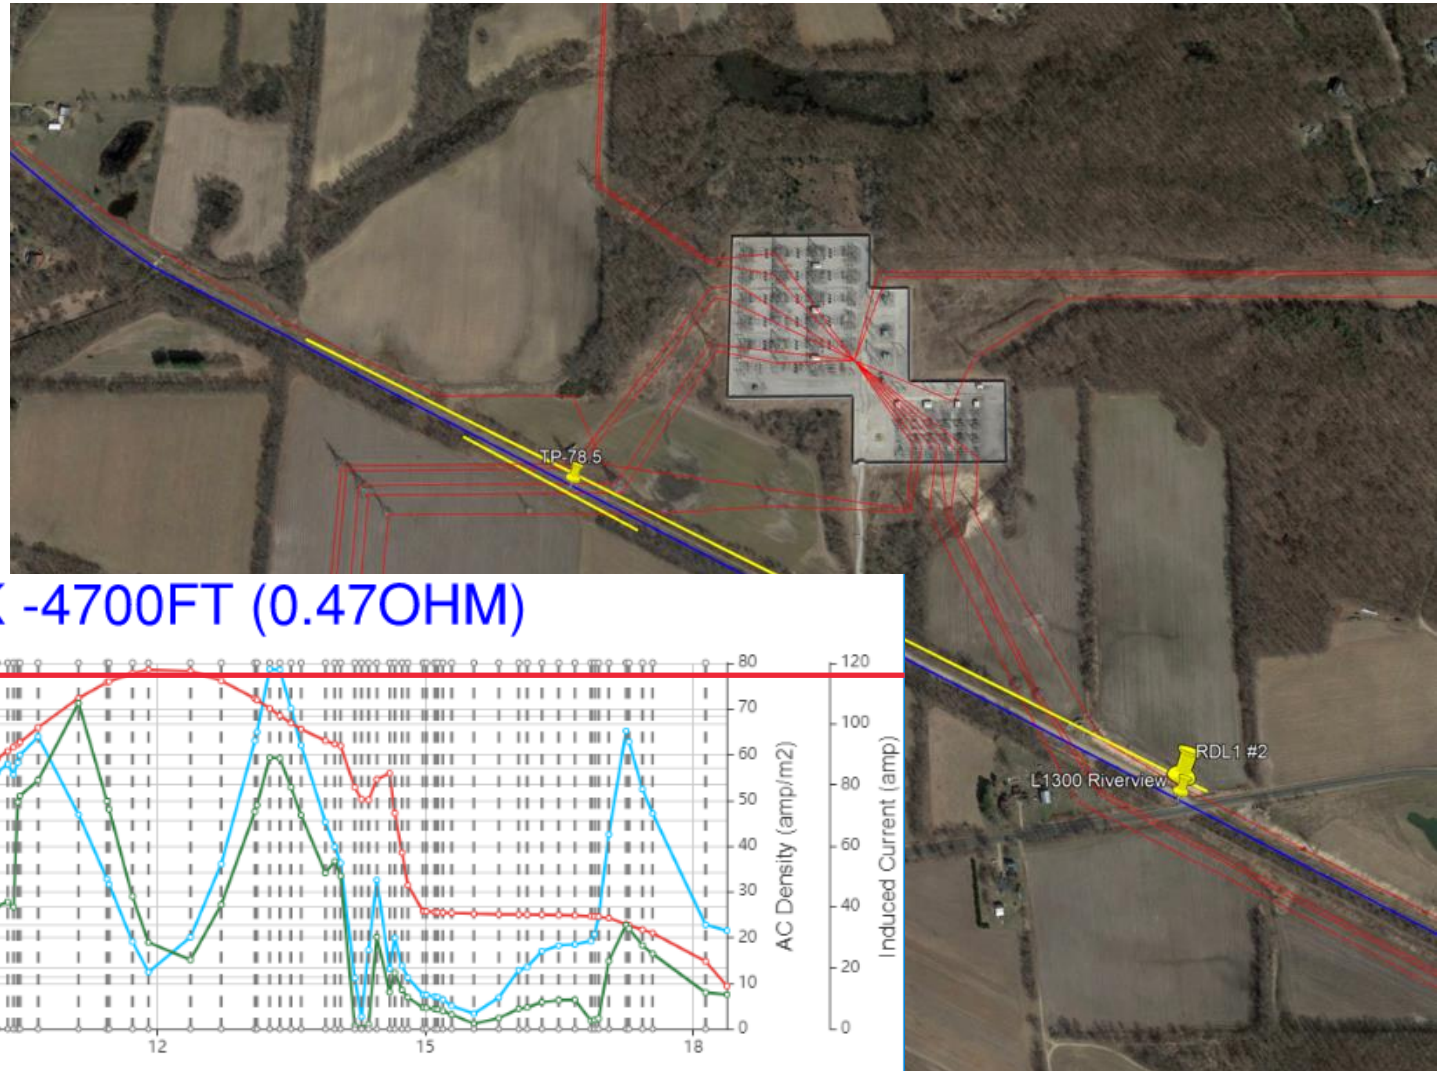
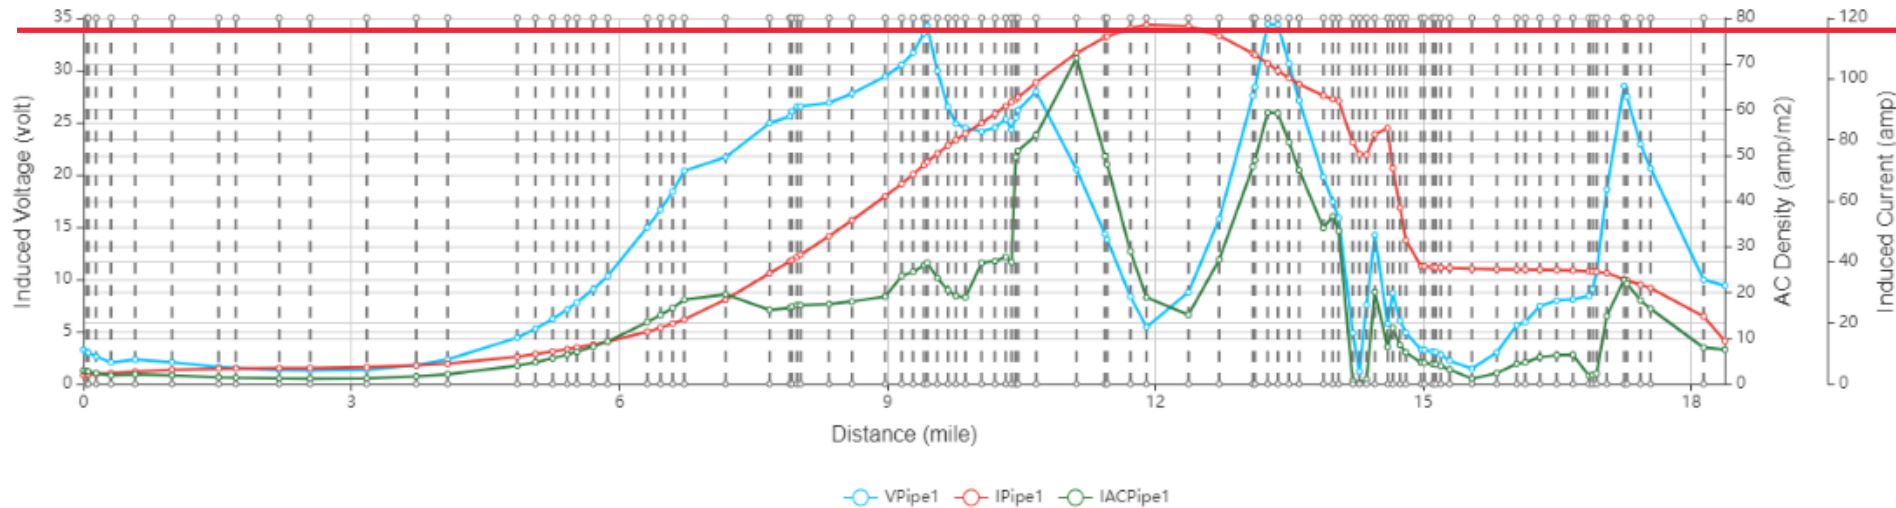
L-1300

RIVERVIEW TO CREEK -4700FT (0.47OHM)

- 4700' of 2/0 Copper
- Might need more mitigation, but we got mitigation installed with our time frame
- Now-
 - Monitor and add more mitigation as needed.
 - The clock has started again.

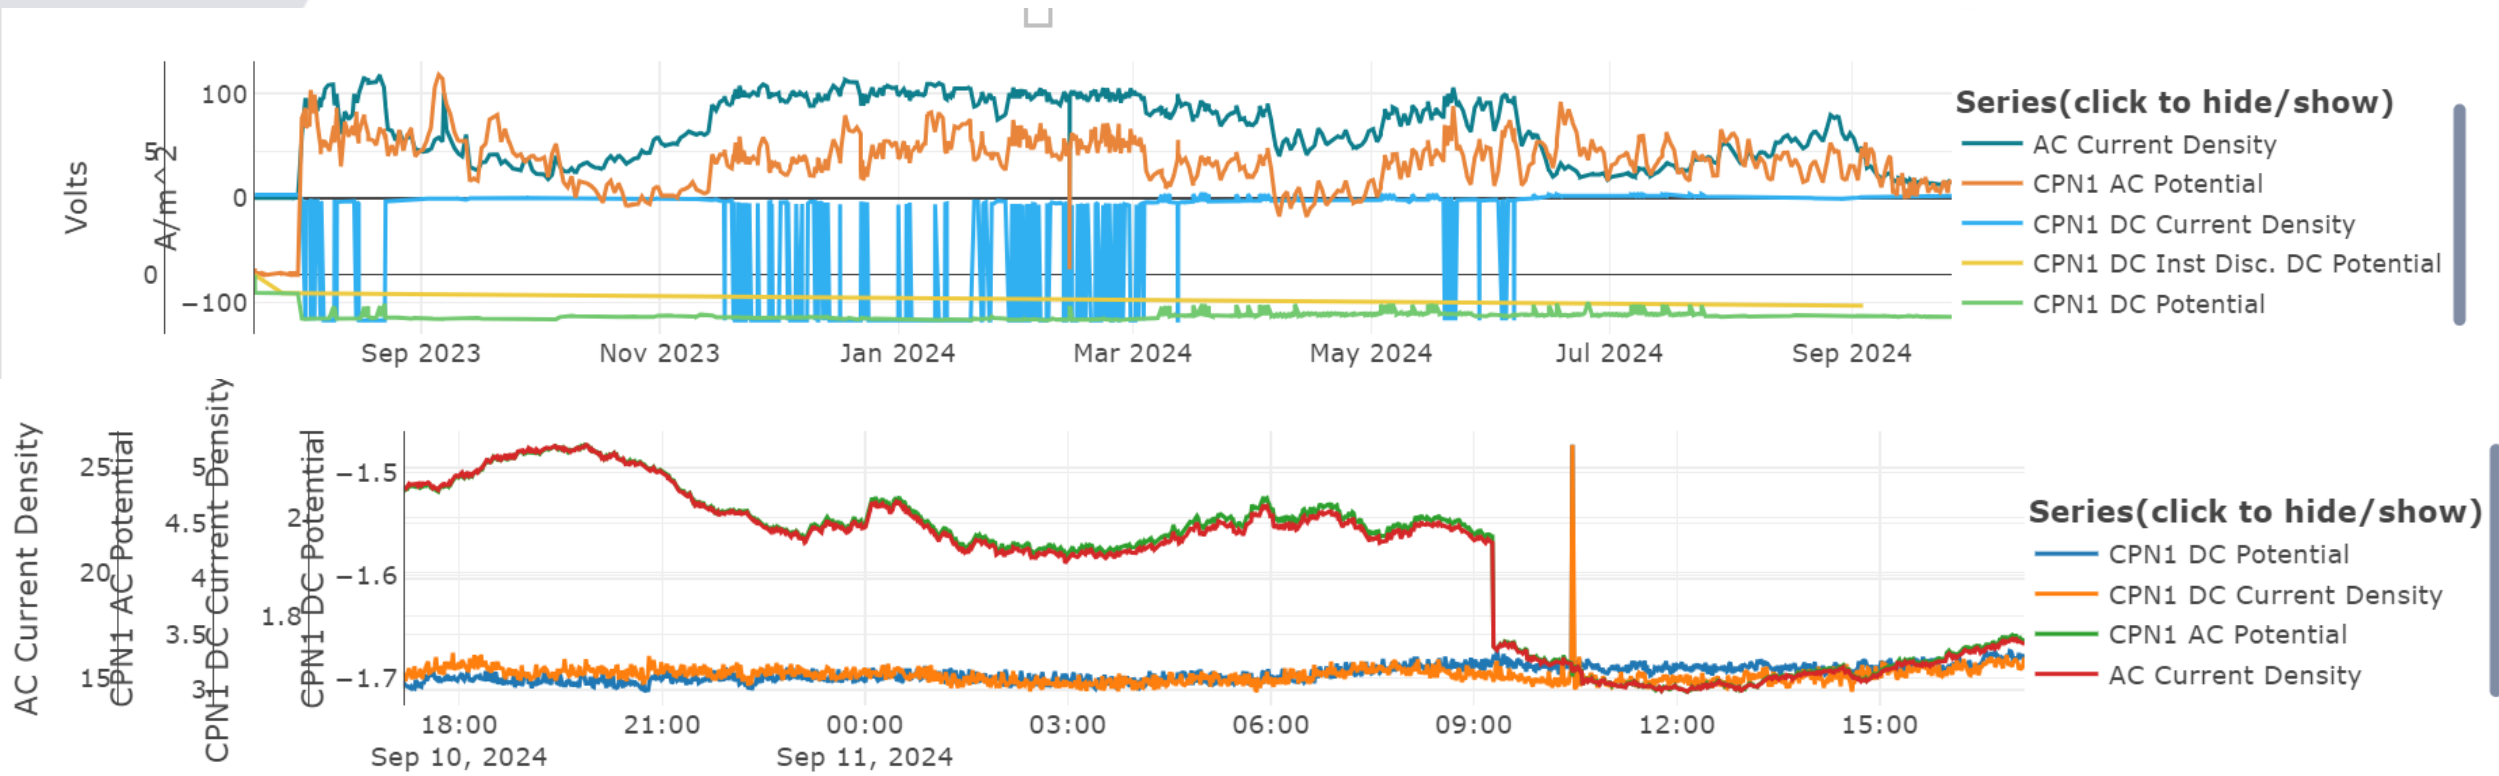
L-1300

25% Reduction in current density

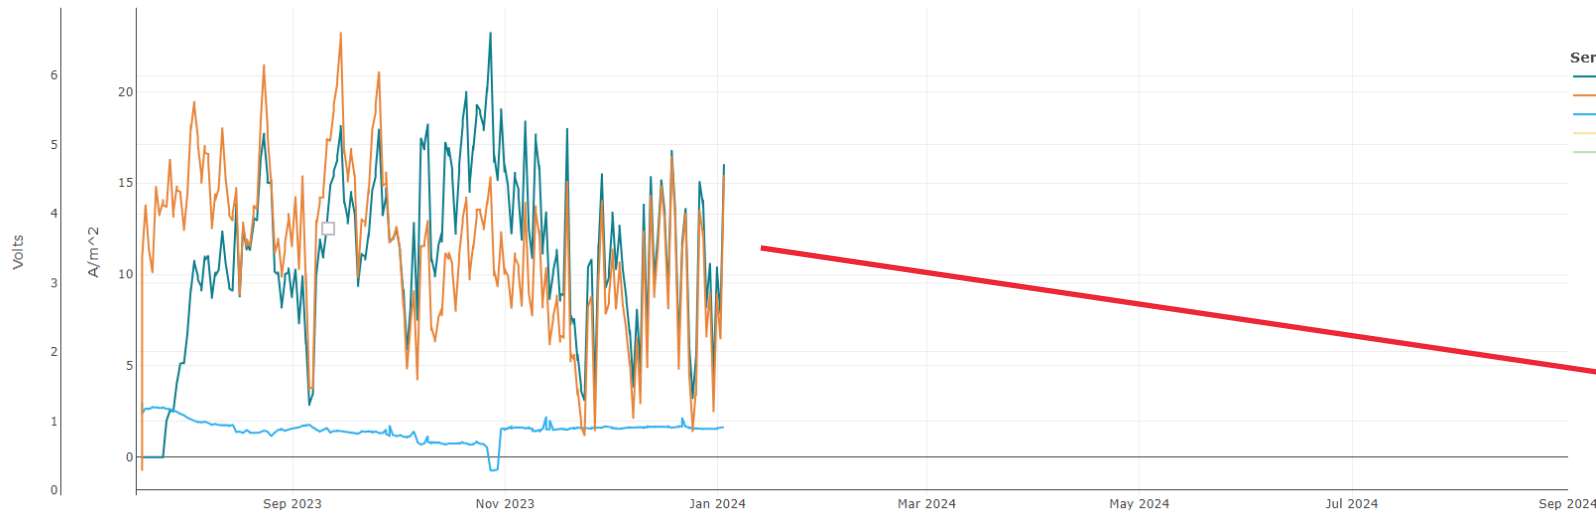
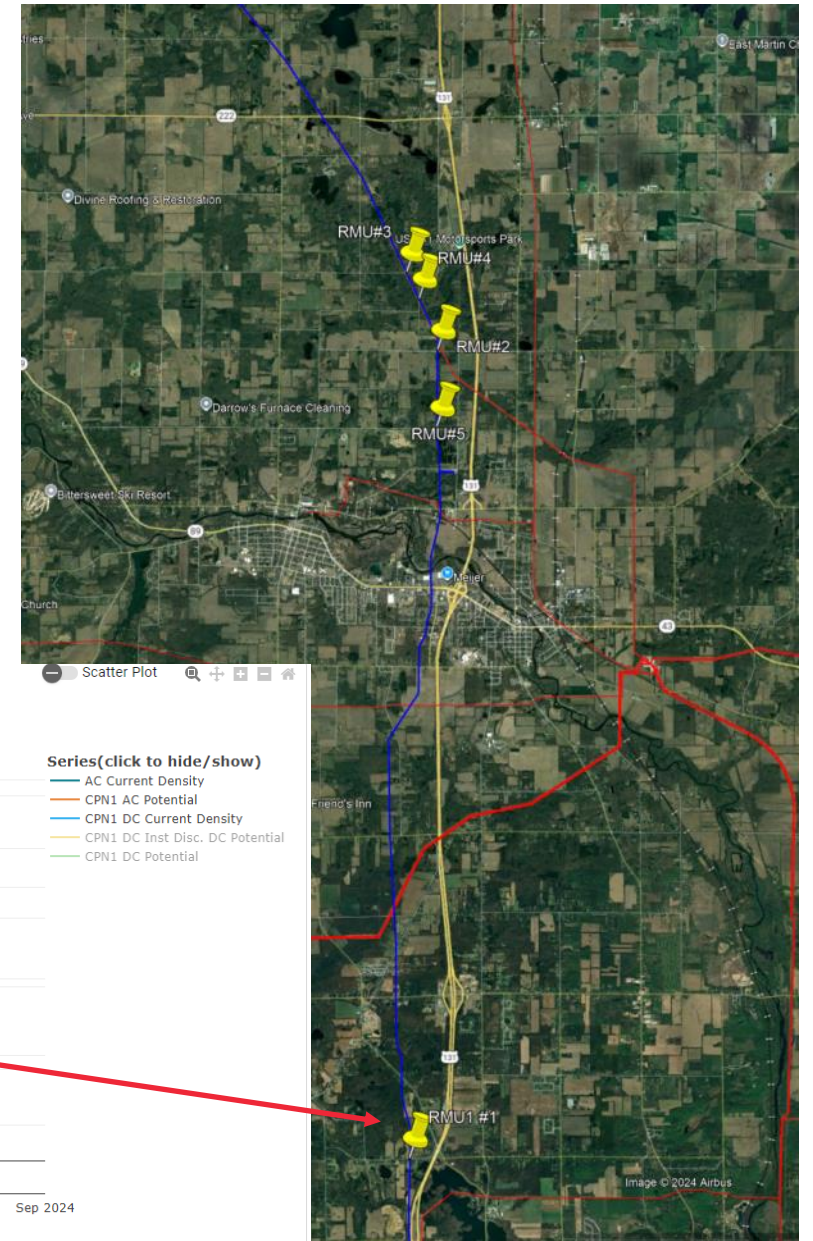
- AC Investigation Starts July of 2023
- RMU #1
 - Stopped working in Winter of 2024
 - Low AC Voltages
 - AC Current Densities 10 to 20 A/m²
 - DC Current Densities over 1 A/m²
- Continue to Monitor, but does not appear to be any real AC interferences.

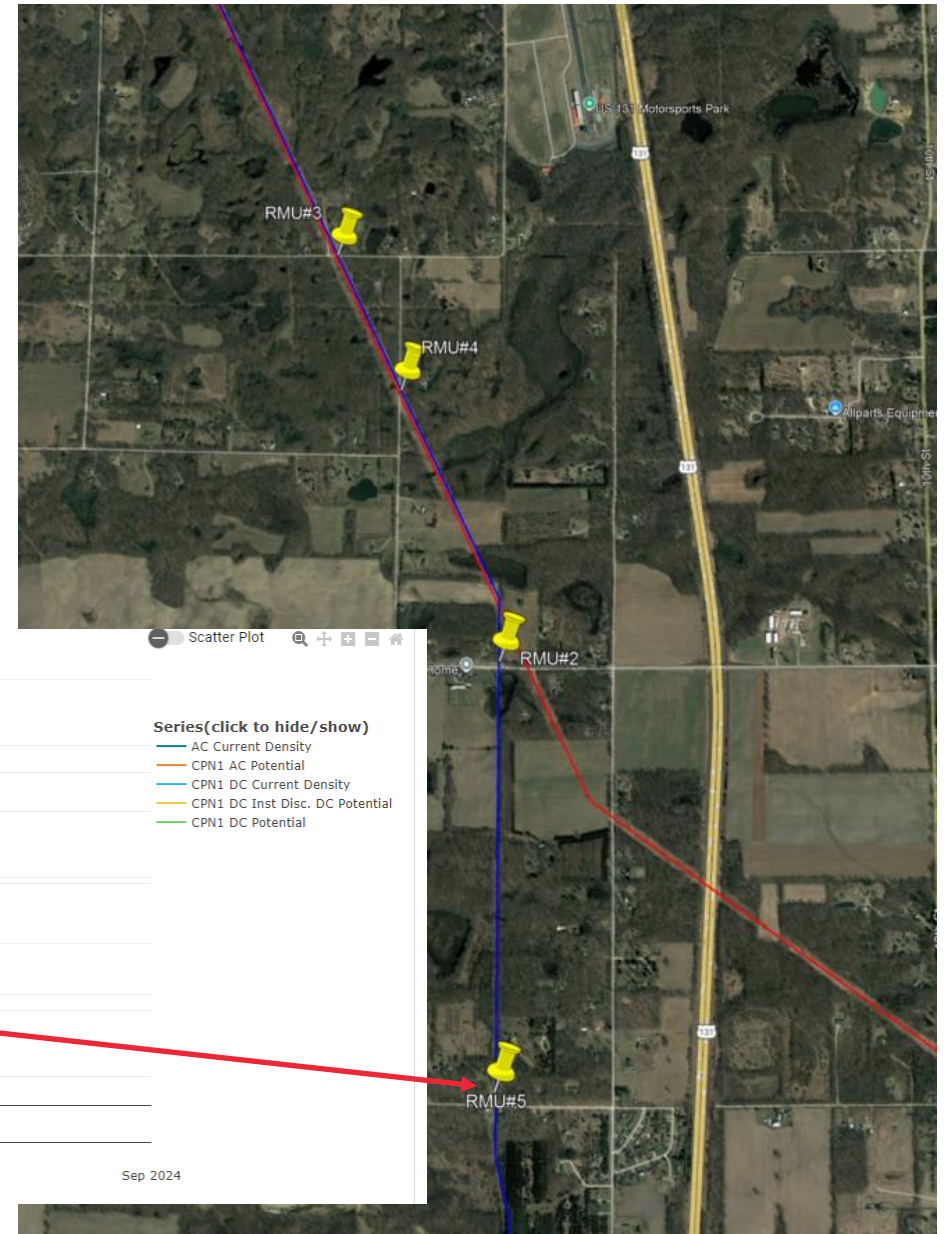
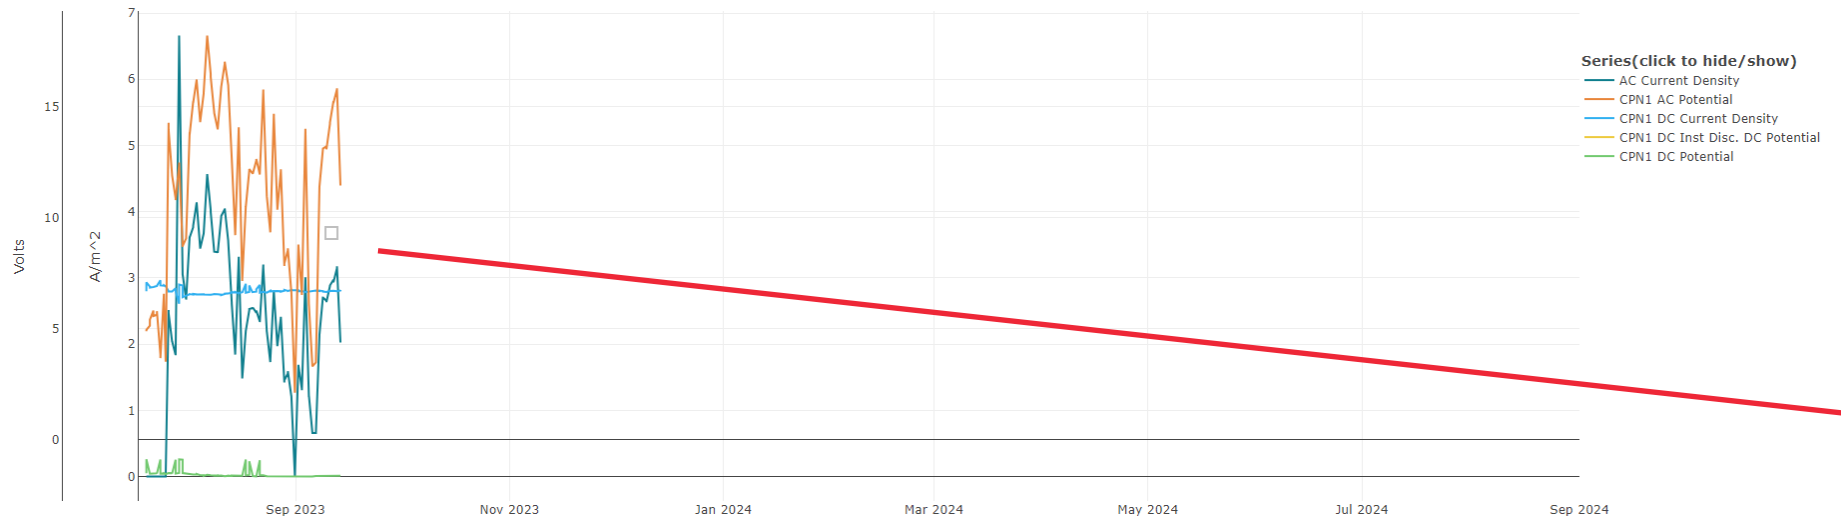
- AC Investigation Starts July of 2023
- RMU #5
 - Stopped working in September of 2023
 - AC Voltages between 10 and 15
 - AC Current Densities very low
 - DC Current Densities over 2 A/m²

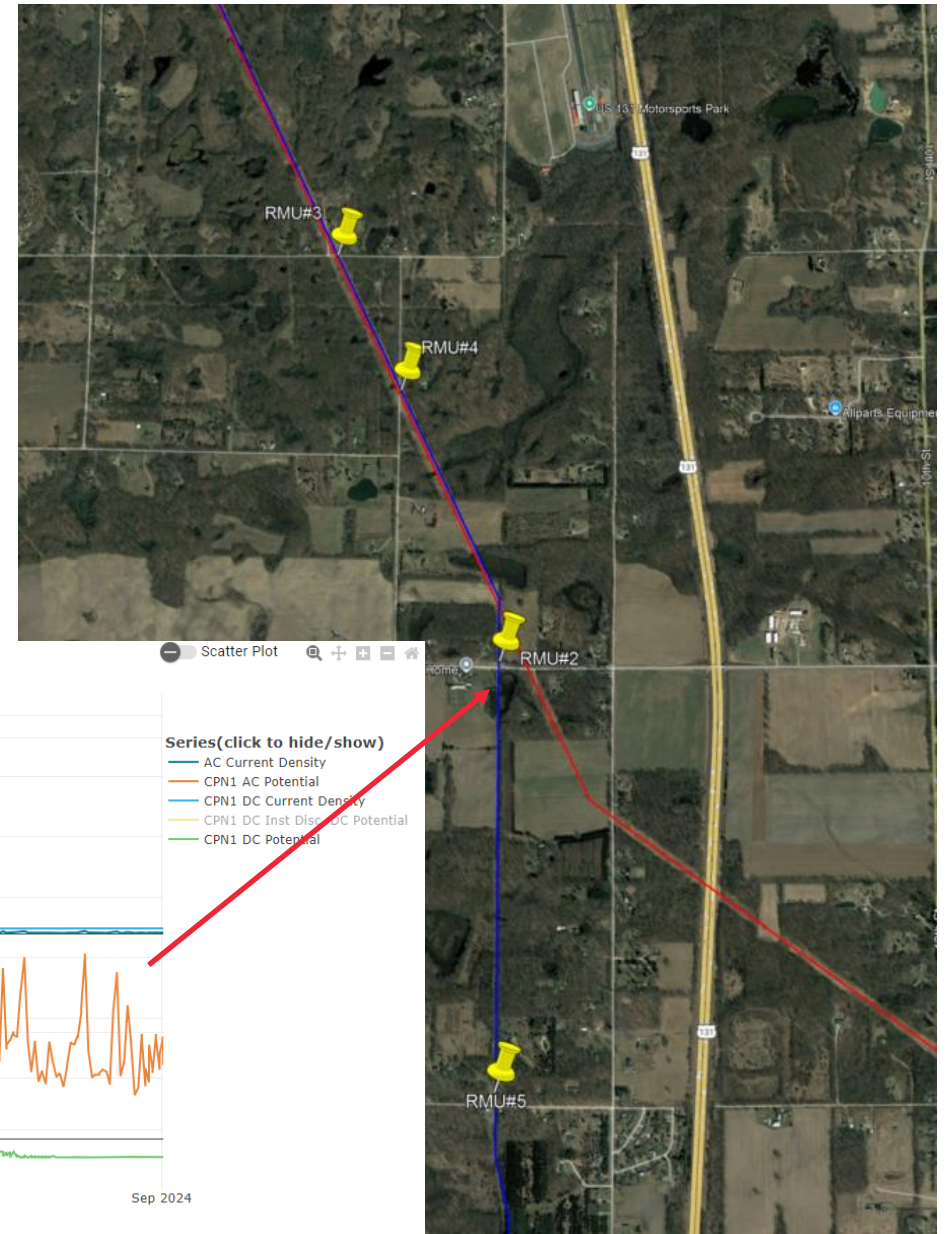
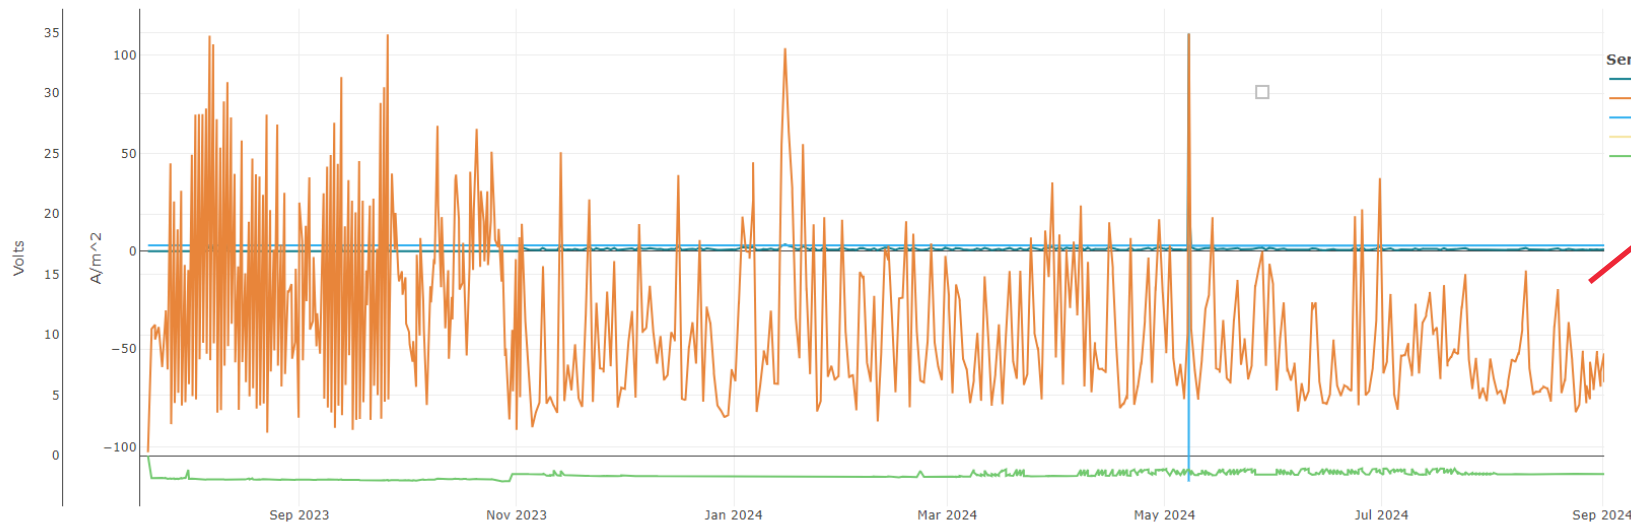
- AC Investigation Starts July of 2023
- RMU #2
 - AC Voltages 30+ VAC
 - AC Current Densities between 5 and 30 A/m²
 - DC Current Densities over 2 A/m²

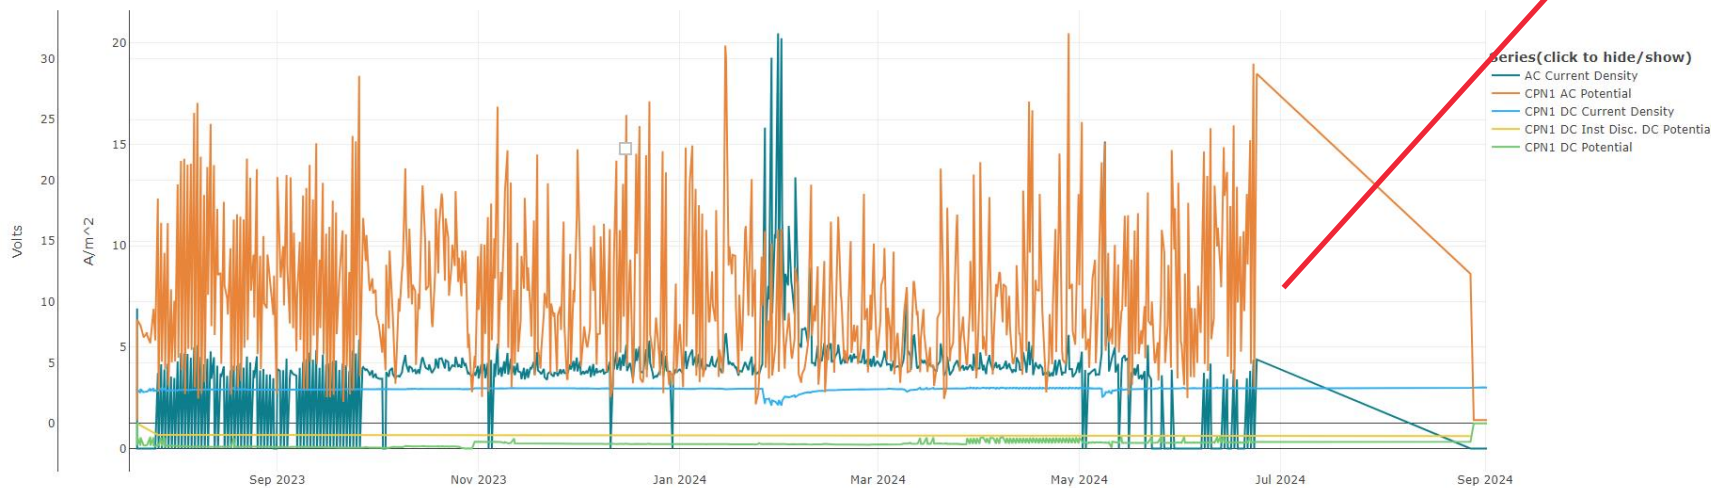
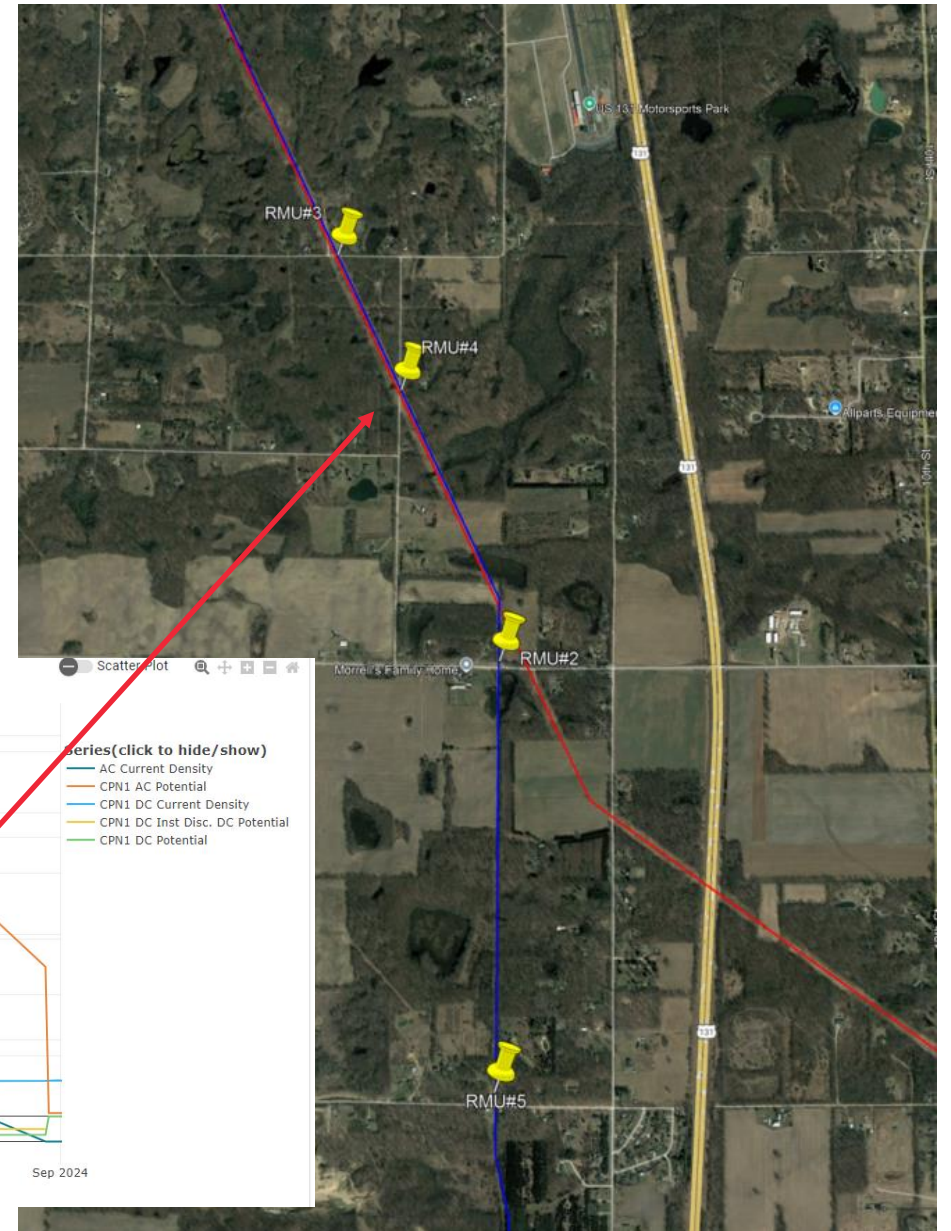
- AC Investigation Starts July of 2023
- RMU #4
 - AC Voltages between 5 and over 25 VAC
 - AC Current Densities between 5 and 15 A/m^2
 - DC Current Densities over 2 A/m^2

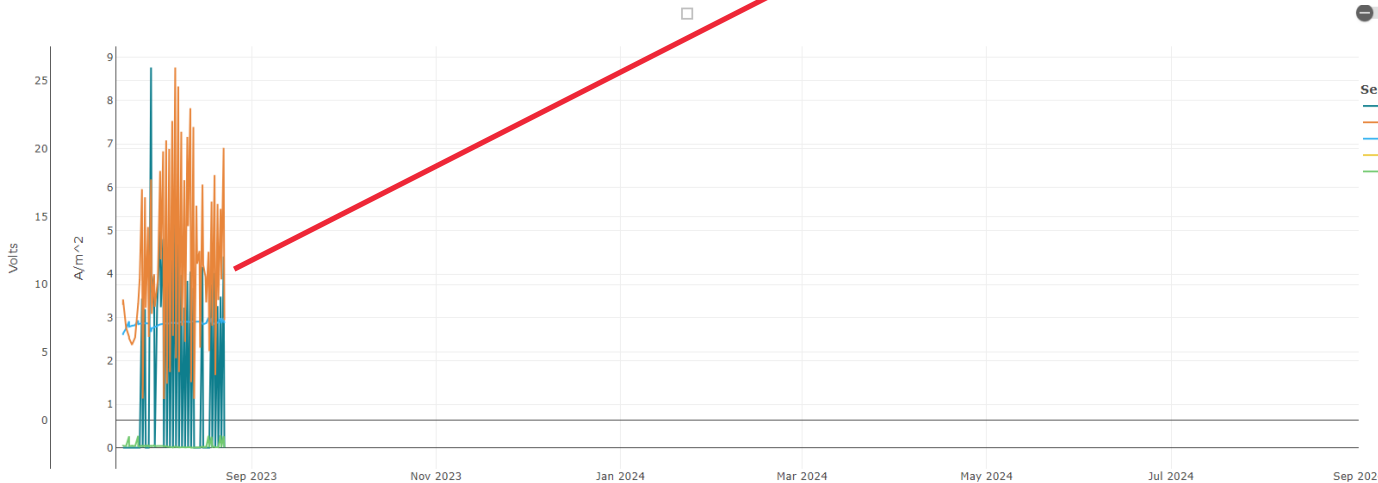
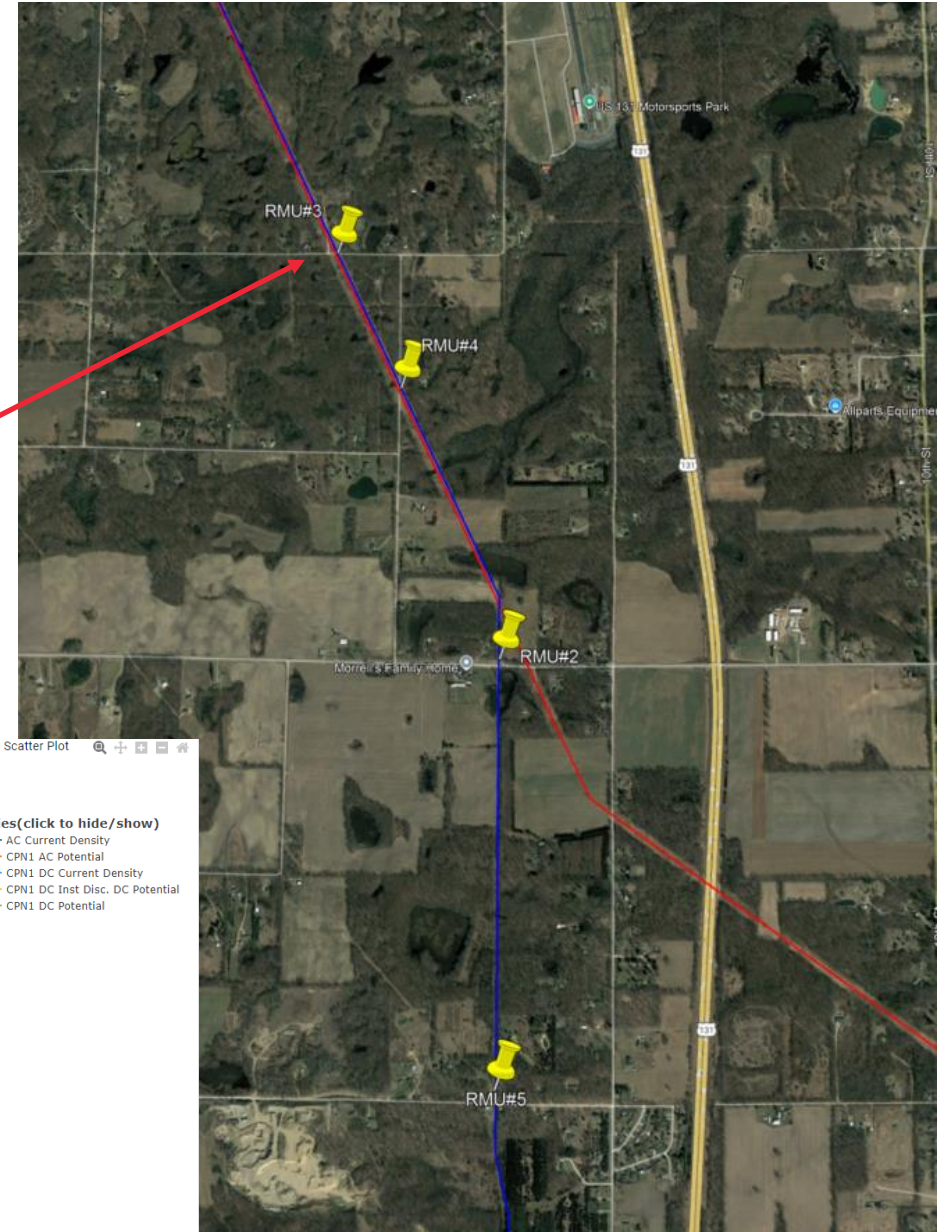
- AC Investigation Starts July of 2023
- RMU #3
 - Stopped before September of 2023
 - AC Voltages between 5 and over 25 VAC
 - AC Current Densities between 0 and 5 A/m²
 - DC Current Densities over 2 A/m²

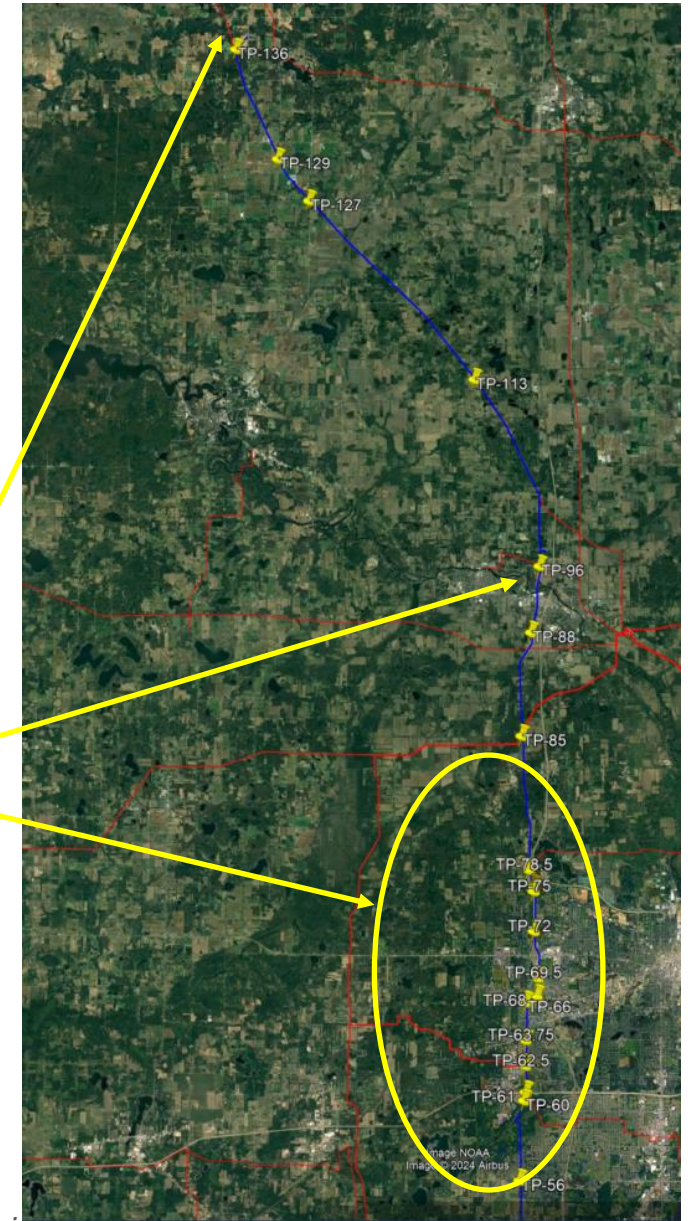
L-1800 Data Logger Data

- The Southern portion of the line shows very little AC interference
- Pulled all southern data loggers
- Two locations show high AC voltages
 - Both where the pipeline and HVAC separate (North and South)

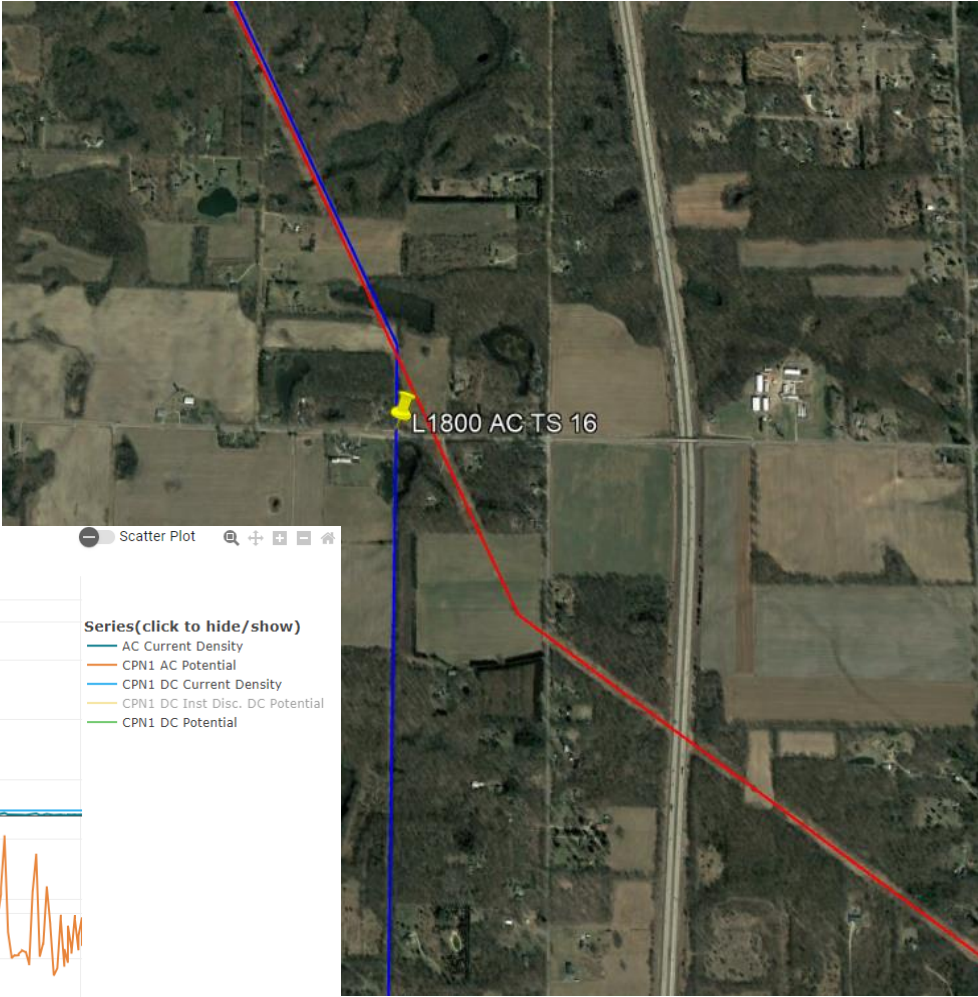
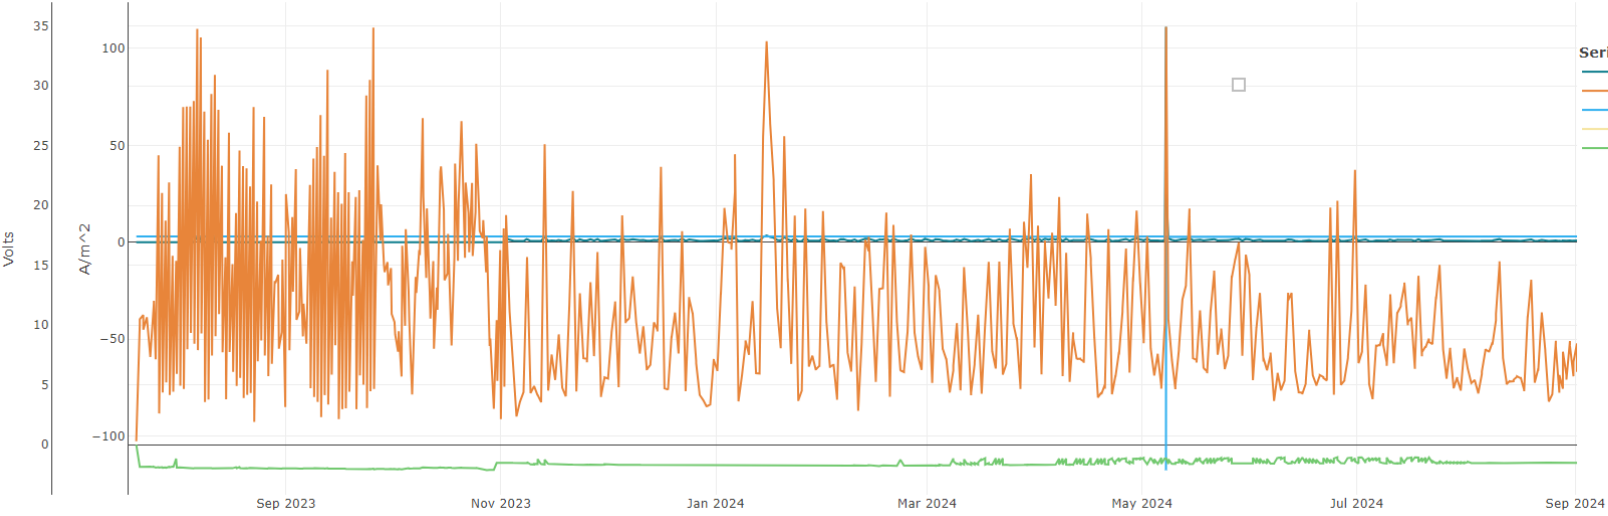
L-1800 Data Logger Data

30+ VAC
