How to Construct an AC Mitigation system from an operator's perspective

From a 6 month to 1 year perspective

Jon-Michael Brand
T&S Corrosion Project Engineer
Consumers Energy

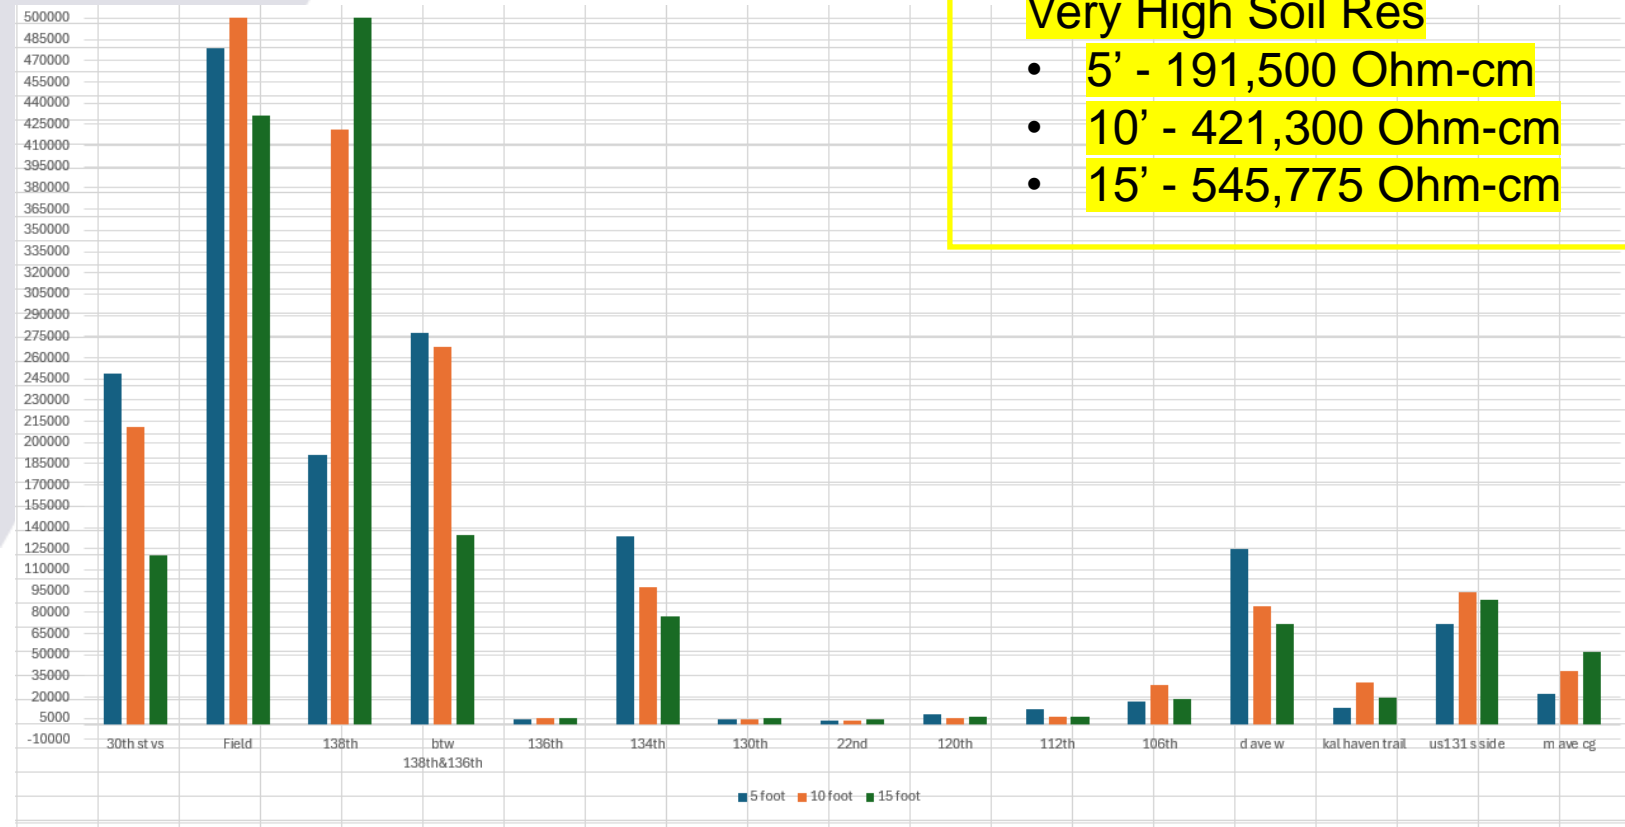
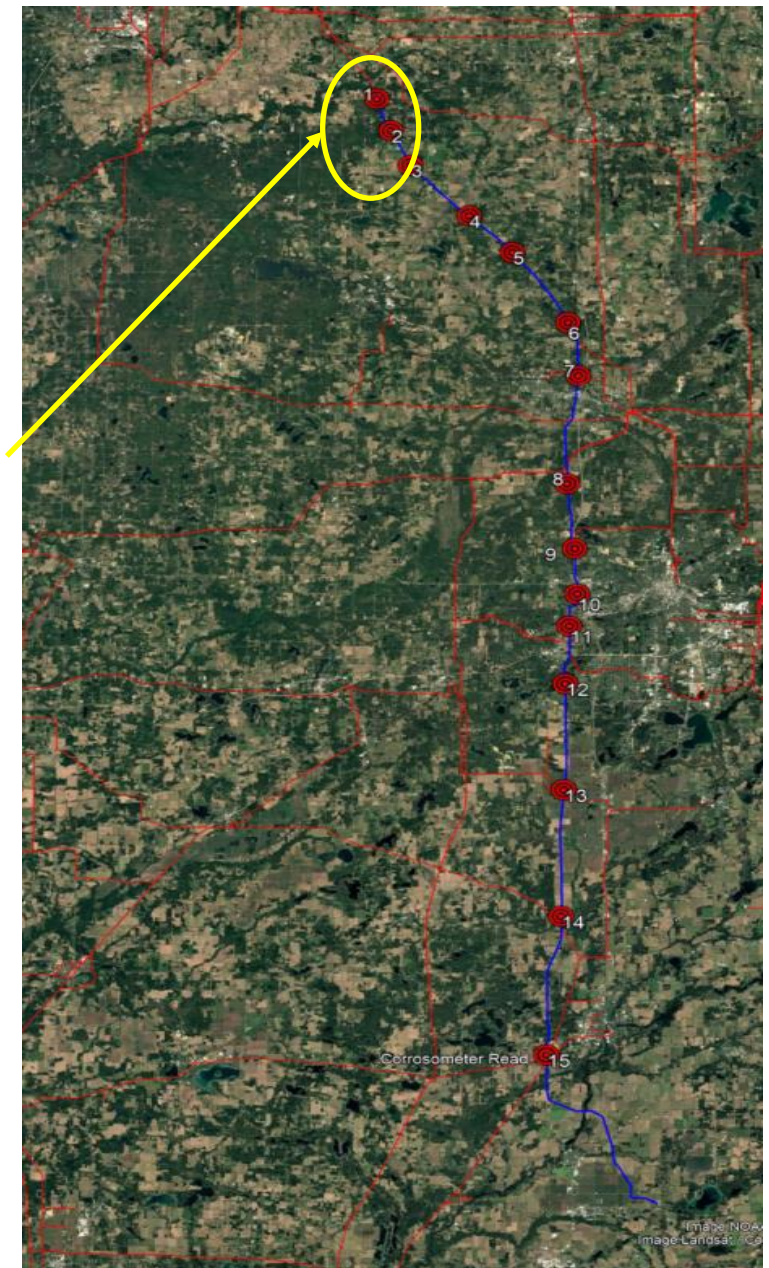
L-1800 Soil Resistivities

Very High Soil Res

- 5' - 191,500 Ohm-cm
- 10' - 421,300 Ohm-cm
- 15' - 545,775 Ohm-cm
