**ELECTRICAL SAFETY AND
FACILITY INTEGRITY:
EVALUATION OF AC POWER &
GROUNDING SYSTEM ISSUES, WHICH
FOUND . . . MORE ISSUES.**

Cal Chapman, P. E.
NACE-Certified Cathodic Protection Specialist #23357
Professional Engineer in TX, FL, LA, NM, ND, NY, OK, TN
Boerne, Texas; Houston, Texas; Columbus, Montana

WEST TEXAS PRODUCED WATER MANAGEMENT FACILITY

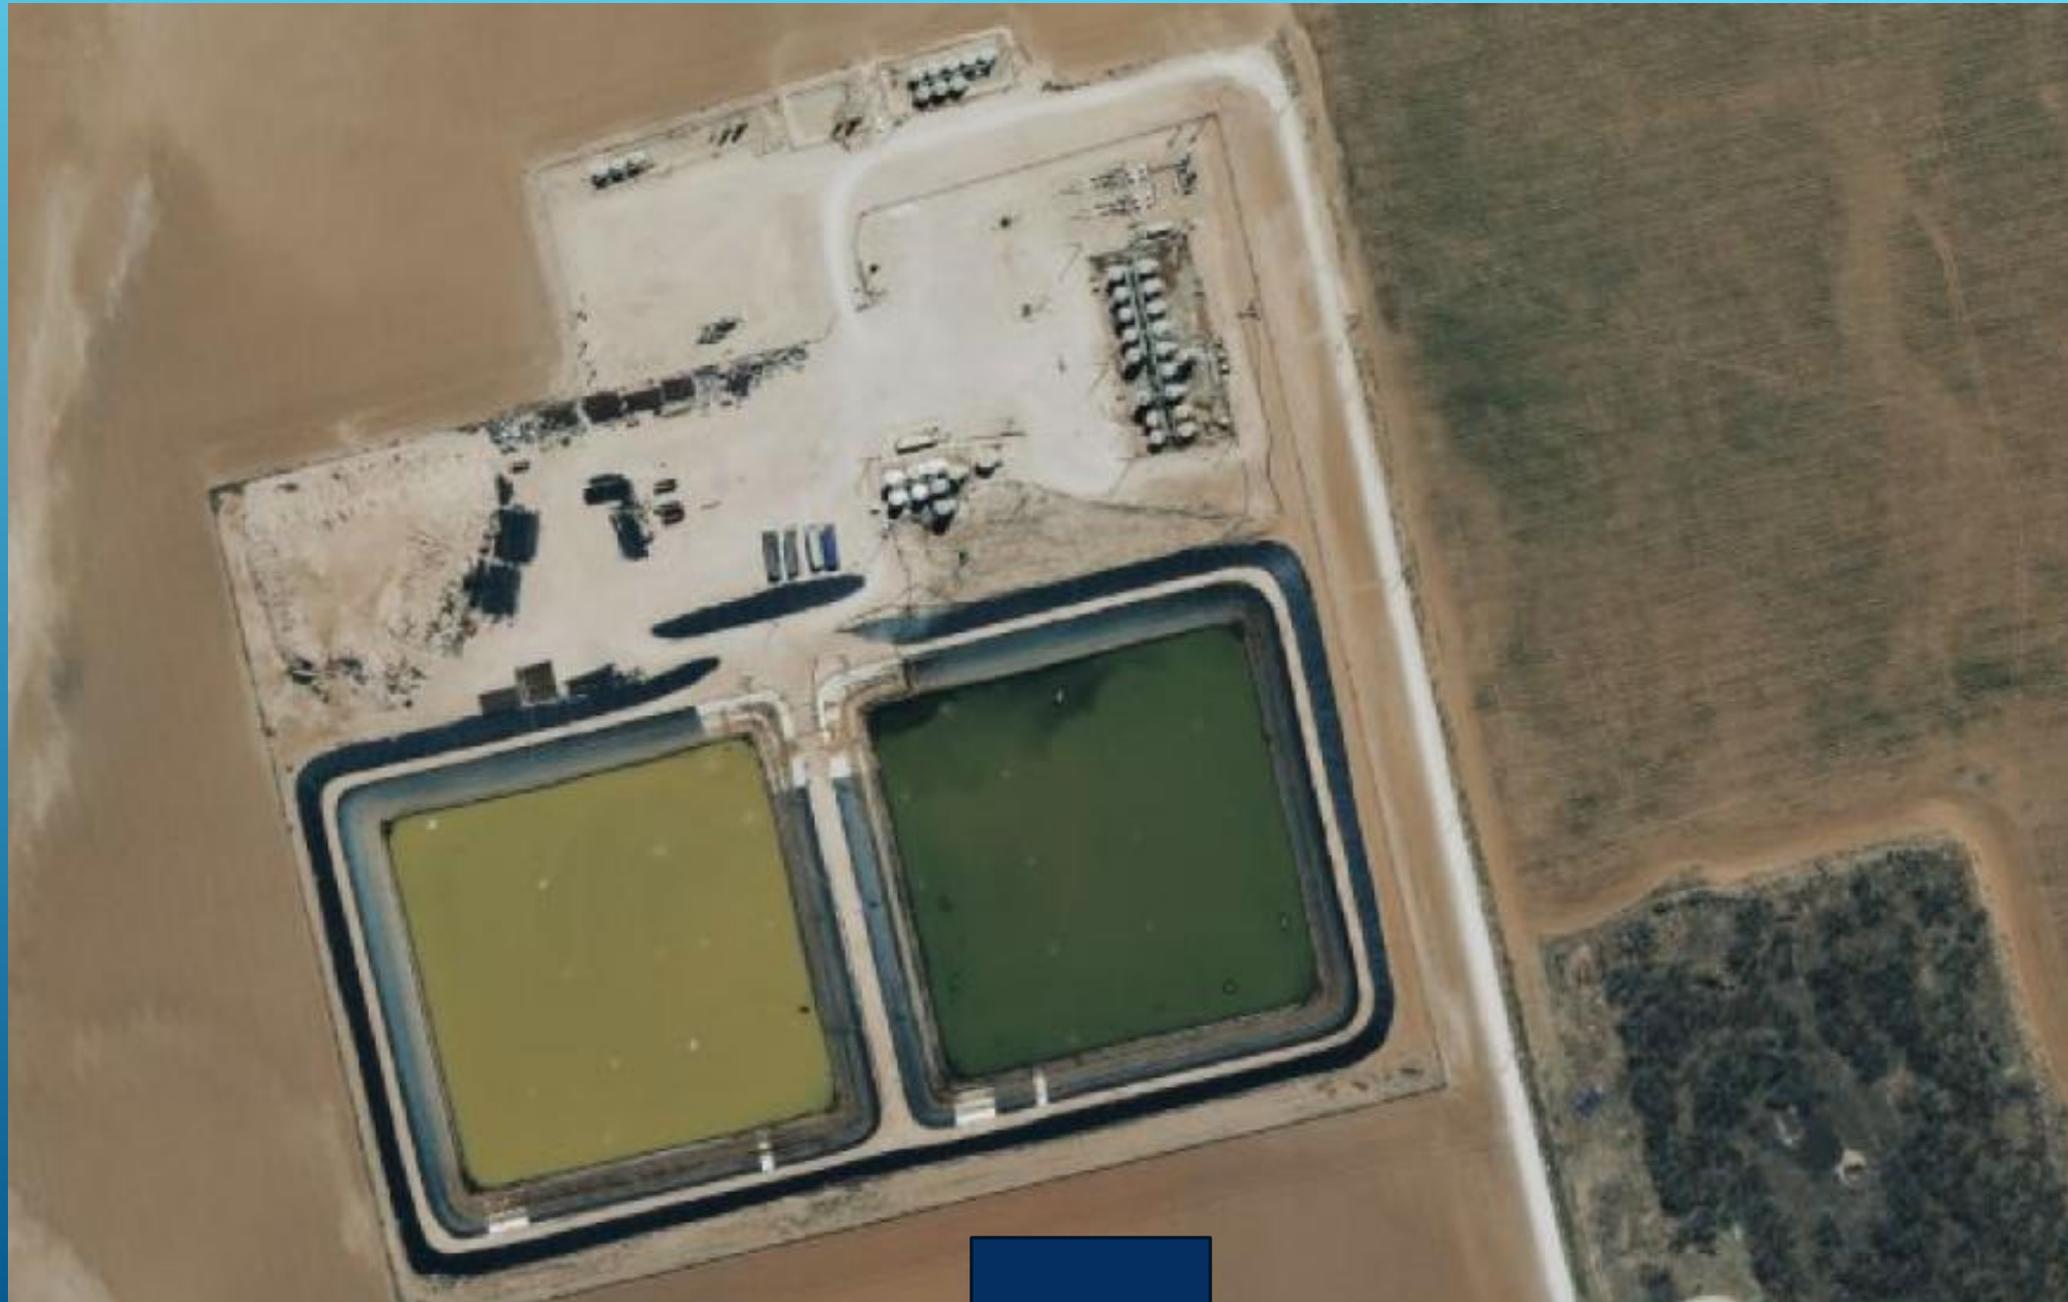
Site electrical system spreads across three tank batteries and measurement devices at ponds.

For scale, each pond is about 500 feet square.

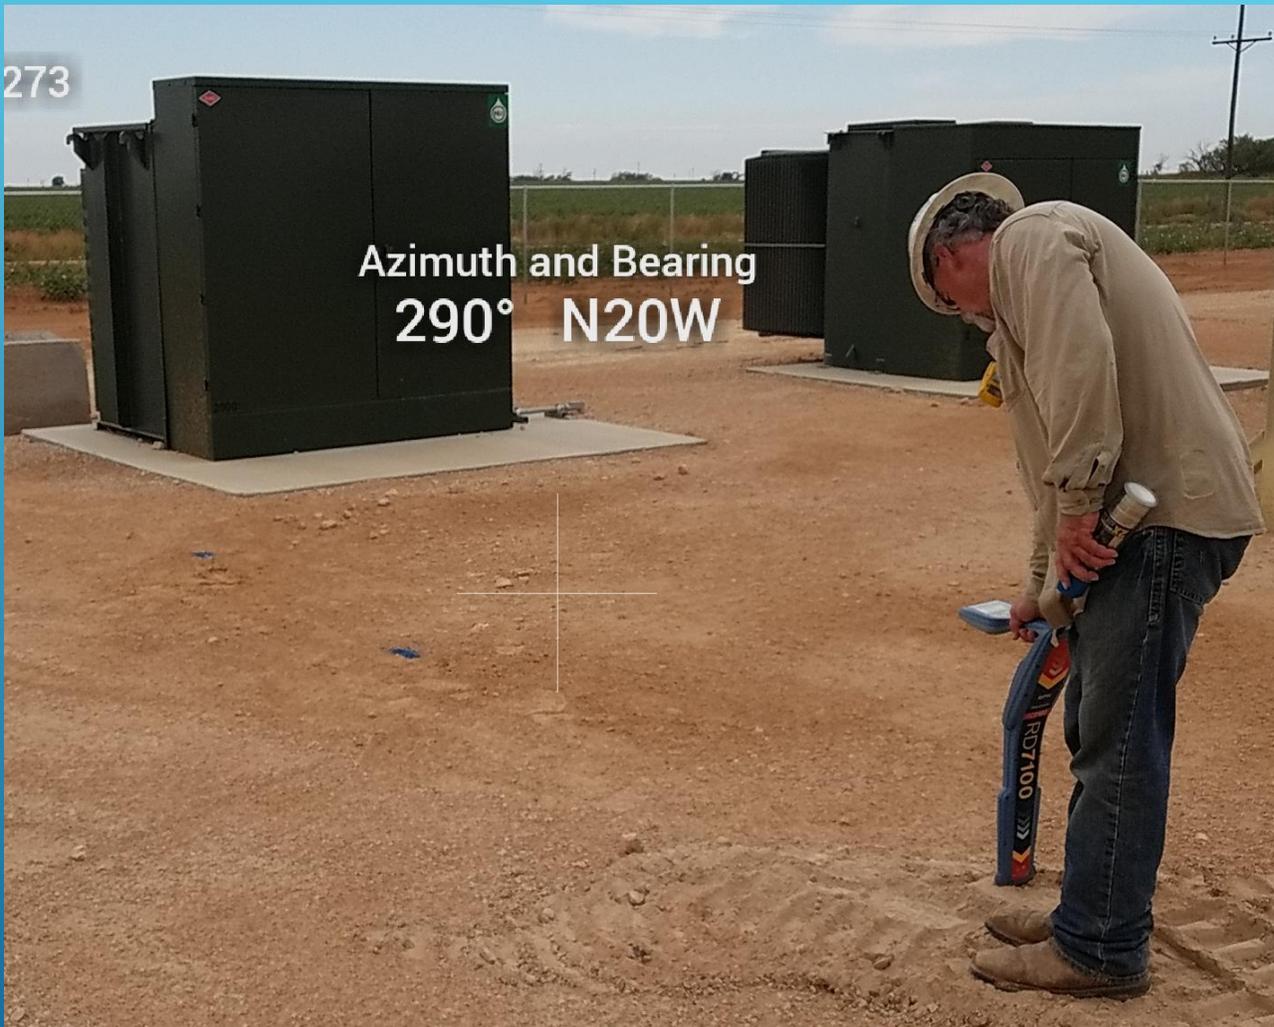
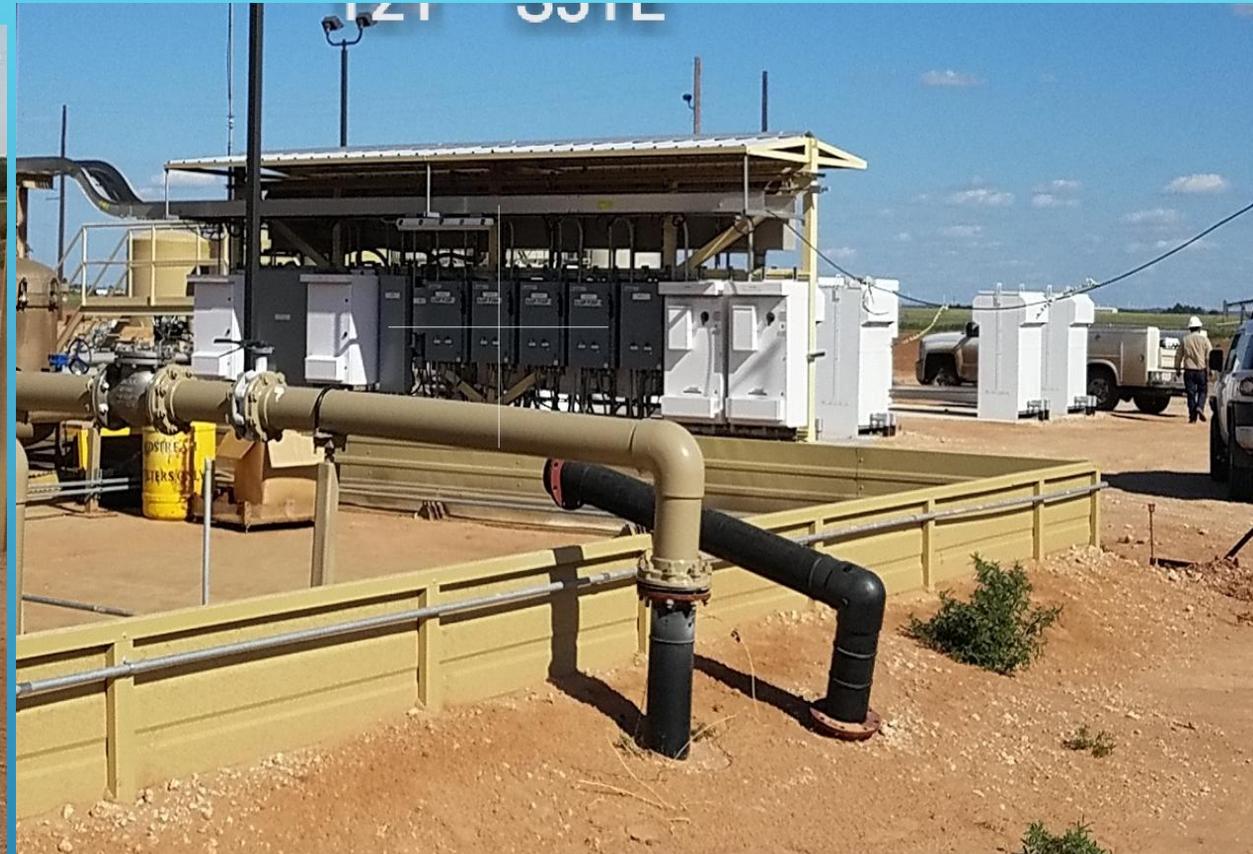
Power distribution rack for the site, above.

Two pad-mounted transformers on site, one rated at 2,500 kVA, second at 2,000 kVA. At 480 VAC output, up to 8,900 amperes of AC current available (at 0.95 power factor).

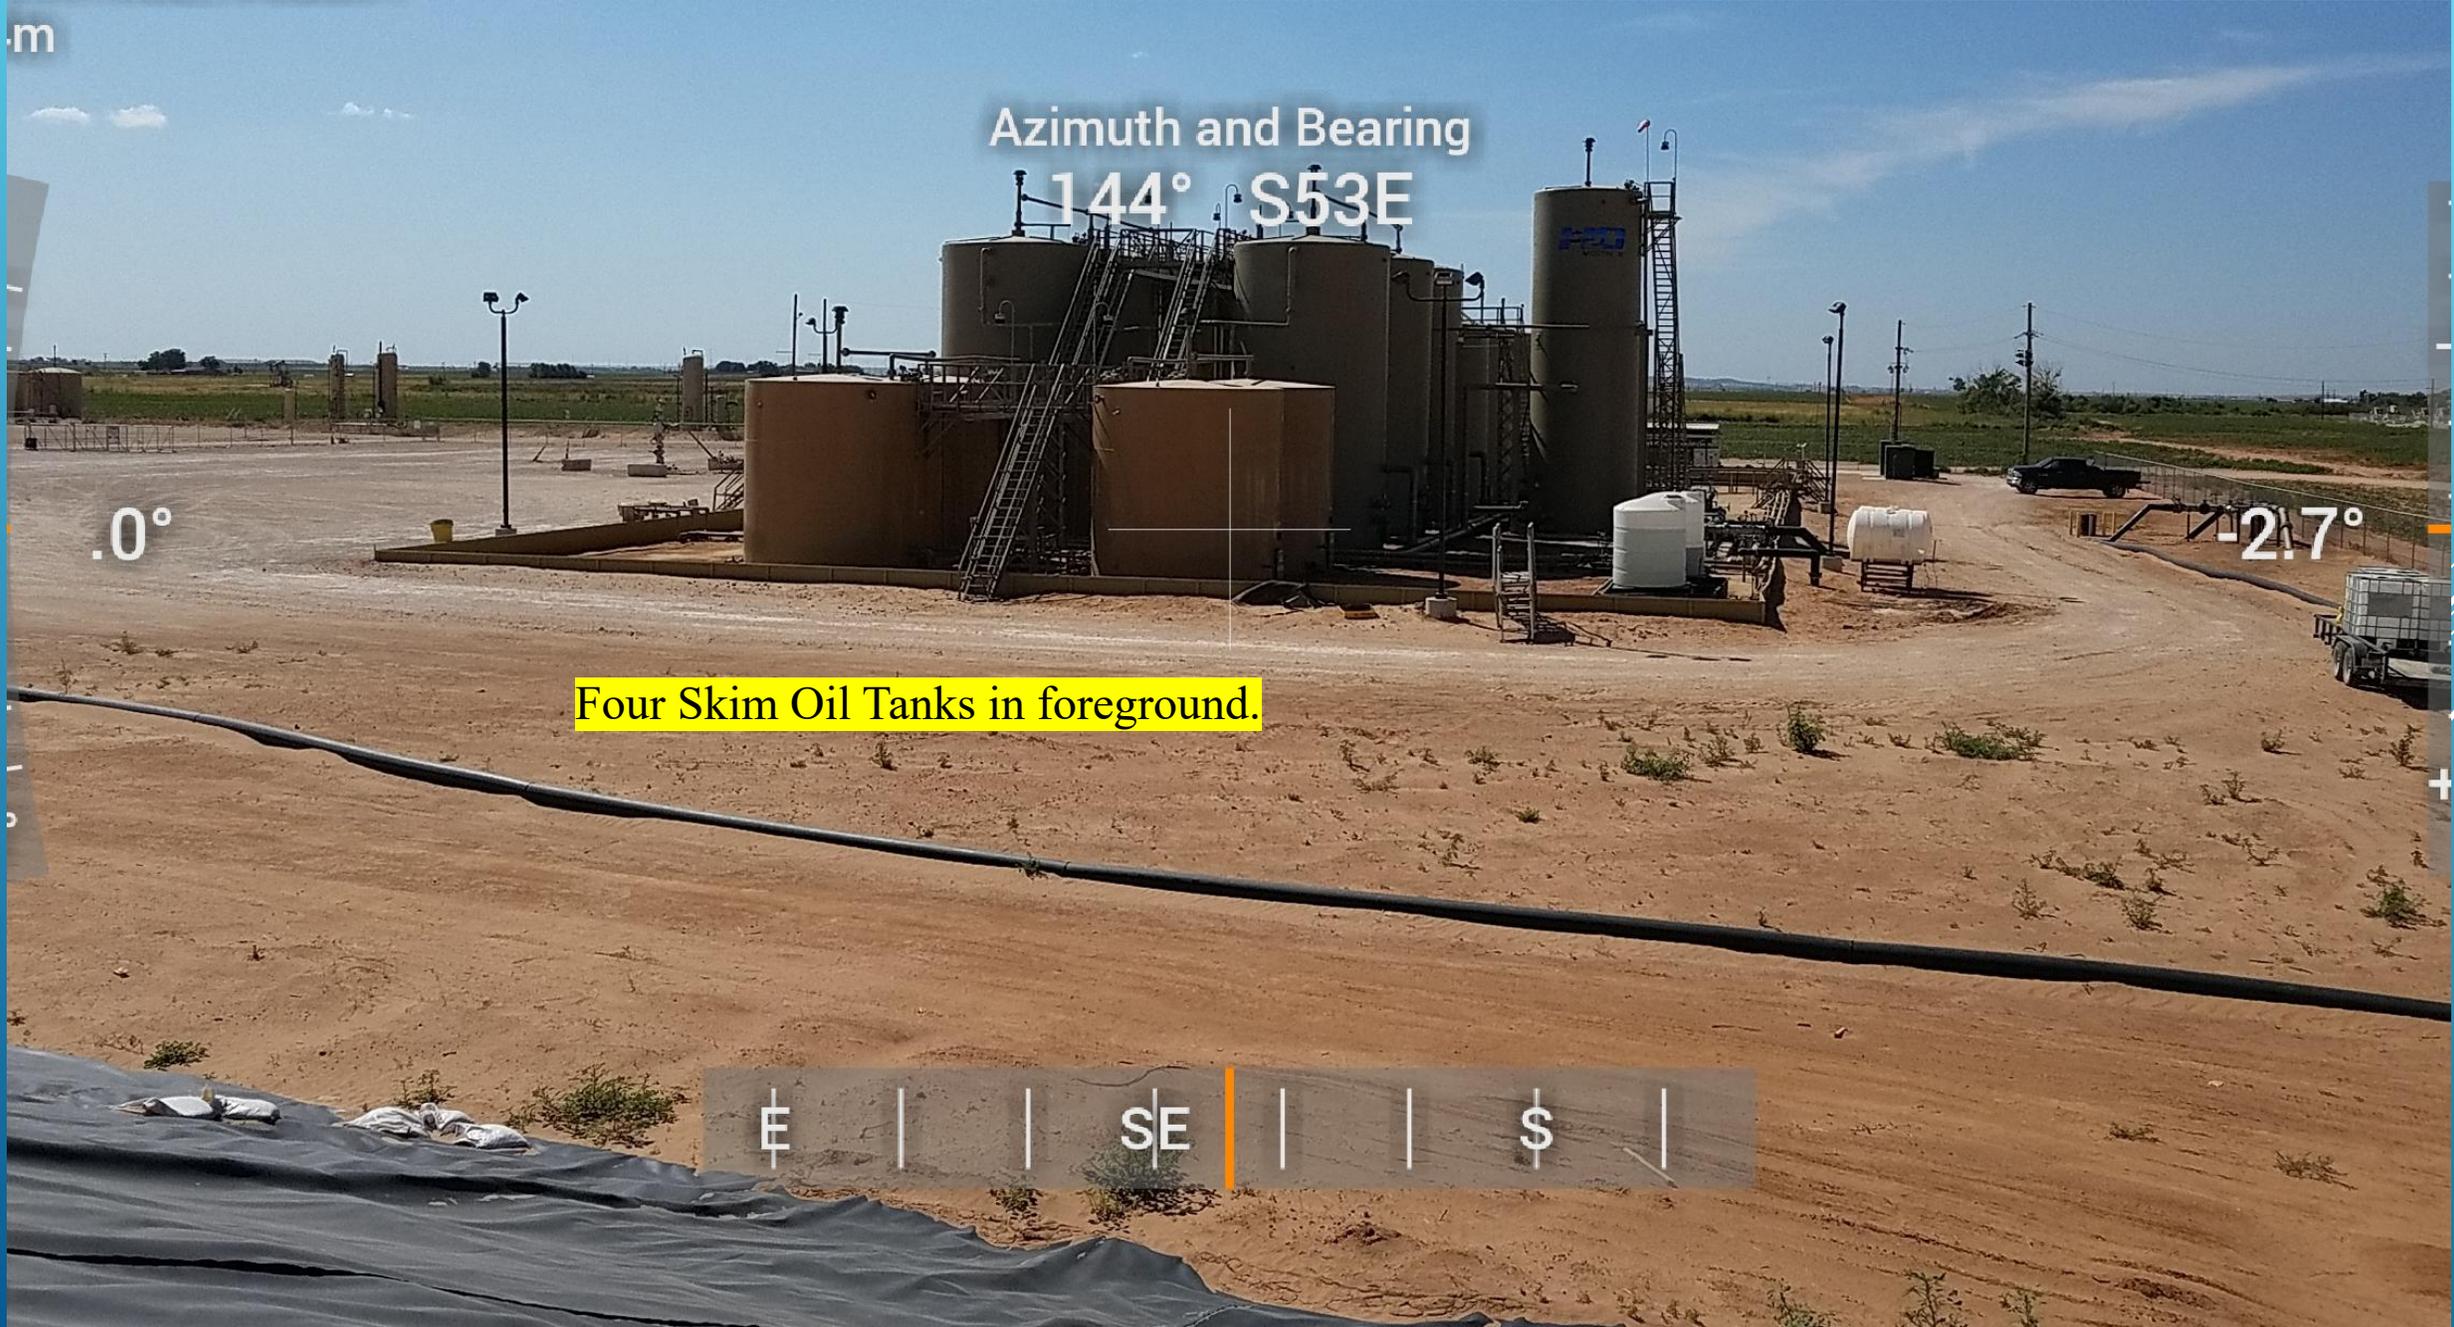
Four Skim Oil Tanks in foreground.

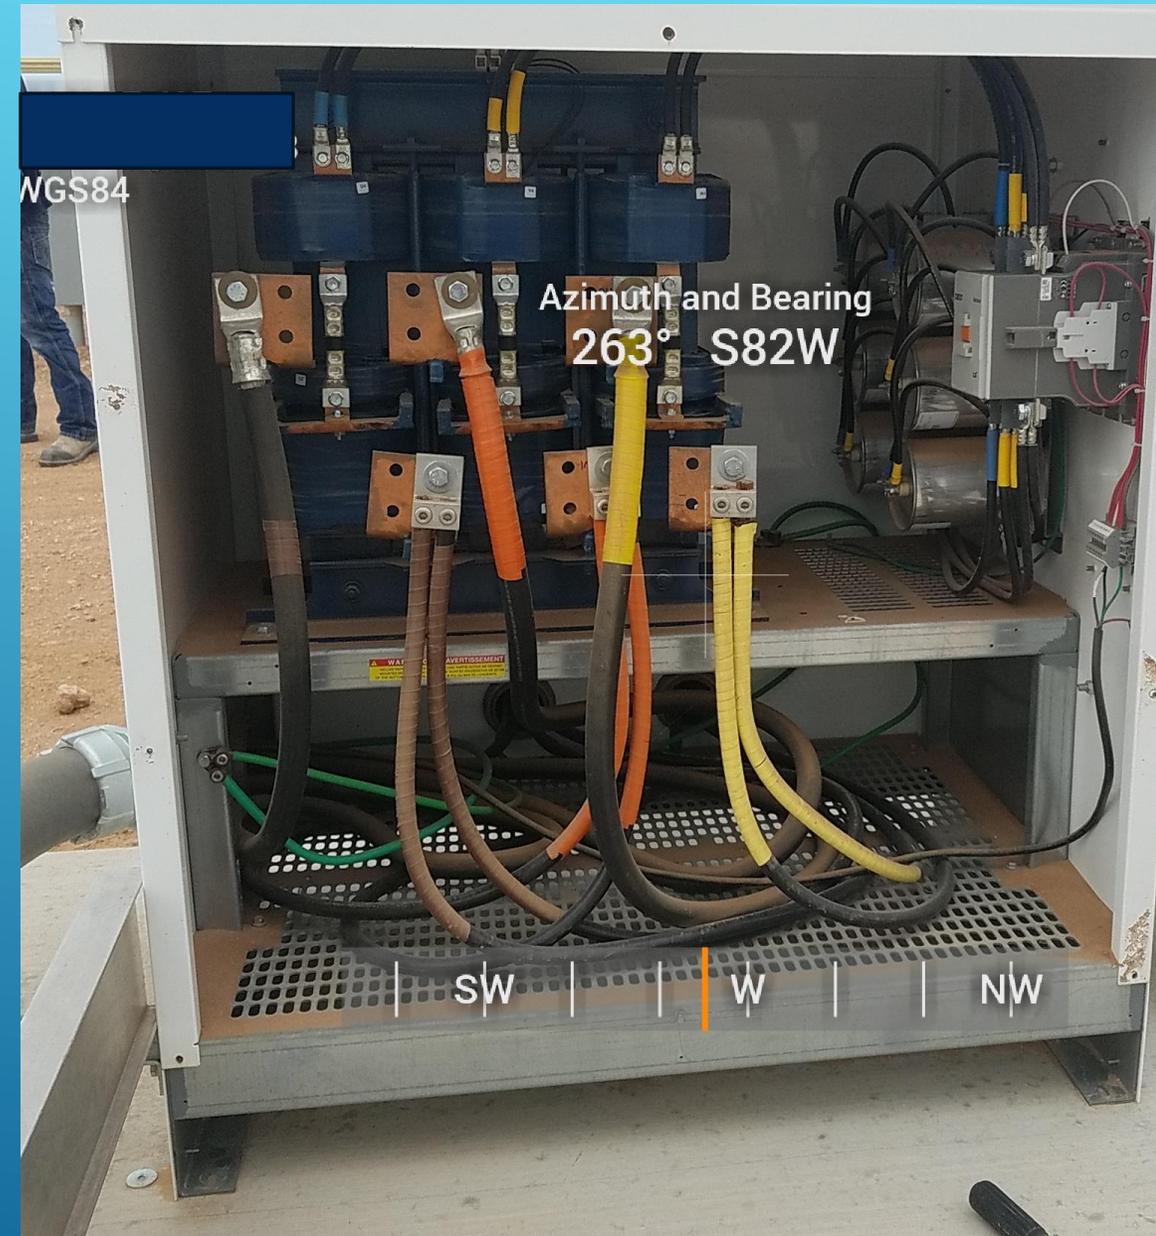
A Variable-Frequency Drive takes 60-Hertz power and converts it to power delivered in frequencies of approx. 100- to 4,800-Hertz. Frequency management varies motor speeds.

Interior View of VFD Reactor Cabinet

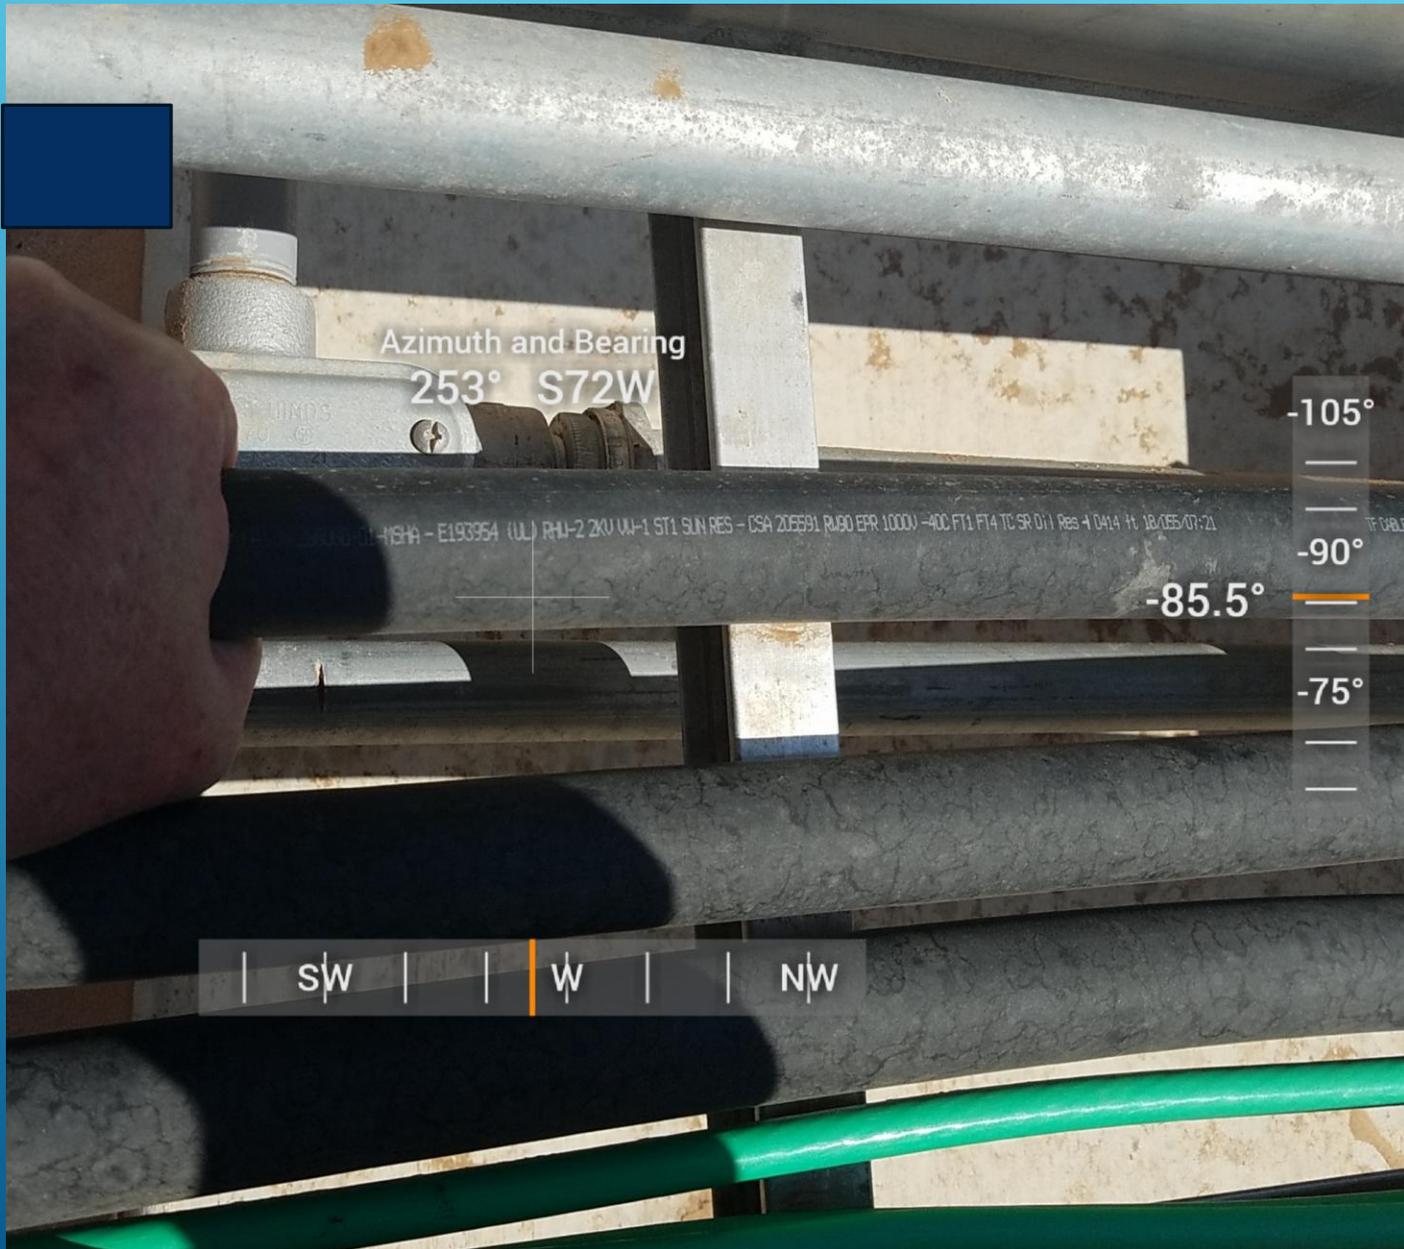
VFD reactors, conditioners and wiring to motors, for each of three power phases, was in non-shielding rubberized conduit. Noise was transmitted downstream and induced onto nearby, adjacent conductors – for instance, the green bond wire at bottom of photo.

Even the VFD cabinet gear was not shielded properly.

Put VFD in steel conduit and mitigate most noise energy.

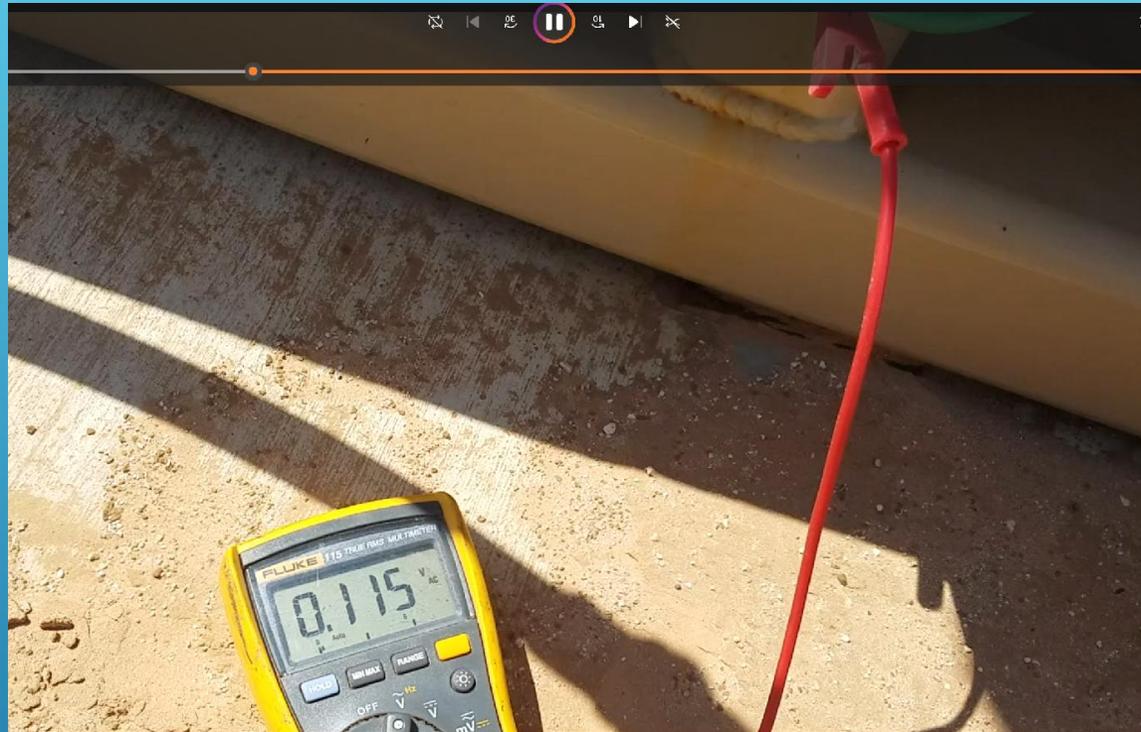
AC CURRENTS MEASURED ON GROUNDS AND BOND WIRE RUNS AT 3.5 TO 18 AMPERES AC. THIS WAS TRUE ONLY ELECTRICALLY DOWNSTREAM OF VFD REACTOR AND CONDITIONER CABINETS, NOT IN TANK BATTERIES.

0.115 V AC PRESENT AT MOTOR BOND POINT

**POWER = VOLTS X AMPS, OR
0.115 V X 18 A AC, MAX OF 2.1
WATTS AT 4-KHZ.**

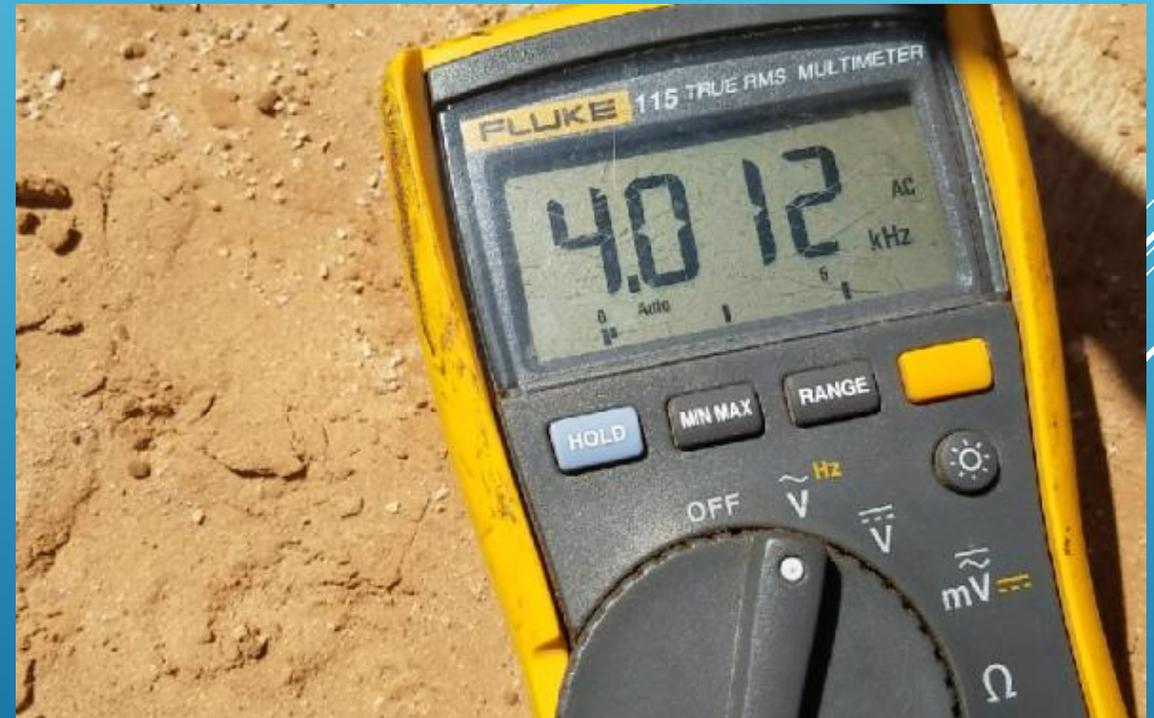
THESE VOLT AND AMP MEASUREMENTS WERE RELATED TO HIGH-FREQUENCY POWER, FAR WEAKER THAN 60-HZ POWER IN ENERGY CONTENT.

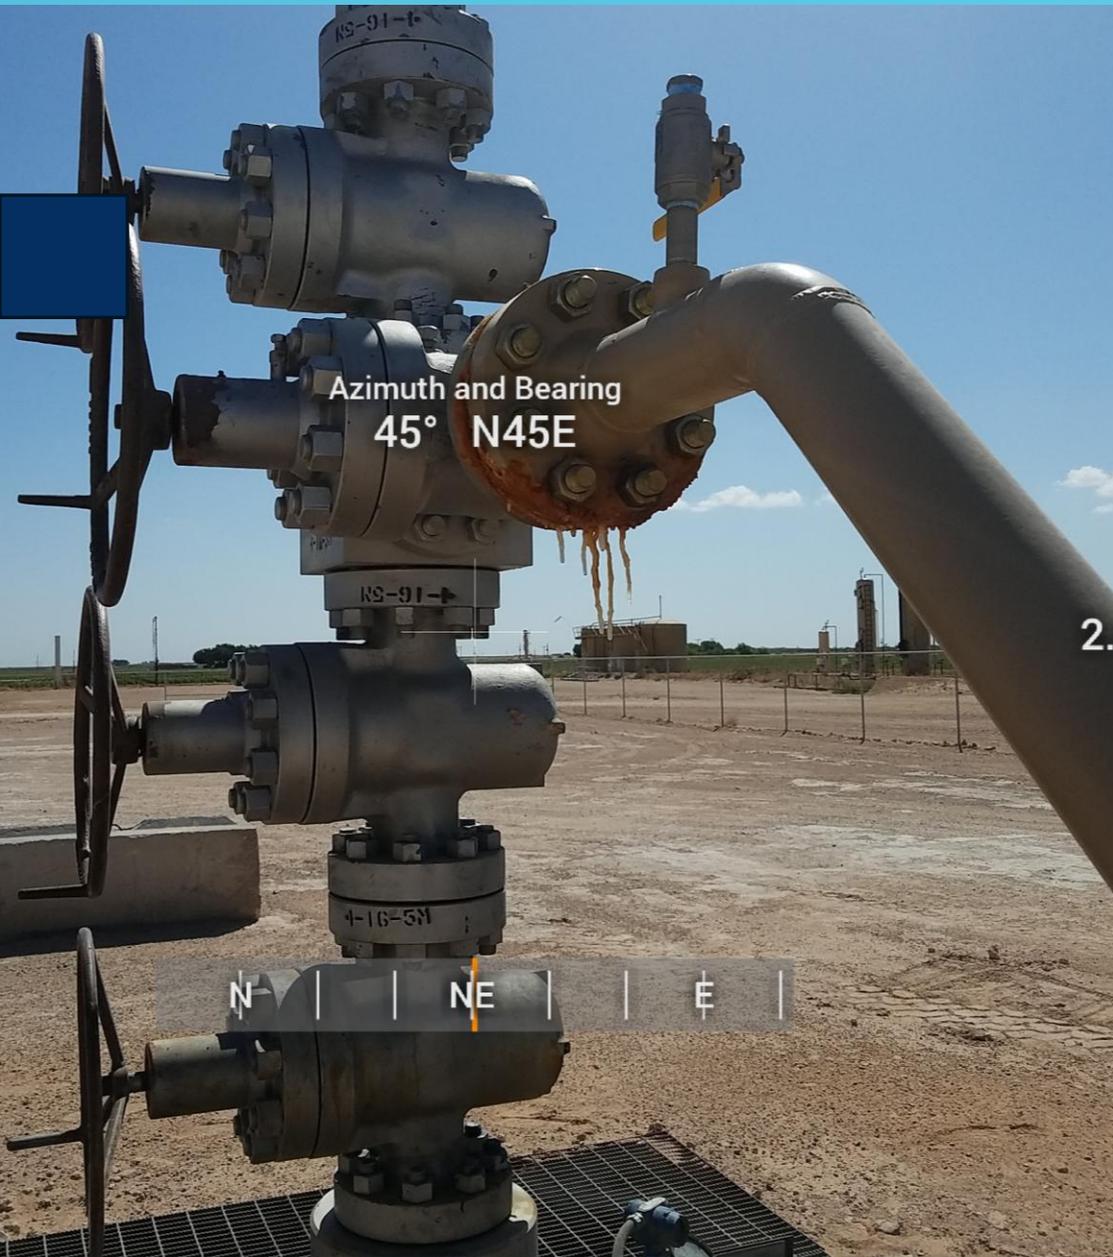
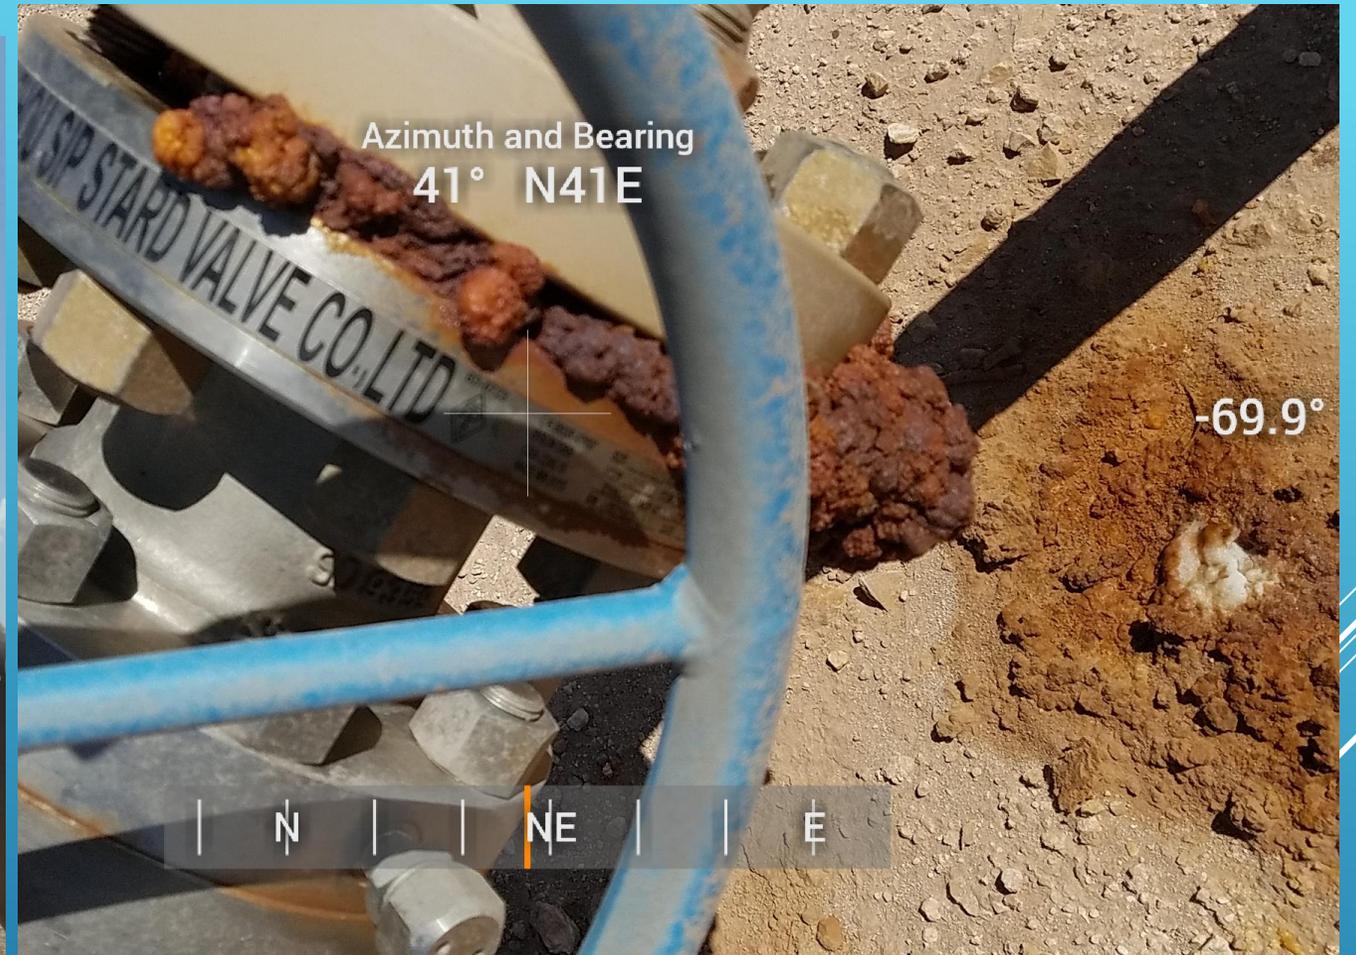
Carbon steel piping mated to stainless-steel valves and well tree metal does not work with salt water on the inside. What is corroding and leaking to create all this rust product? Bolts? CS flange face metal? What kind of pressure is involved?

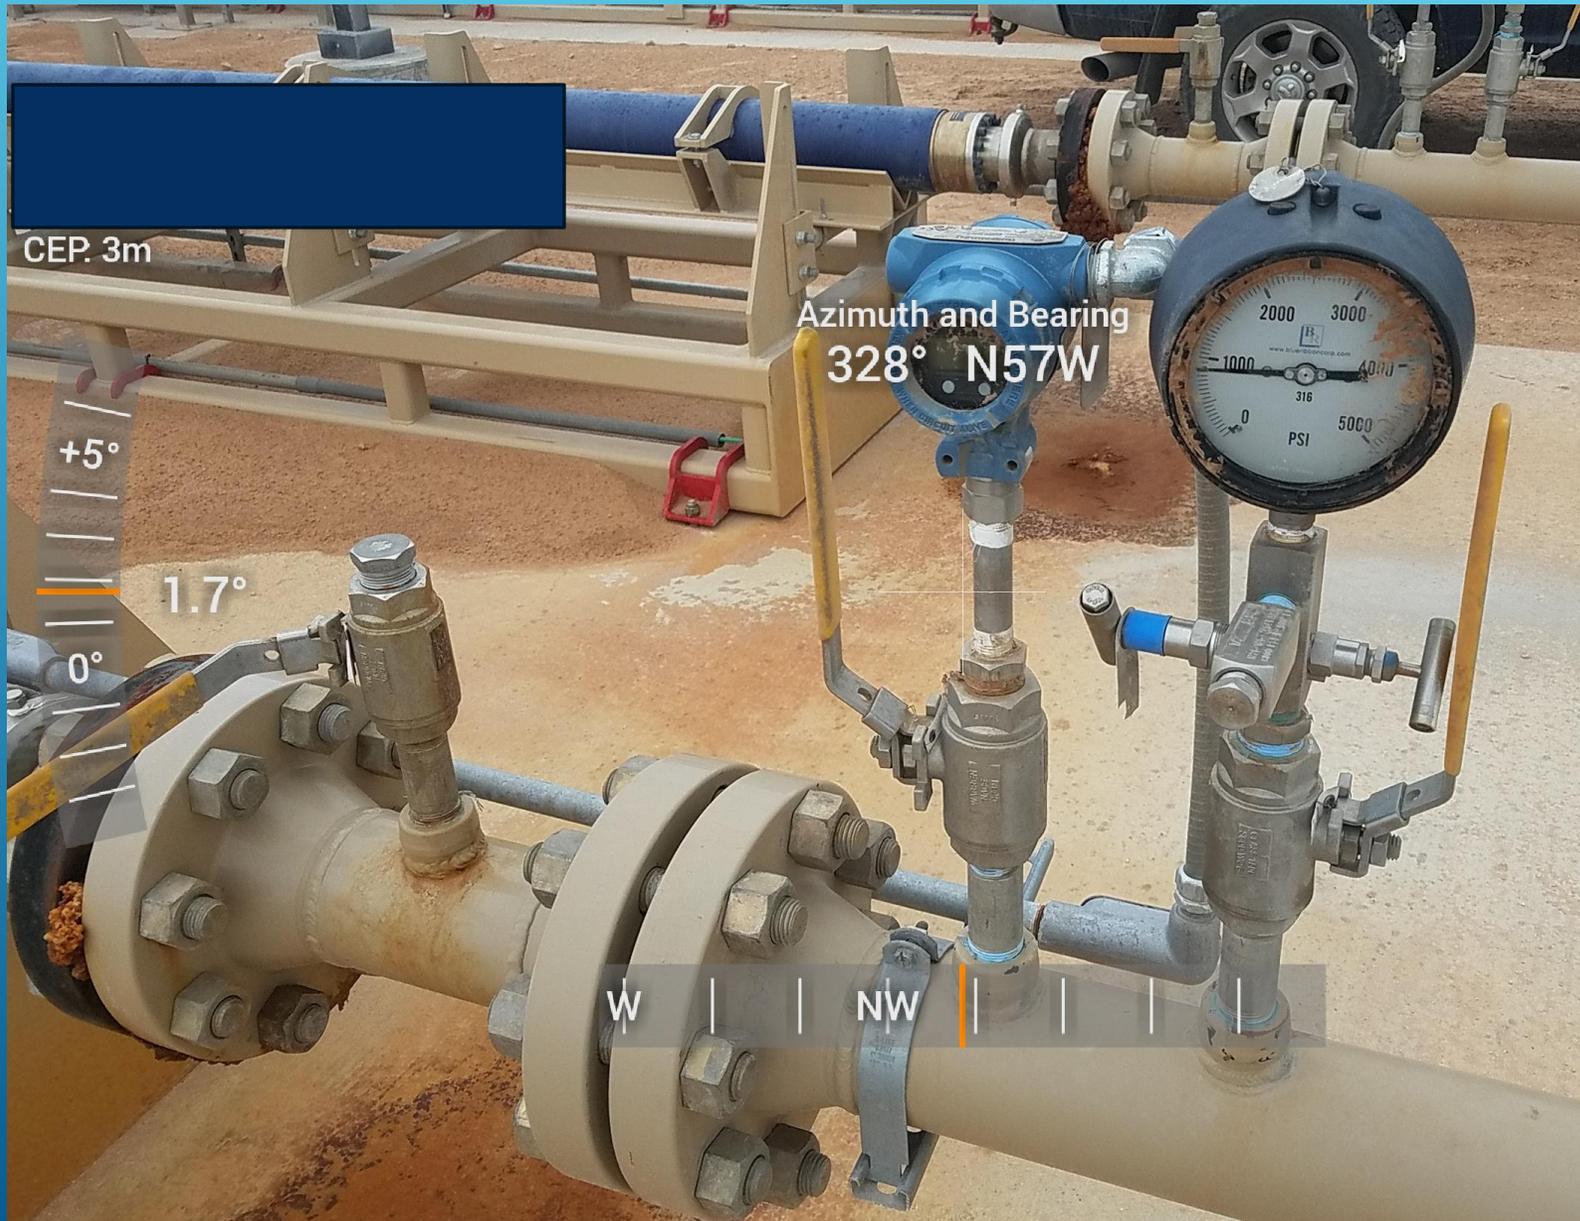
PRESSURES INVOLVED? WELL #1.

While we worked on site, pressures to each disposal well were held lower than normal. This gauge shows 900 psi, whereas normal operation was 1,500 to 2,000 psi.

See the small leaks and rust blooms at far left, some at 6 o'clock and more at 9 o'clock.

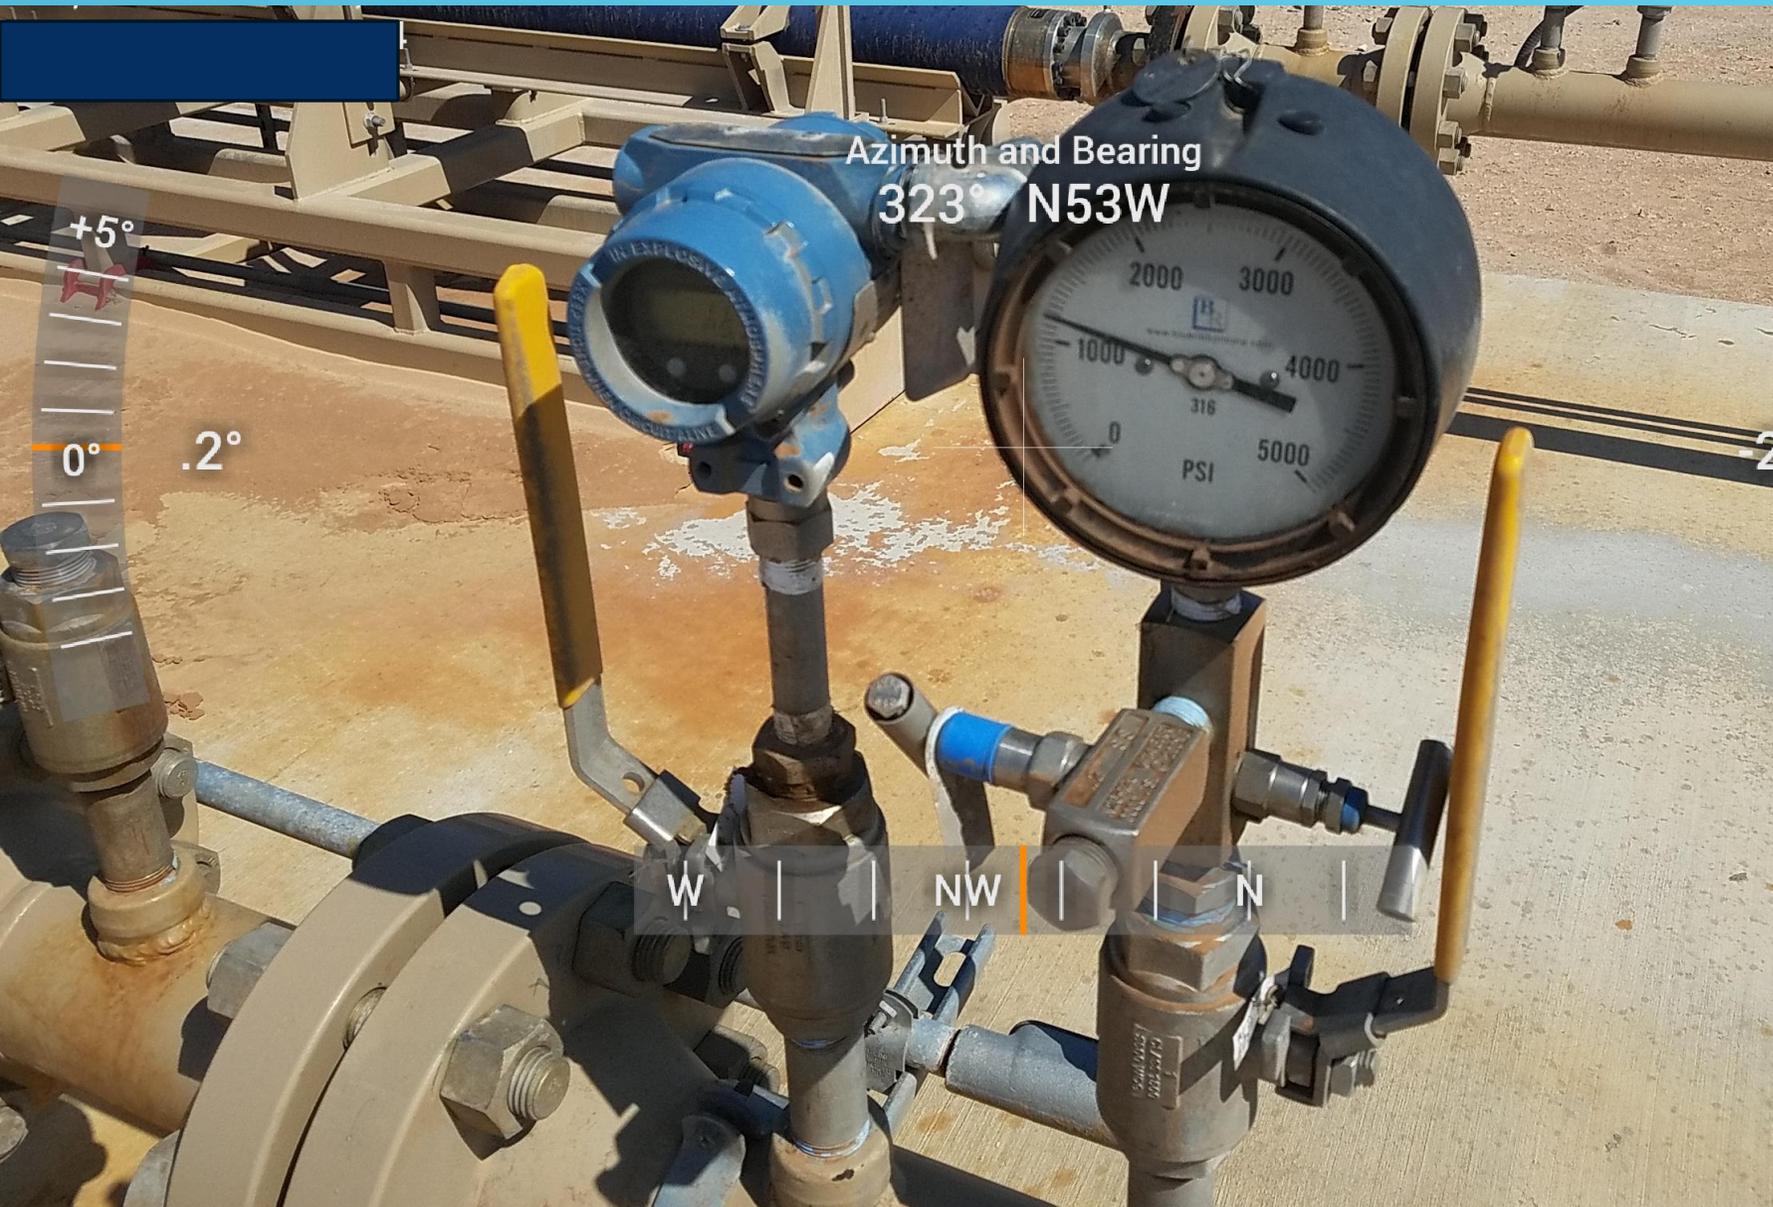
PRESSURES INVOLVED? WELL 2.

This gauge shows 1,200 psi, whereas normal operation was 1,500 to 2,000 psi.

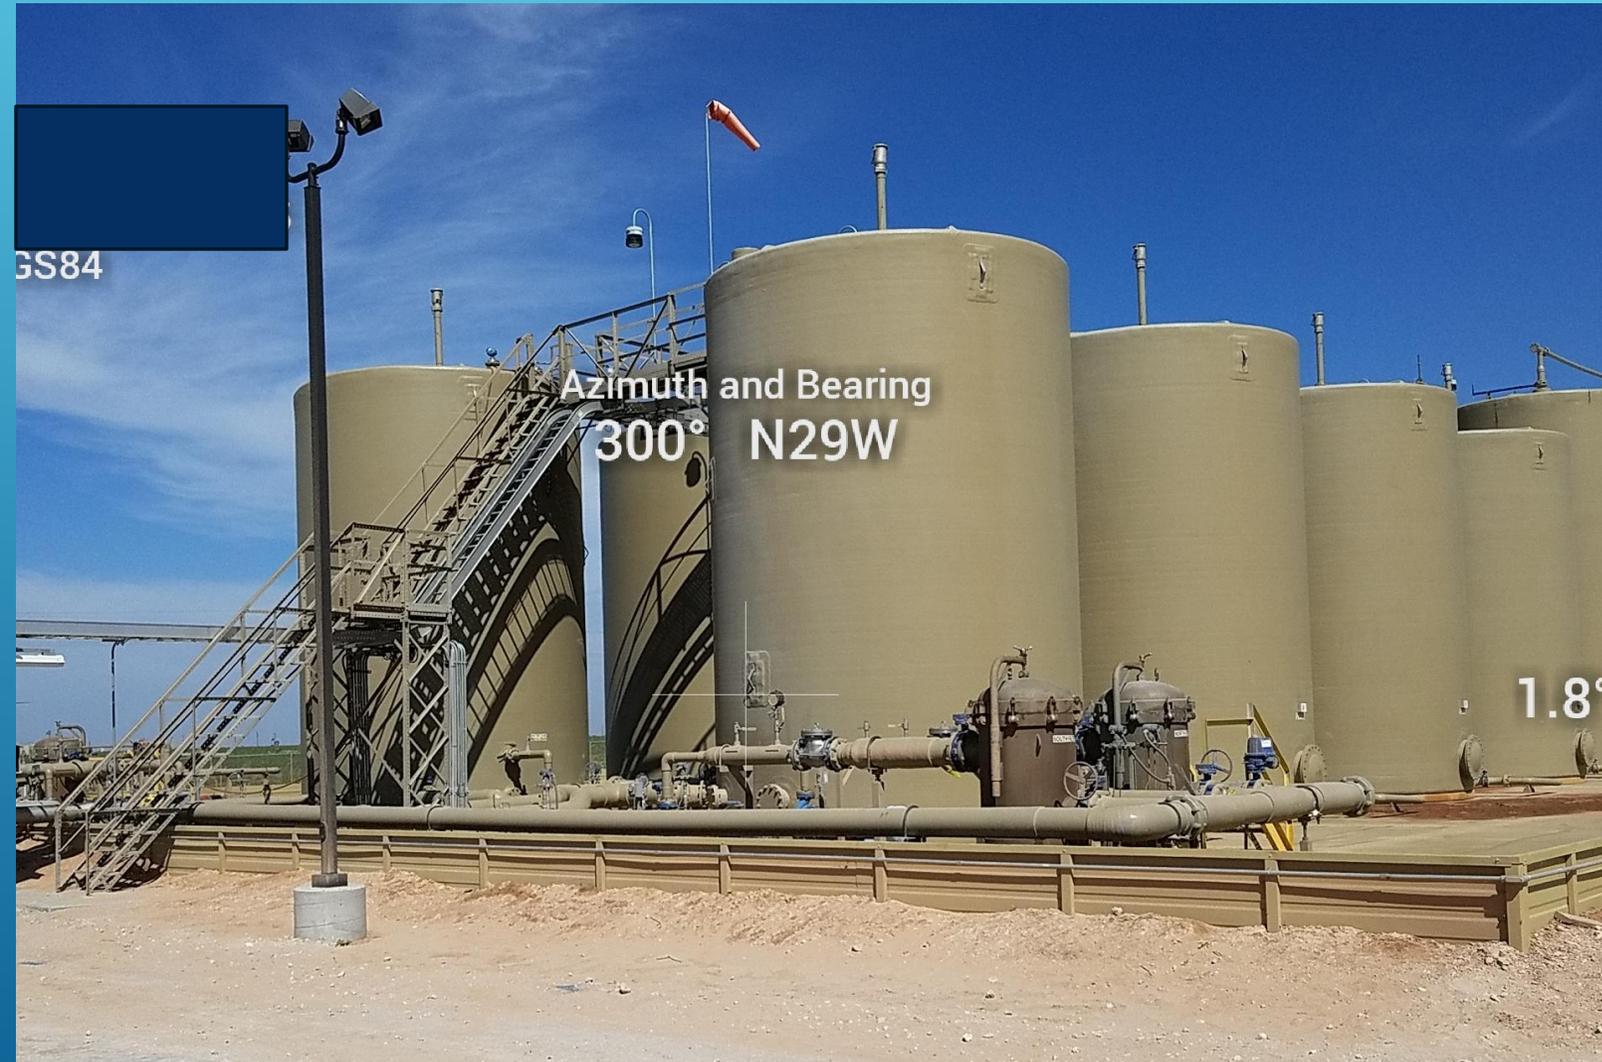
We measured resistances along particular runs of bonding cables, up on the catwalks and then down in the floor level of the battery.

Numbers were not good.
