**ELECTRICAL SAFETY AND
FACILITY INTEGRITY:
EVALUATION OF AC POWER &
GROUNDING SYSTEM ISSUES, WHICH
FOUND . . . MORE ISSUES.**

Cal Chapman, P. E.
NACE-Certified Cathodic Protection Specialist #23357
Professional Engineer in TX, FL, LA, NM, ND, NY, OK, TN
Boerne, Texas; Houston, Texas; Columbus, Montana

WEST TEXAS PRODUCED WATER MANAGEMENT FACILITY

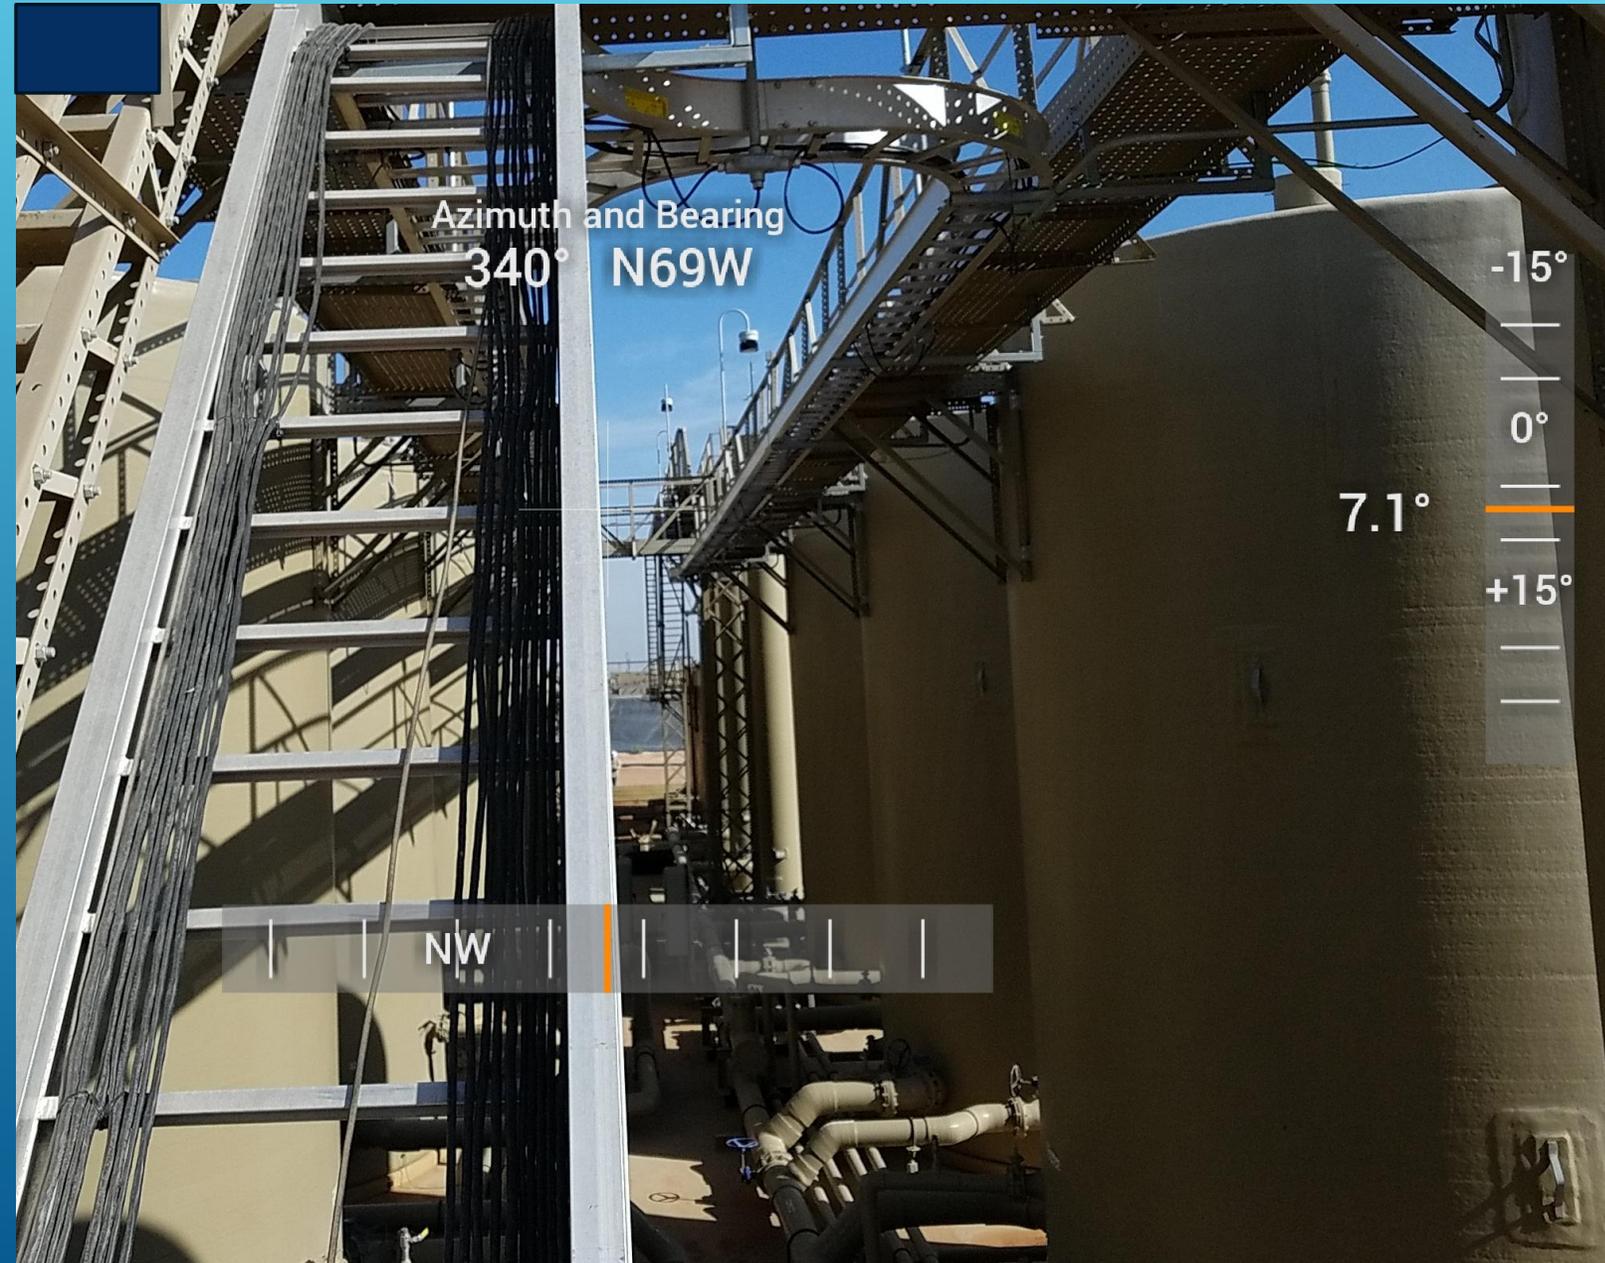
Bonding cable (bare copper) run, measurement cabling for tank levels, other instrument wiring all running up the tray.

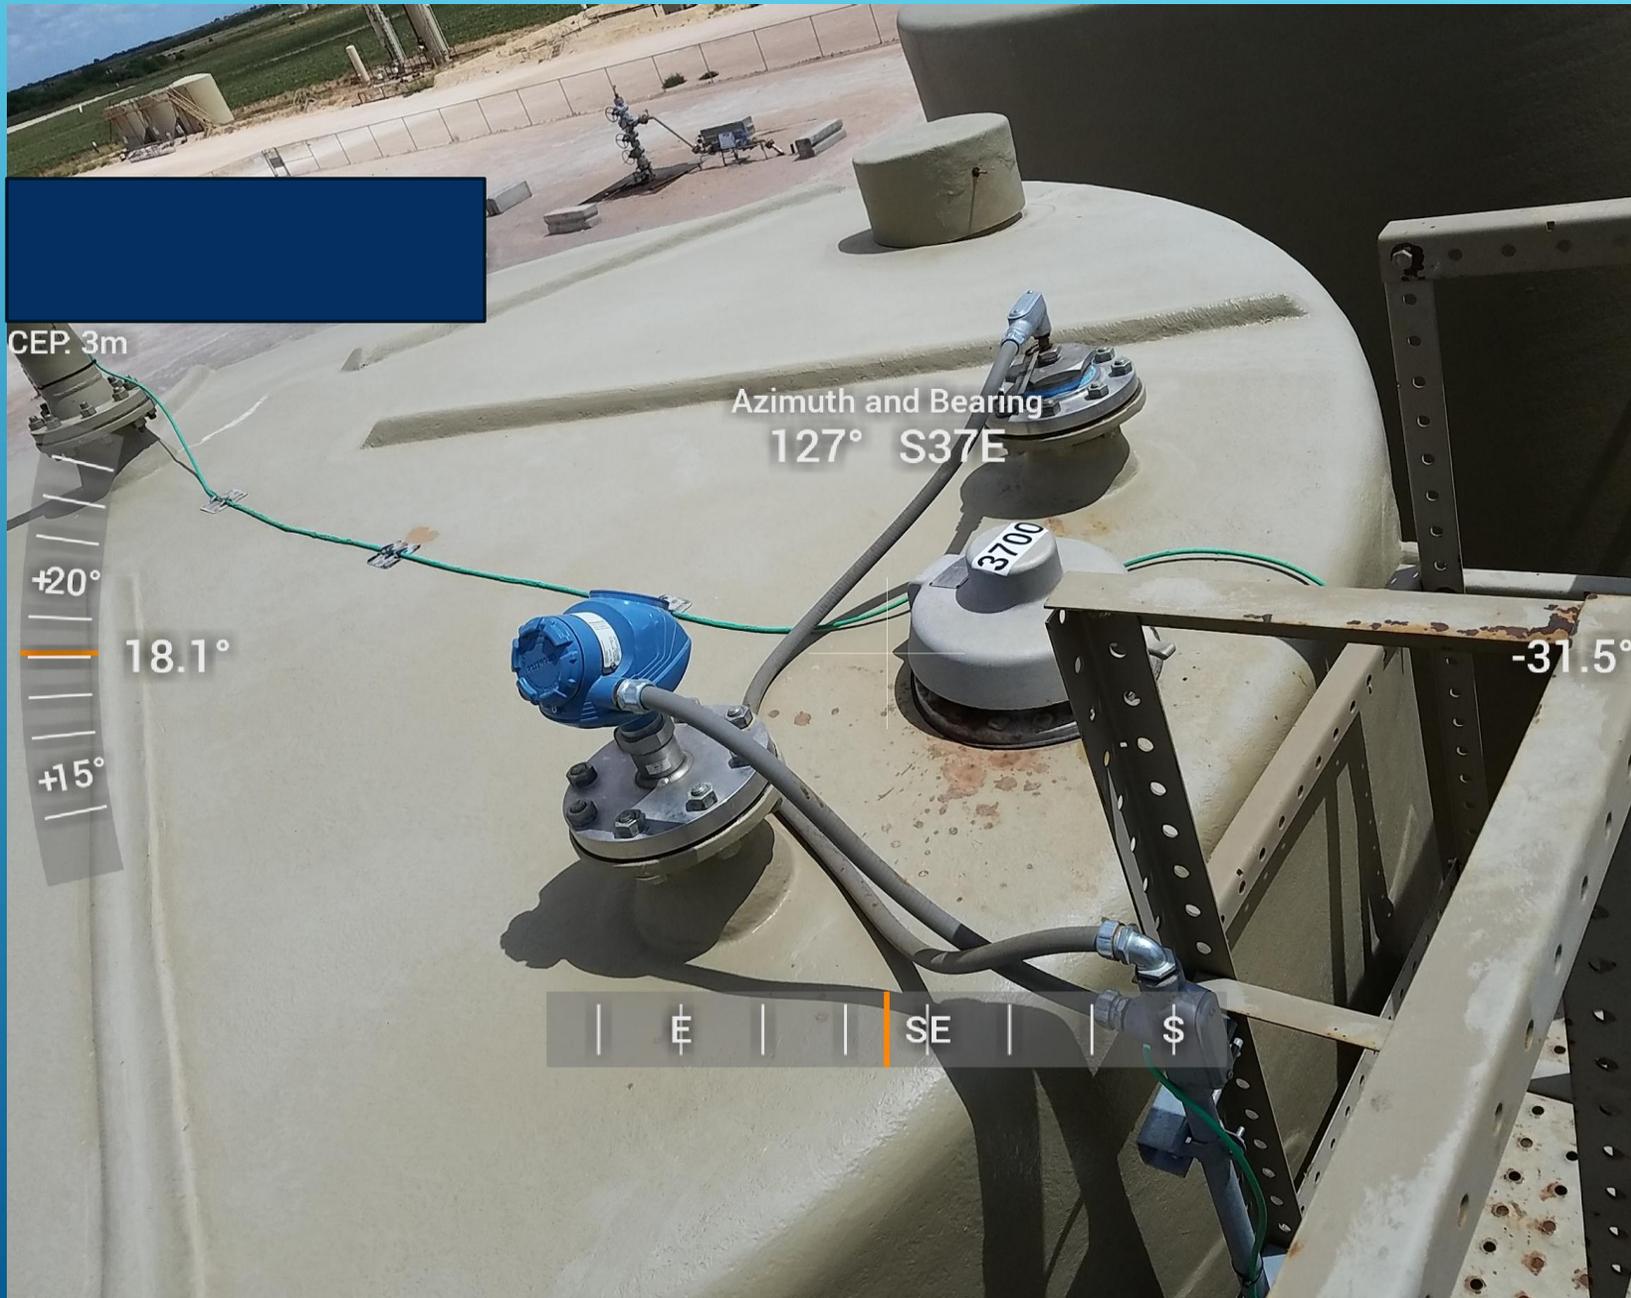
Bonding cables (green insulation), measurement cabling for tank levels, other instruments, and all tanks generating light hydrocarbon vapors.

We do not want static sparks on site.

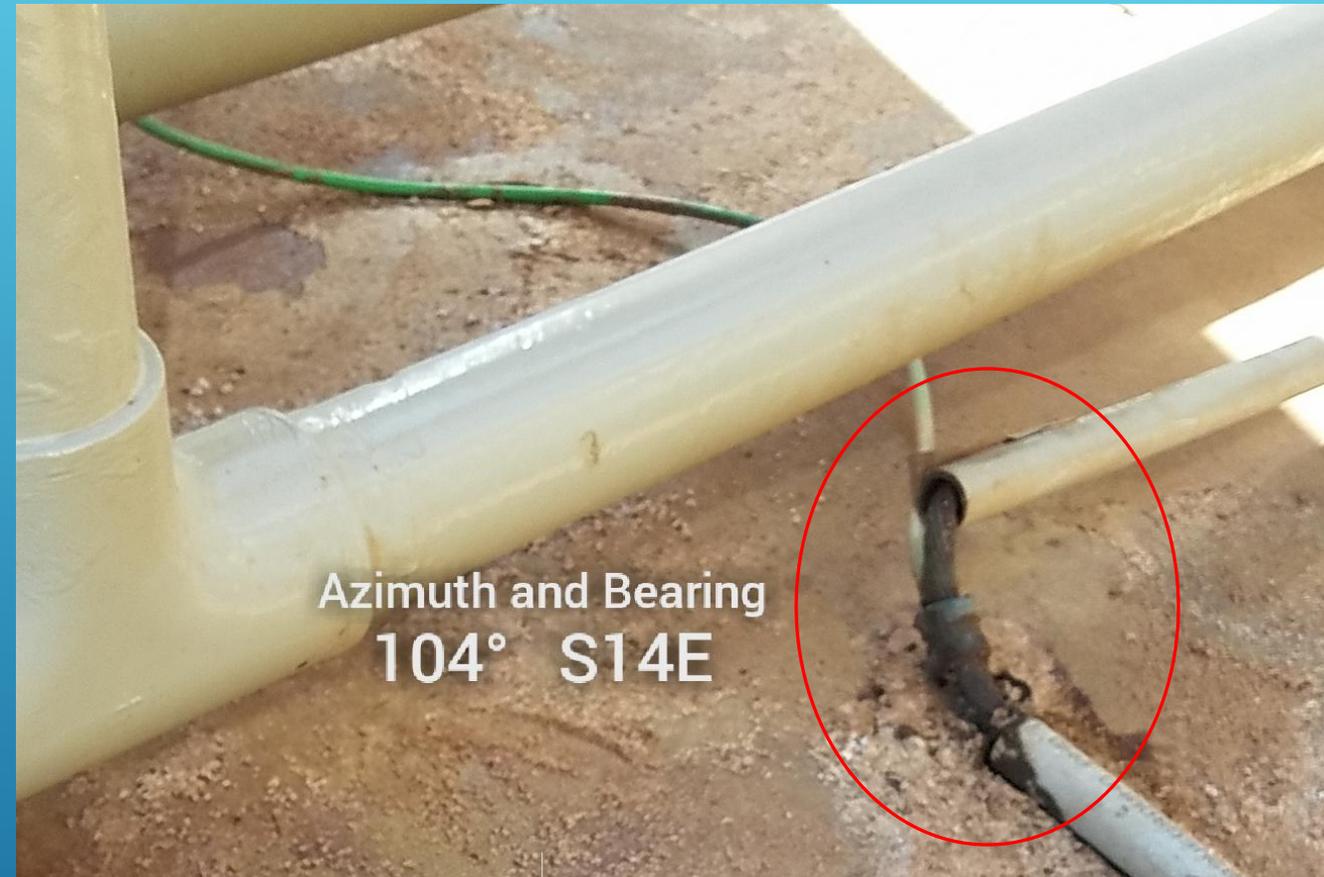
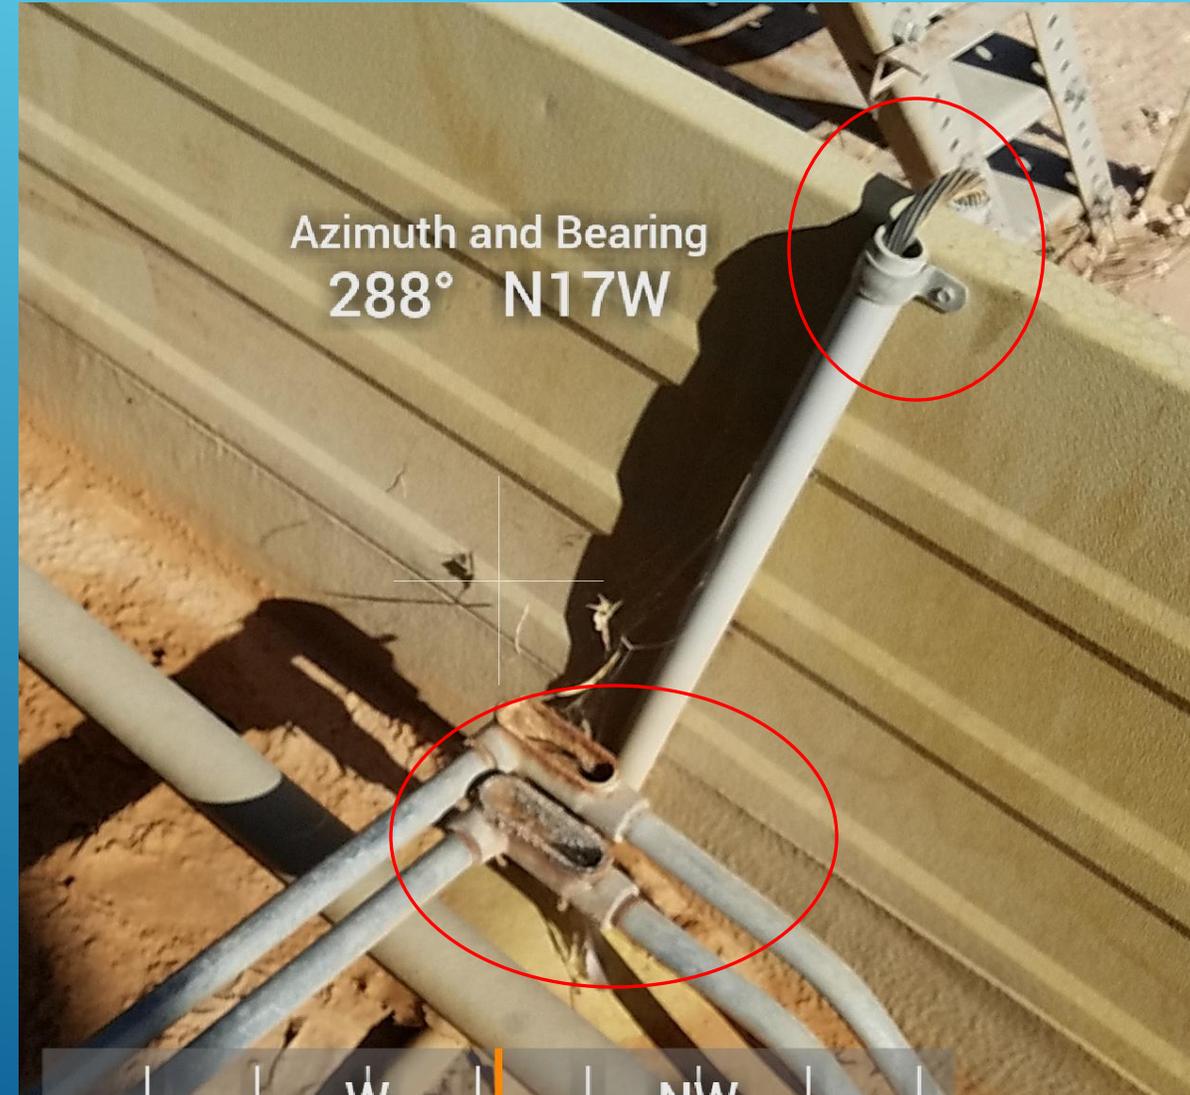
Bare copper bonding wires down low looked damaged by chemical attack (salt residues, right). Manager admitted there had been a significant salt-water spill inside the containment, with water depth up to eight inches.

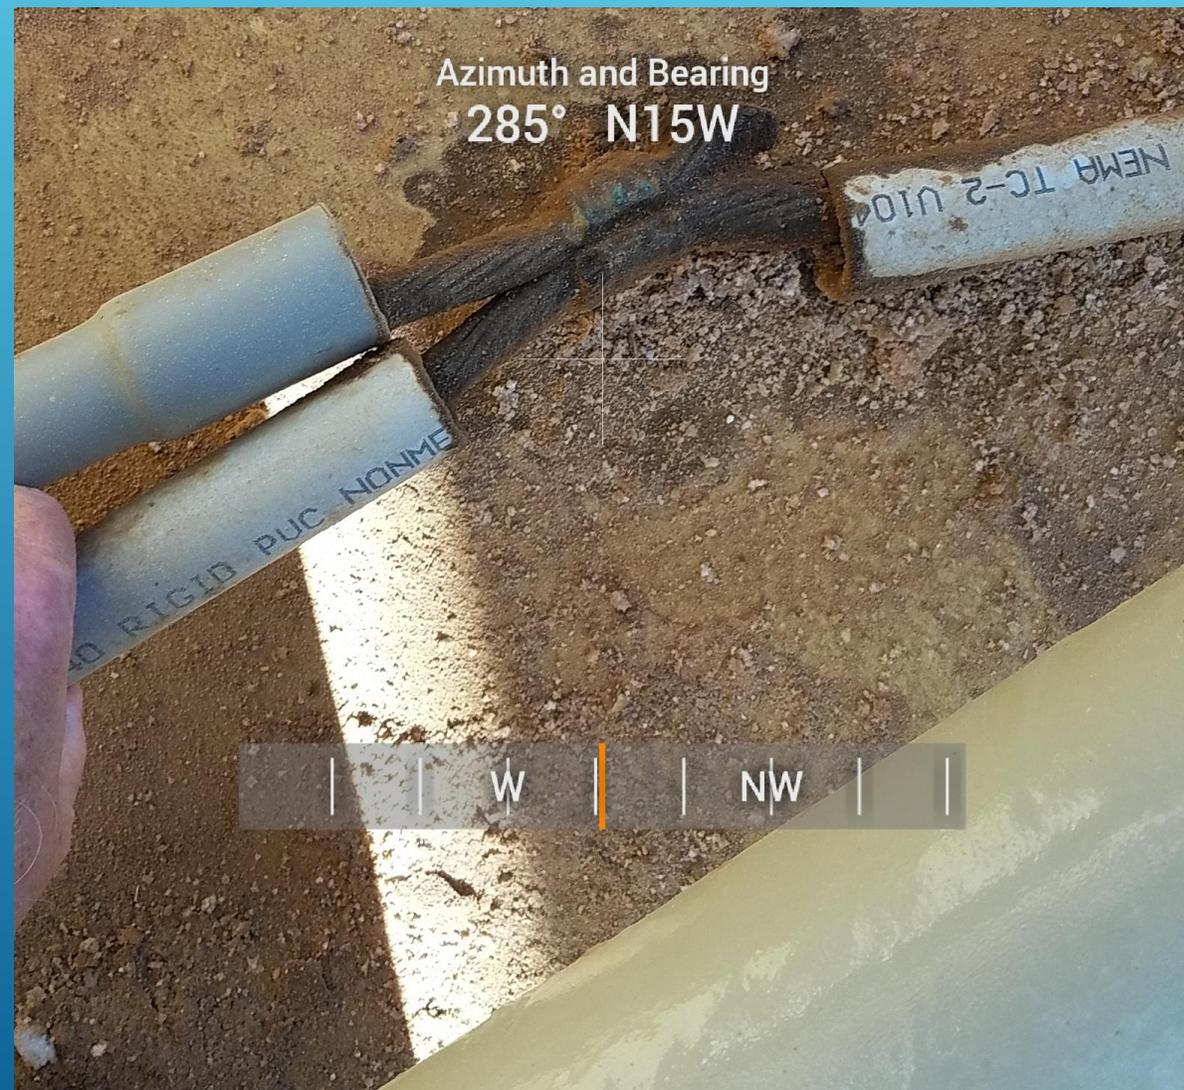
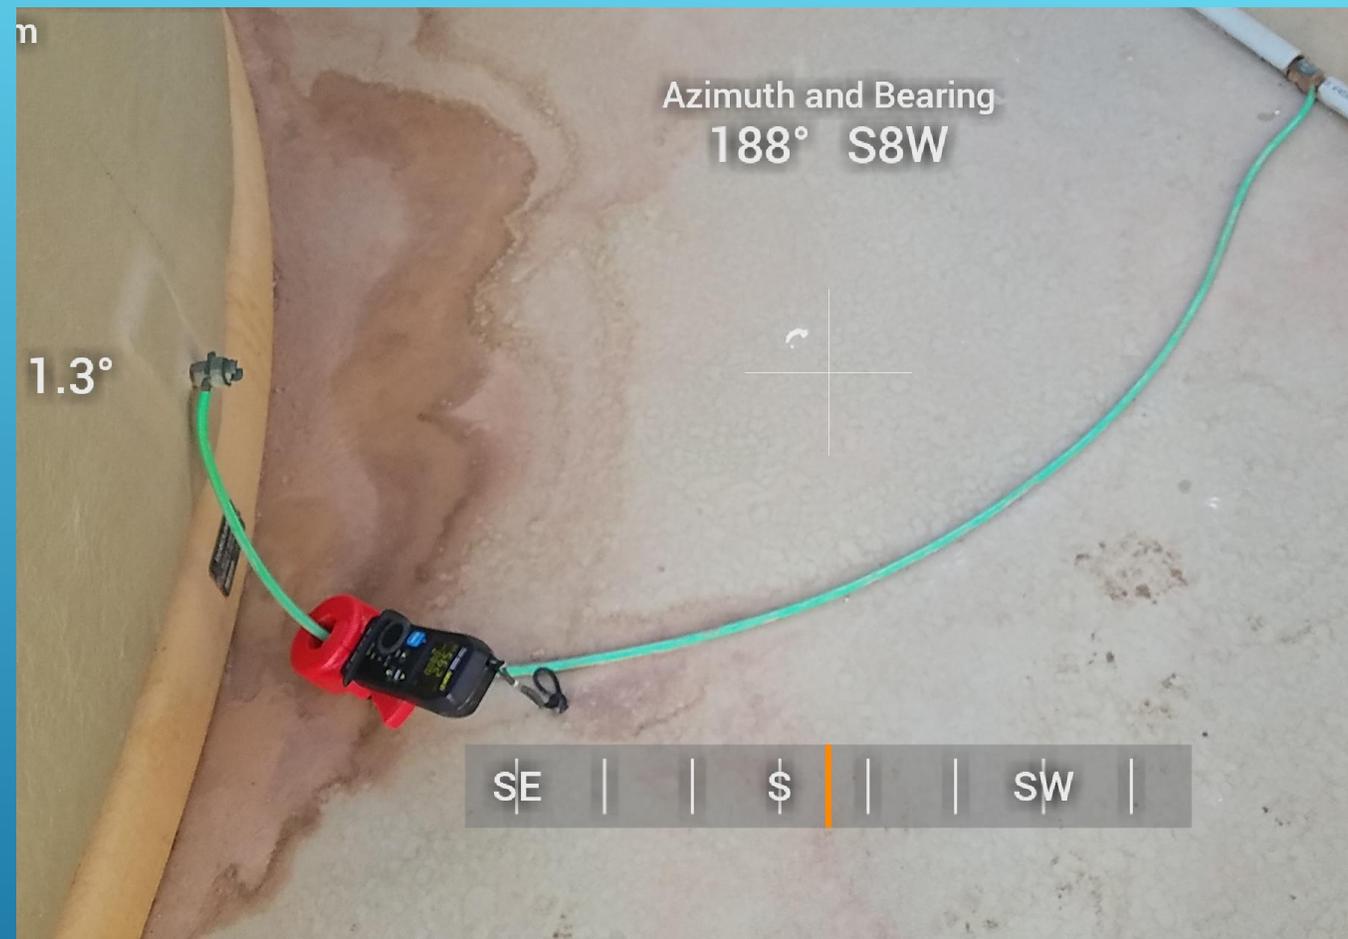
SALT WATER DAMAGE TO COPPER WIRE BONDING HAD CORRODED EVERY BOND AND COMPROMISED WIRES.

295 ohms on grounding tester.

We recommended replacement of all damaged copper, and new testing.

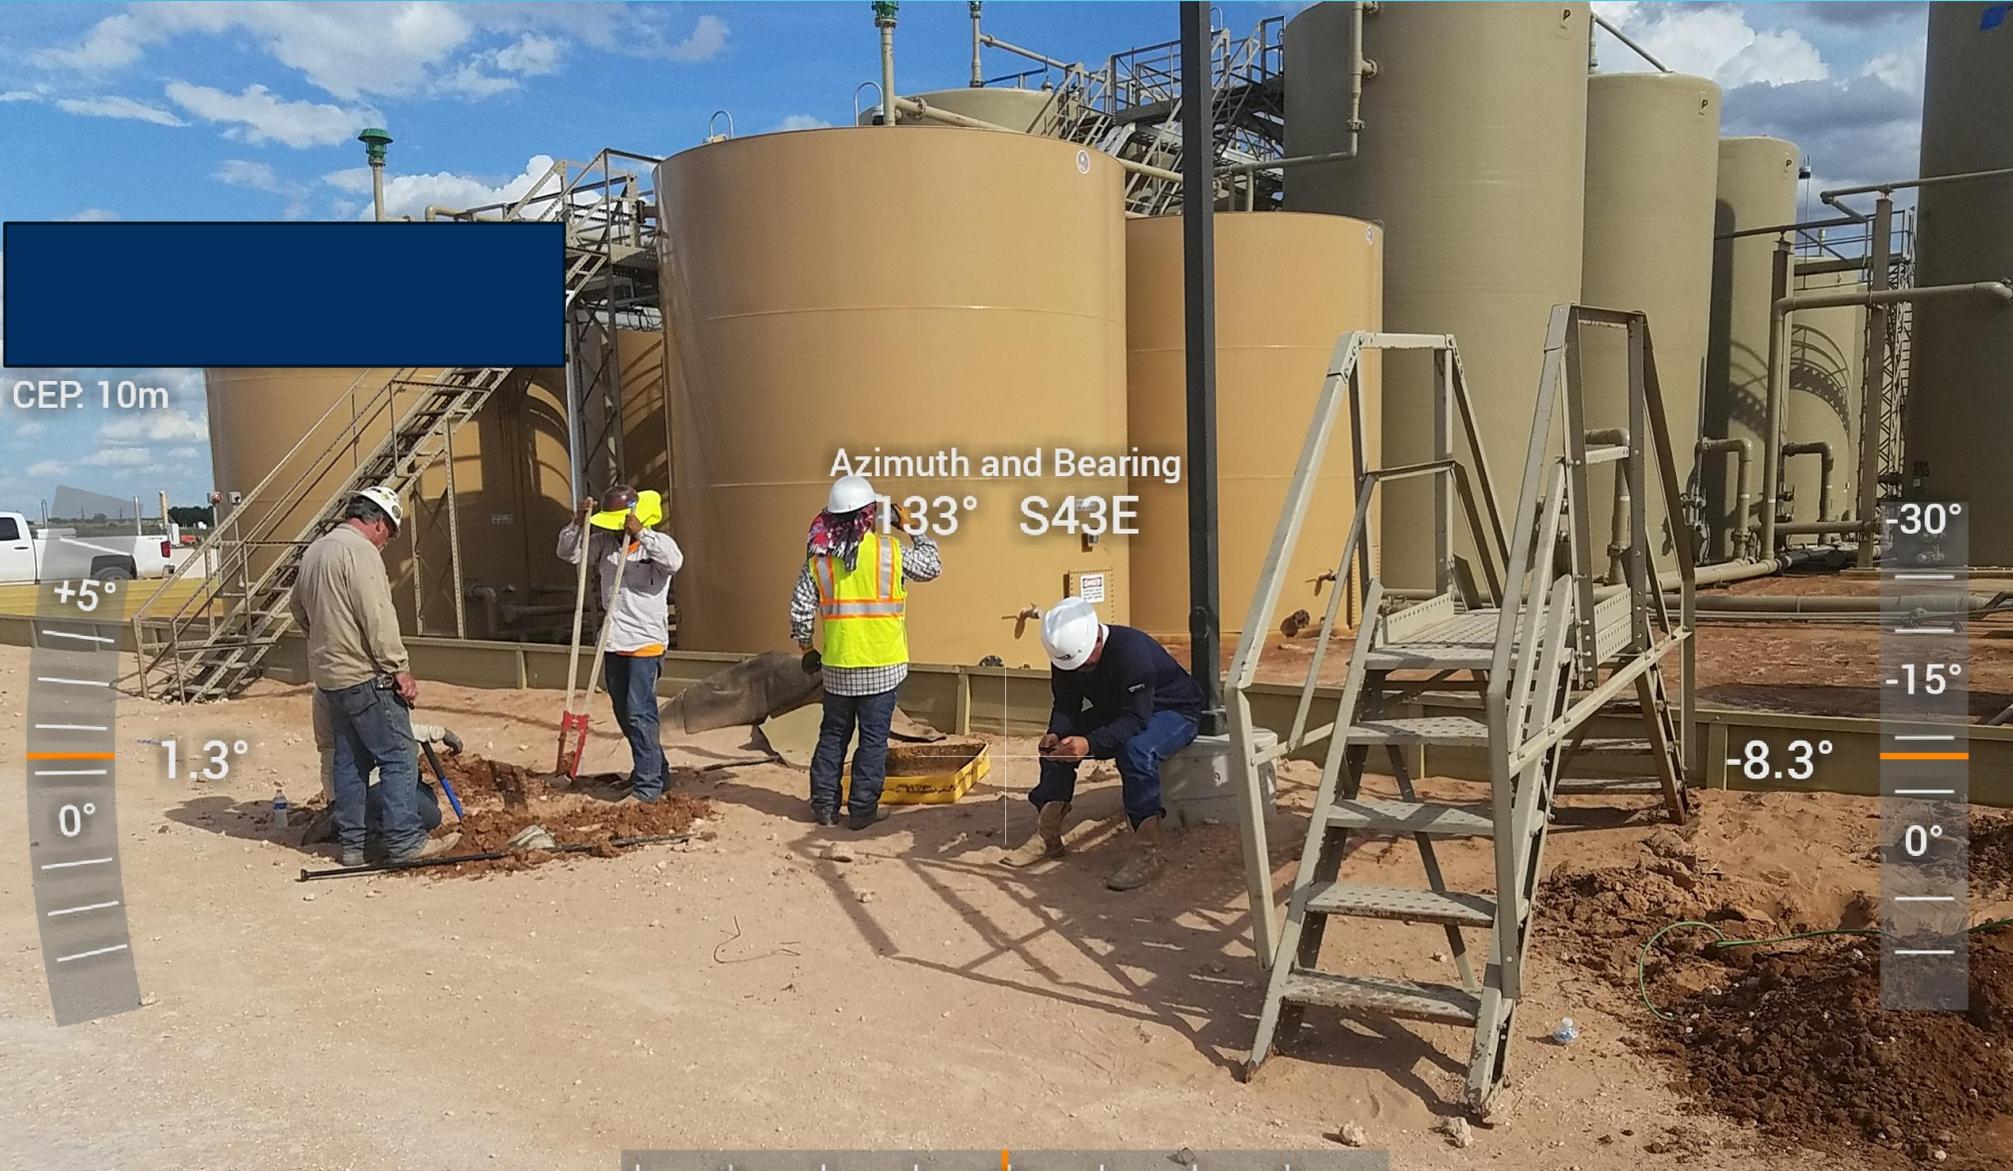
Bond runs ran with stair sets (and other runs) from inside containment to join grounding ring outside the containment. But some did not connect properly. Lots of digging was done to locate cables, then improve connections.
