How to Construct an AC Mitigation system from an operator's perspective

From a 6 month to 1 year perspective

Jon-Michael Brand
T&S Corrosion Project Engineer
Consumers Energy

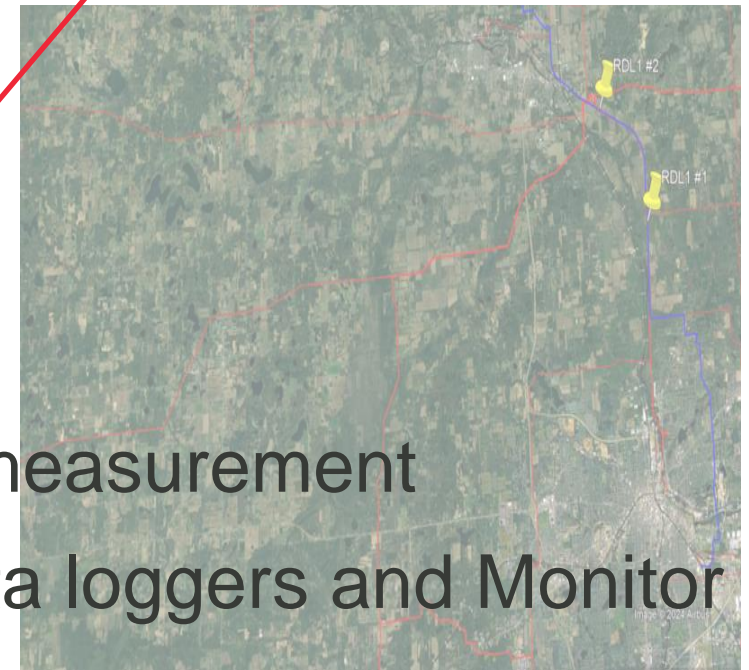
- Annual Survey
 - 6/2/2023 – 7:49 am – 10.1 VAC
 - 6/2/2023 – 9:11 am – 6.4 VAC
- Start interference testing

FACILITY Code and Pipe	Milepost	Location Description	Inspection Date	ACP/S	e P/S	e IRF	Effective Date
LINE: 1300-4	64	107TH AVE	5/19/2023 03:55:48 PM	0	-1.522	-1.112	5/1/2023
LINE: 1300-4	69	MGU PL(E. OF 10TH ST)	5/19/2023 03:56:11 PM	0	-1.269	-1.078	5/1/2023
LINE: 1300-4	70	106TH AVE W/CASING	5/19/2023 03:56:28 PM	0	-1.332	-1.158	5/1/2023
LINE: 1300-4	71	MILLER RD	5/19/2023 03:56:42 PM	-0.001	-1.378	-1.083	5/1/2023
LINE: 1300-4	72	CE ELECTRIC ROW(BTW MILLER & ACORN)	6/2/2023 10:01:33 AM	0.406	-0.972	-0.852	5/10/2023
LINE: 1300-4	74	RR NW OF ACORN ST W/CASING	6/2/2023 09:24:21 AM	1.966	-1.288	-0.908	5/10/2023
LINE: 1300-4	76	M-89 HWY(BRIDGE ST)	6/2/2023 09:21:50 AM	3.028	-1.432	-1.004	5/1/2023
LINE: 1300-4	78	8TH ST	6/2/2023 09:18:04 AM	2.037	-1.645	-1.158	5/1/2023
LINE: 1300-4	80	RIVERVIEW DR(SE OF 8TH ST)	6/2/2023 09:11:52 AM	6.442	-1.529	-1.053	5/1/2023
LINE: 1300-4	83	4TH ST	6/2/2023 08:24:15 AM	4.082	-1.745	-1.151	5/1/2023

LINE: 1300-4	86	B AVE	6/2/2023 08:16:11 AM	2.269	-1.612	-1.136	5/1/2023
LINE: 1300-4	87	1320(S. SIDE OF B AVE)	6/2/2023 08:14:05 AM	1.224	-1.562	-1.158	5/1/2023
LINE: 1300-4	90	TEST LEAD(1.2 MI. OF B AVE)	6/2/2023 08:07:49 AM	10.141	-1.539	-1.101	5/1/2023
LINE: 1300-4	93	D AVE W/CASING	6/2/2023 07:44:11 AM	4.559	-1.405	-1.079	5/1/2023
LINE: 1300-4	94	E AVE	6/2/2023 07:36:54 AM	3.824	-1.48	-1.082	5/1/2023

- Verify measurement
- Set Data loggers and Monitor

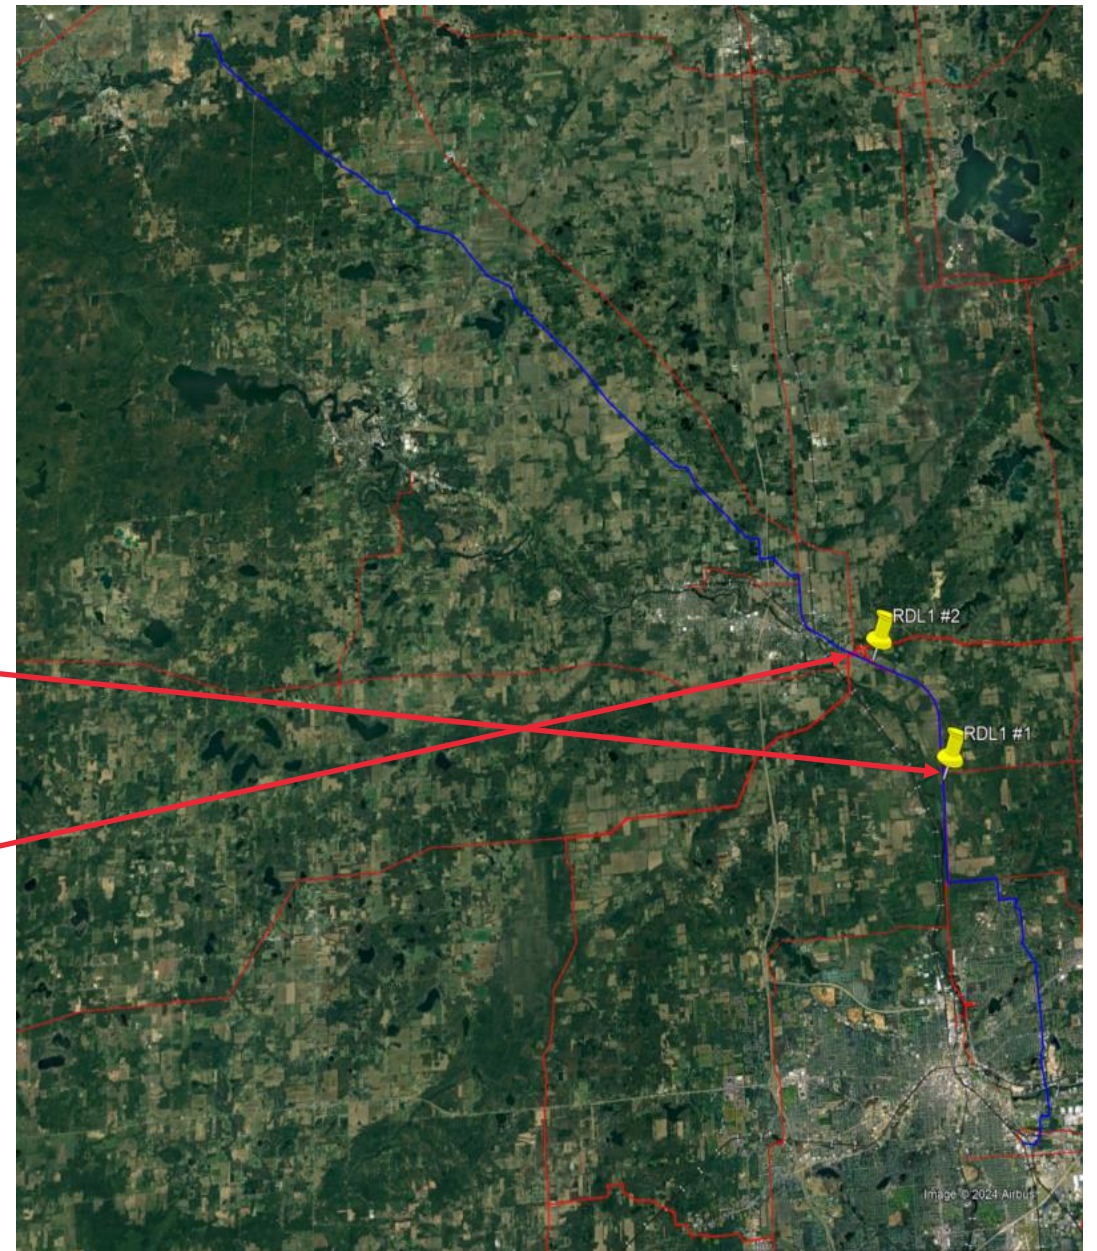
L-1300

- Two RMU data loggers and monitored.

- RDL#1- 1.2 miles of B Ave.
 - 6/2/2023 – 7:49 am – 10.1 VAC

- RDL#2 – Riverview Drive
 - 6/2/2023 – 9:11 am – 6.4 VAC

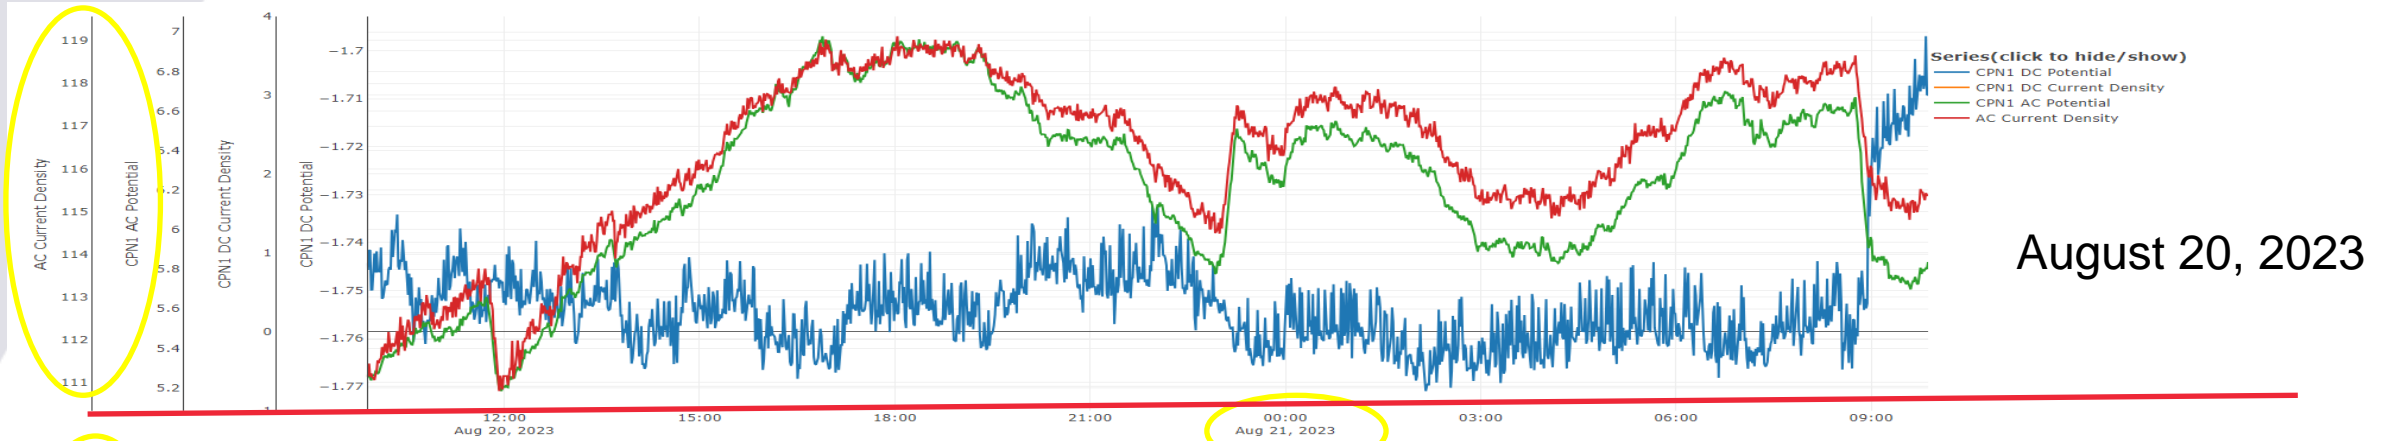
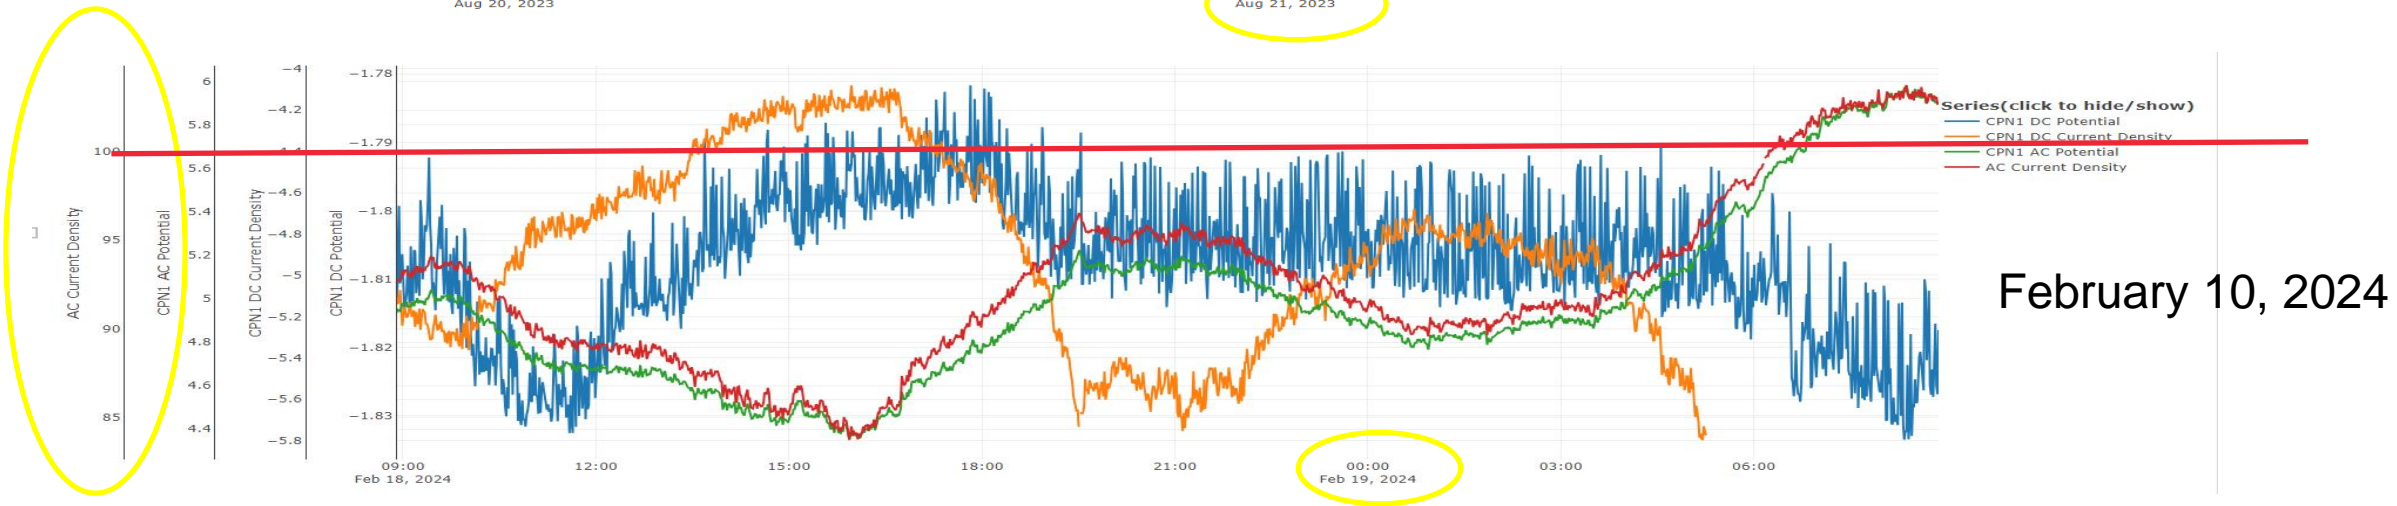
L-1300 RDL#2

- AC Current Density over 100 A/m²
- AC voltage less than 15 VAC

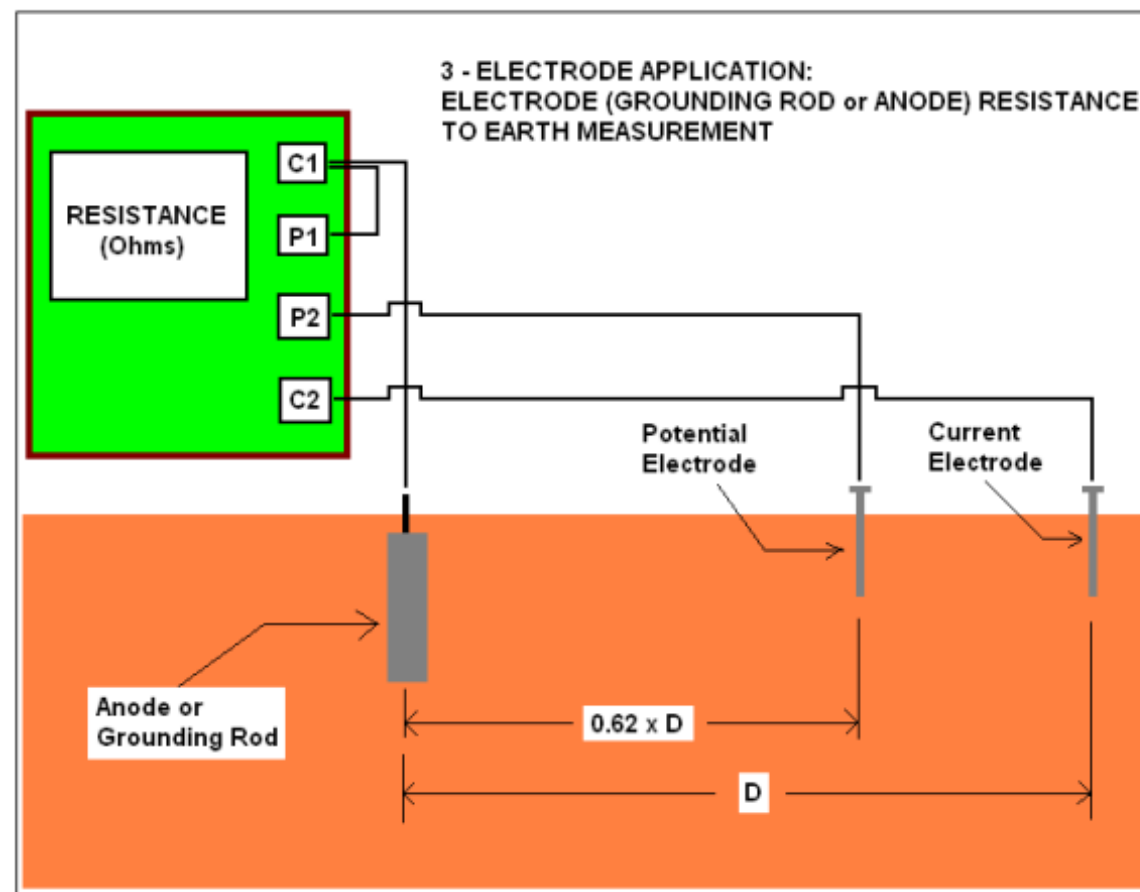
L-1300 Coating Quality Testing

Measurement Ref #	Line	Measured R (ohm)	Conductance (S)2	OD (in)
1	1300-12"	0.88	1.1	12.75
2	1300-12"	0.33	3.0	12.75
3	1300-12"	1.03	1.0	12.75
4a	1300-12"	0.55	1.8	12.75
4b	1300-12"	0.41	2.4	12.75
5	1300-12"	1.18	0.8	12.75
6	1300-12"	1.01	1.0	12.75
21	1300-12"	0.92	1.1	12.75
7	1800-20"	5.75	0.2	20
8	1800-20"	5.23	0.2	20
9	1800-20"	6.02	0.2	20
10	1800-20"	4.54	0.2	20
11	1800-20"	5.25	0.2	20
12a	1800-20"	0.96	1.0	20
12b	1800-20"	1.11	0.9	20
13	1800-20"	5.04	0.2	20
14	1800-20"	#DIV/0!		20
15	1800-20"	0.93	1.1	20
16	1800-20"	2.37	0.4	20
17	1800-20"	3.21	0.3	20
18	1800-20"	1.55	0.6	20
19	1800-20"	0.11	9.1	20
20	1800-20"	0.04	25.0	20

- It is hard to believe that a 1960's era pipeline is experiencing this high of AC current density.
 - This is old coating
 - Very poor coating
 - Hard to cathodically protect
 - Pipe to Earth resistance confirms coating quality
 - ILI and integrity digs are not showing external metal loss due to AC corrosion
 - Issue with measurement
 - Coupon size
 - 1 cm²
 - Is there really this small of holiday on this pipe where AC current is discharging?
 - Moving forward:
 - Monitor AC current densities with a 10 cm² coupon.
 - Continue to monitor
 - Consider increases to HVAC loads
- Timeline**
- **Identified Problem in September of 2023**
 - **Installed and Commissioned in September of 2024**

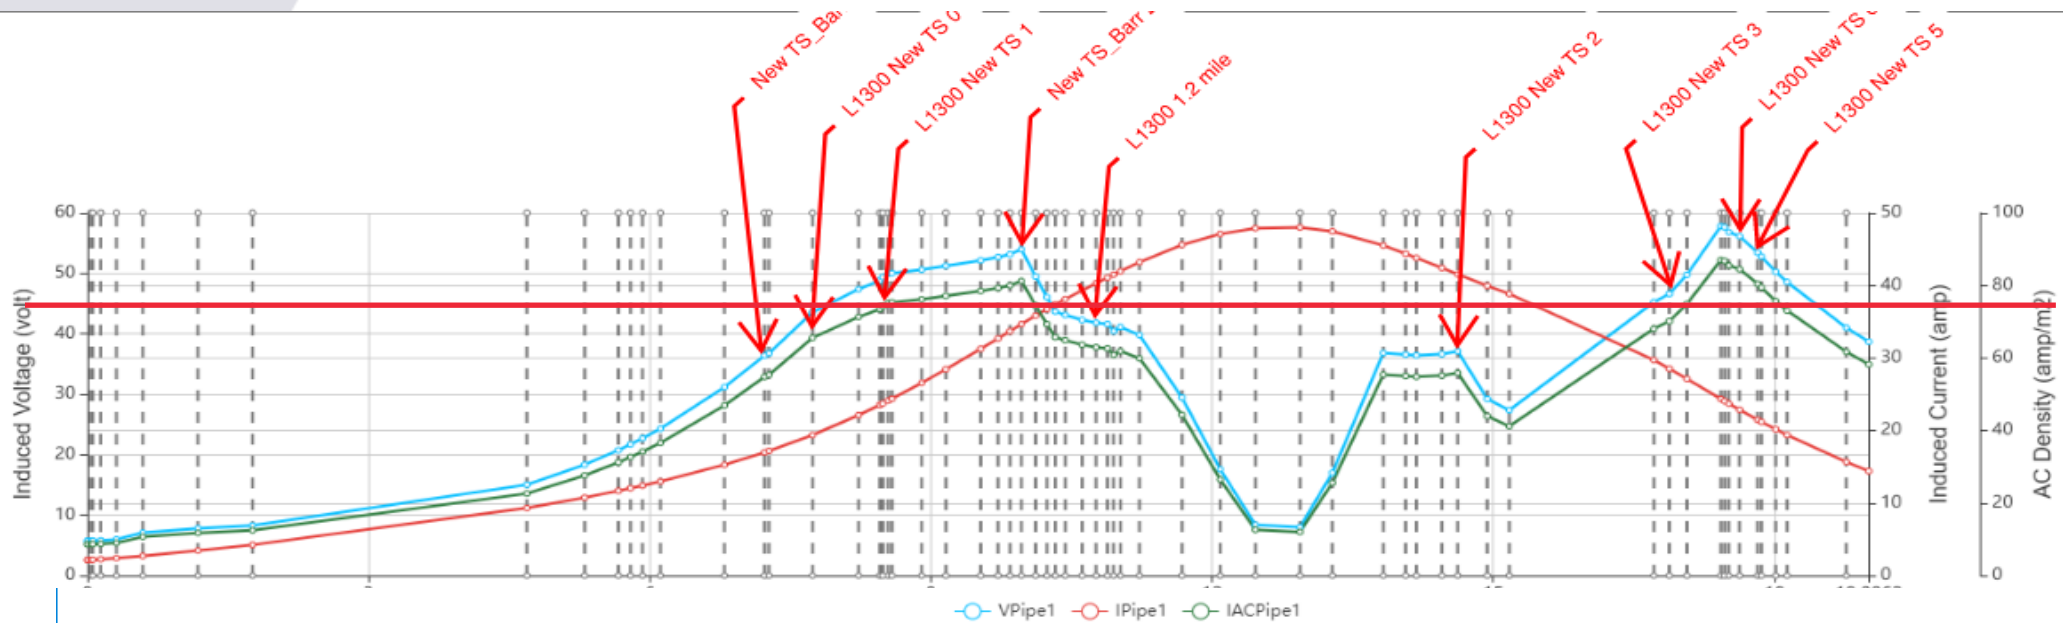
L-1300 Updated Model with New Soil Res Data

NO MITIGATION (UPDATED COATING RESISTANCE)

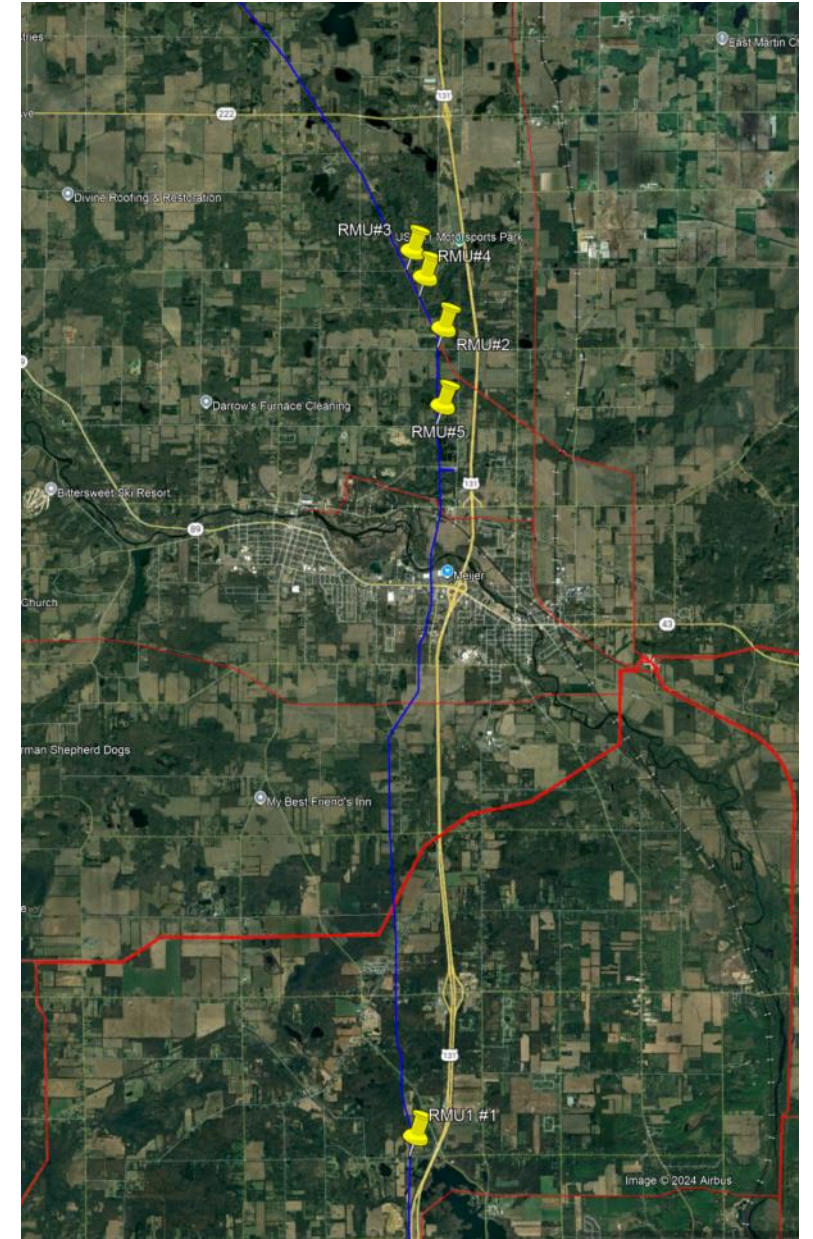
20.817 VAC at 138th Ave on 4/19/2024

- AC Investigation Starts July of 2024
 - 3 months after annual survey
 - 5 RMU Data Loggers Installed in 2023

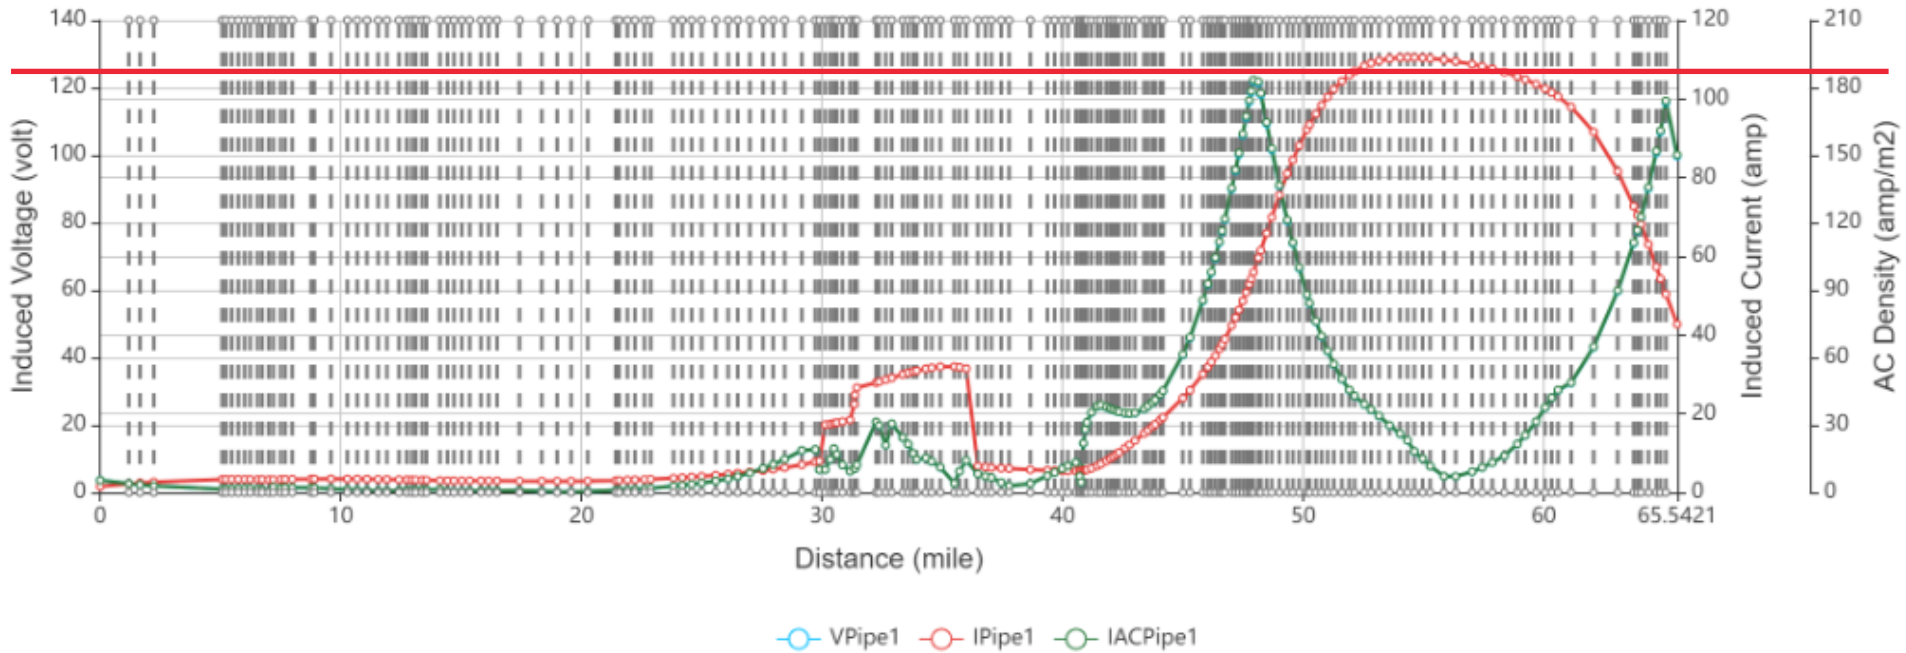
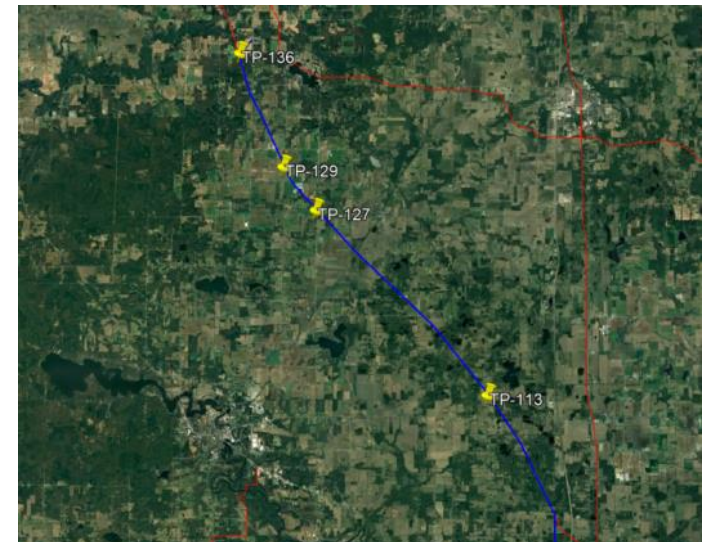
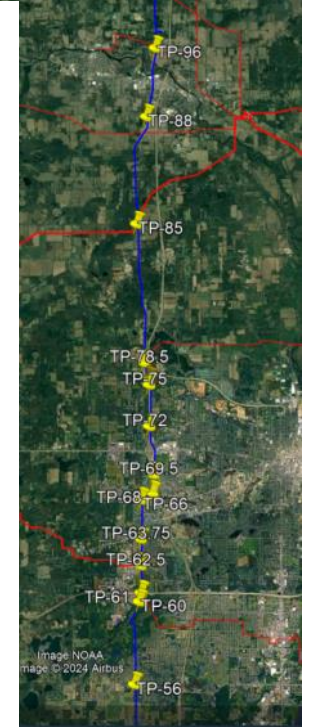
L-1800

- 1st model (PRCI)
- Installed coupon test stations at peak locations
- Monitored with data logger

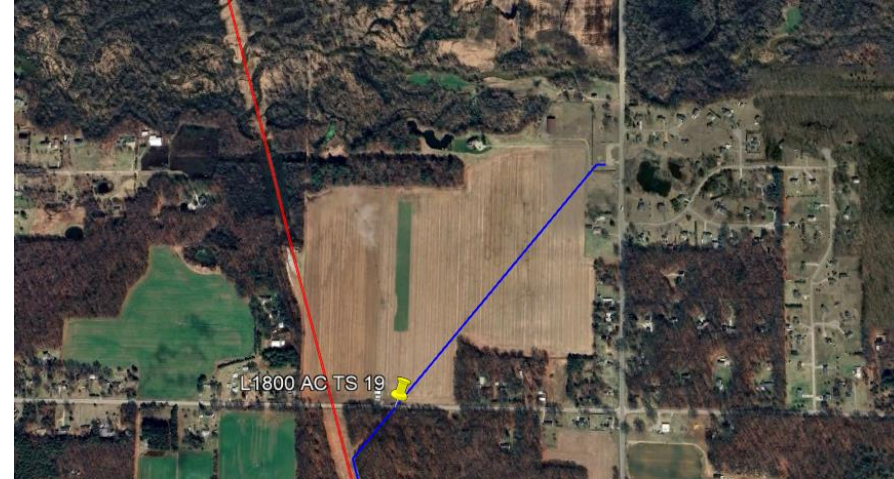
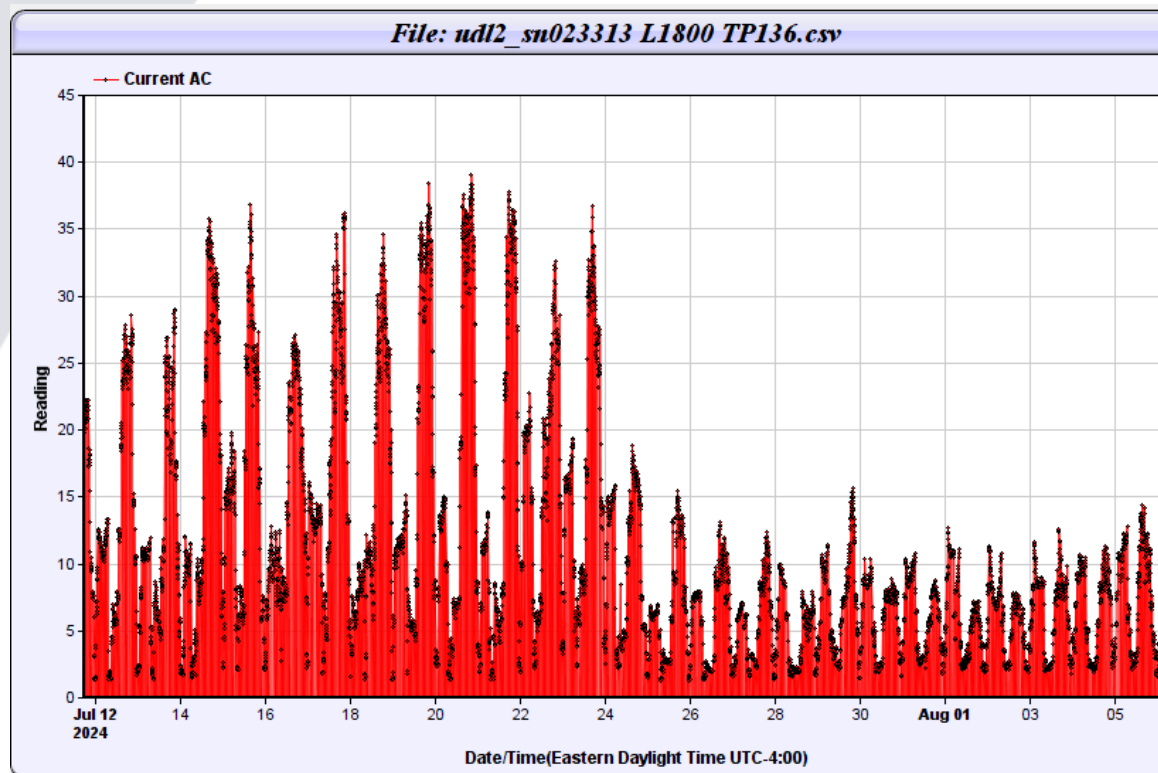
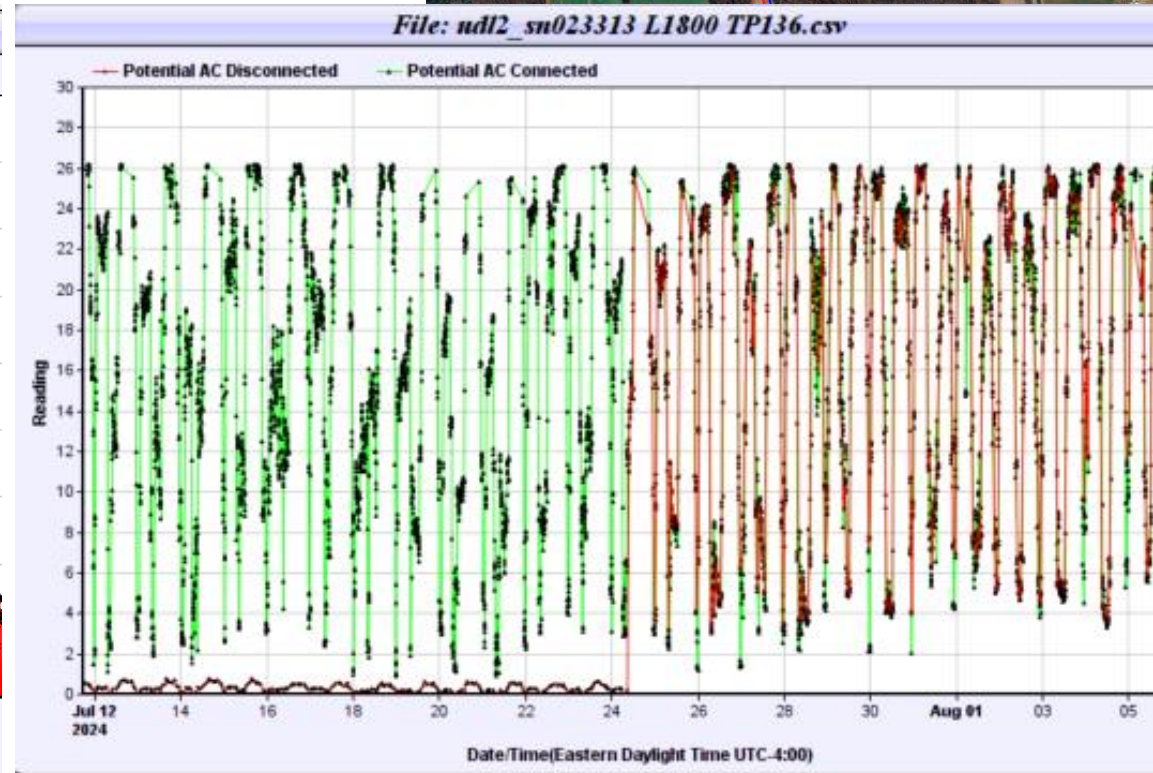
L-1800 Data Logger Data

- The Southern portion of the line shows very little AC interference
- Pulled all southern data loggers
- Two locations show high AC voltages
 - Both where the pipeline and HVAC separate (North and South)

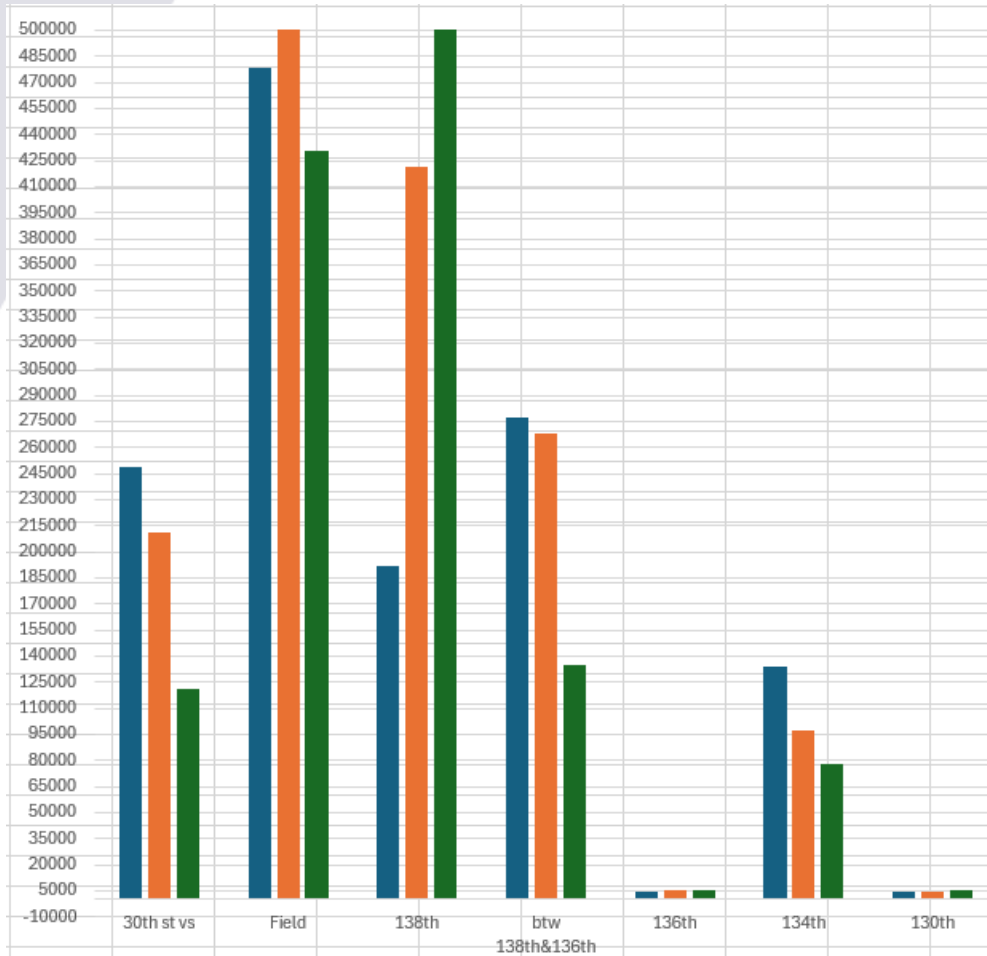
L-1800 Soil Resistivities

Very High Soil Res

- 5' - 191,500 Ohm-cm
- 10' - 421,300 Ohm-cm
- 15' - 545,775 Ohm-cm

Location	pin space (ft)	Resistivity (ohms-cm)
0	5	248,950.0
	10	210,650.0
	15	120,645.0
0.5	5	478,750.0
	10	555,350.0
	15	430,875.0
1	5	191,500.0
	10	421,300.0
	15	545,775.0
1.5	5	277,675.0
	10	268,100.0
	15	135,007.5
1.7	5	4,404.5
	10	4,979.0
	15	5,457.8
2	5	134,050.0
	10	97,665.0
	15	77,557.5
2.5	5	4,883.3
	10	4,979.0
	15	6,032.3
3	5	4,117.3
	10	4,596.0
	15	5,457.8

- Install mitigation ribbon on the North and South end where L-1800 exits/enters the HVAC corridor.
- Improve model to assist with changes in future HVAC loads

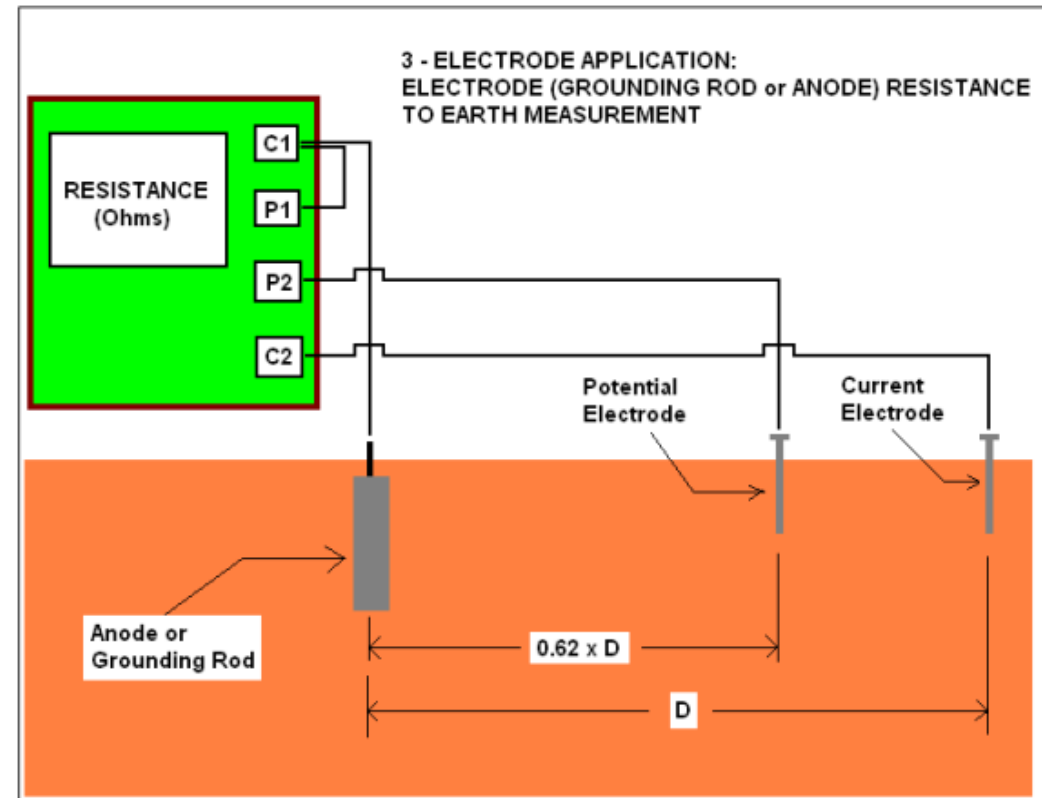
L-1800 Coating Quality Testing

Measurement Ref #	Line	Measured R (ohm)	Conductance (S) ²	OD (in)
1	1300-12"	0.88	1.1	12.75
2	1300-12"	0.33	3.0	12.75
3	1300-12"	1.03	1.0	12.75
4a	1300-12"	0.55	1.8	12.75
4b	1300-12"	0.41	2.4	12.75
5	1300-12"	1.18	0.8	12.75
6	1300-12"	1.01	1.0	12.75
21	1300-12"	0.92	1.1	12.75
7	1800-20"	5.75	0.2	20
8	1800-20"	5.23	0.2	20
9	1800-20"	6.02	0.2	20
10	1800-20"	4.54	0.2	20
11	1800-20"	5.25	0.2	20
12a	1800-20"	0.96	1.0	20
12b	1800-20"	1.11	0.9	20
13	1800-20"	5.04	0.2	20
14	1800-20"		#DIV/0!	20
15	1800-20"	0.93	1.1	20
16	1800-20"	2.37	0.4	20
17	1800-20"	3.21	0.3	20
18	1800-20"	1.55	0.6	20
19	1800-20"	0.11	9.1	20
20	1800-20"	0.04	25.0	20
